Arboricultural Inventory and Report

Bosa Waterfront Landing
Laurelwood Road -Squamish, BC

Date: January 23, 2020

Revised: February 17, 2021

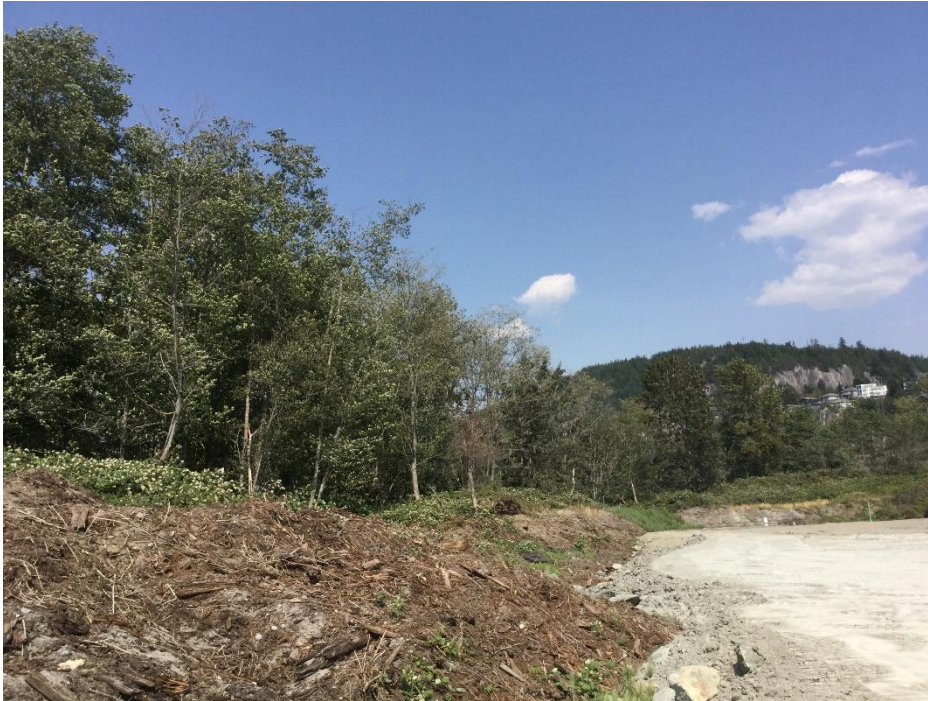
Photo 1. Northeastern section of assessment area, limited by rail right of way.

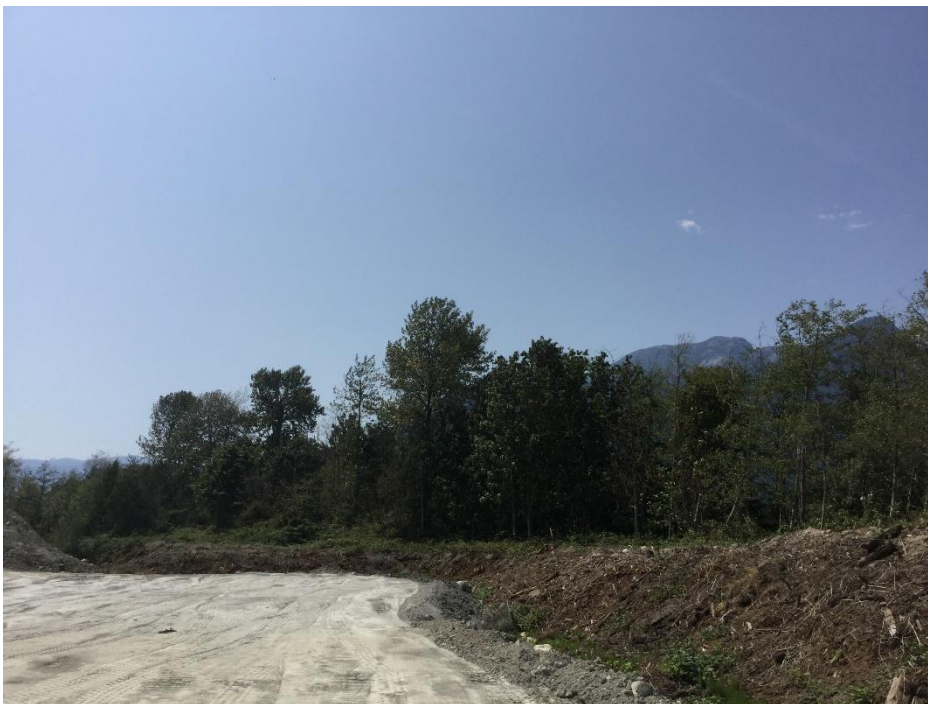
Photo 2. Middle portion of assessment area.

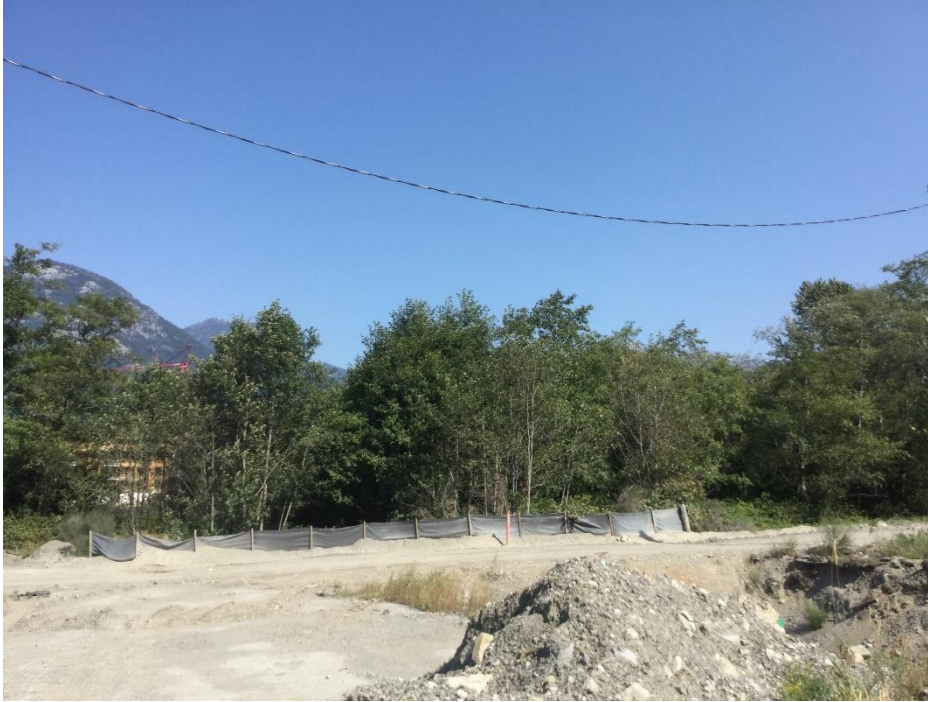
Photo 3. Western portion of assessment area.

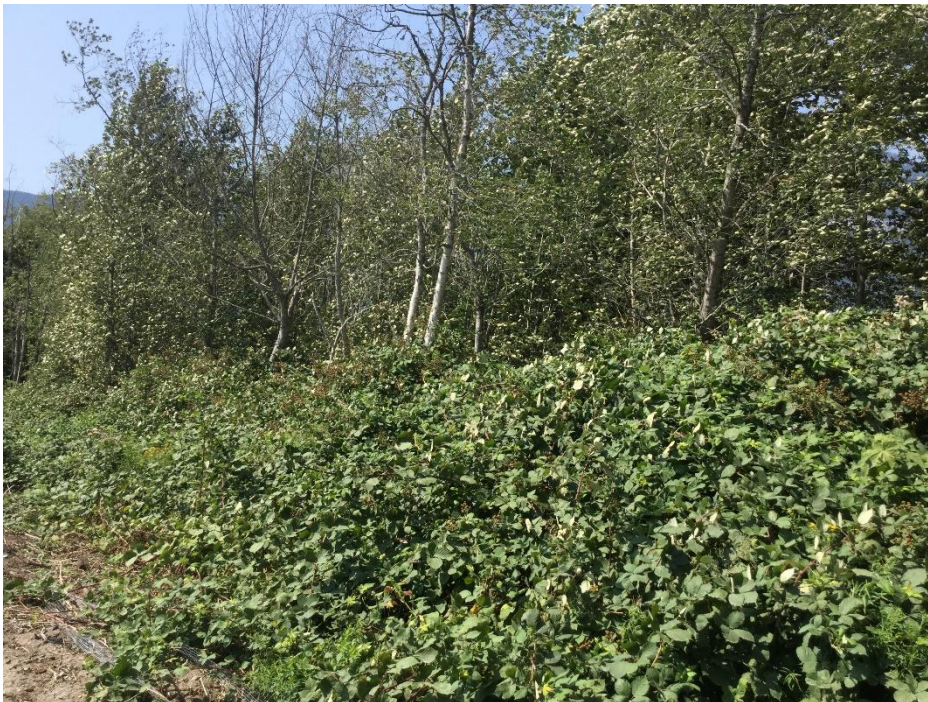
Photo 4. Extremely dense blackberry was encountered throughout the site.

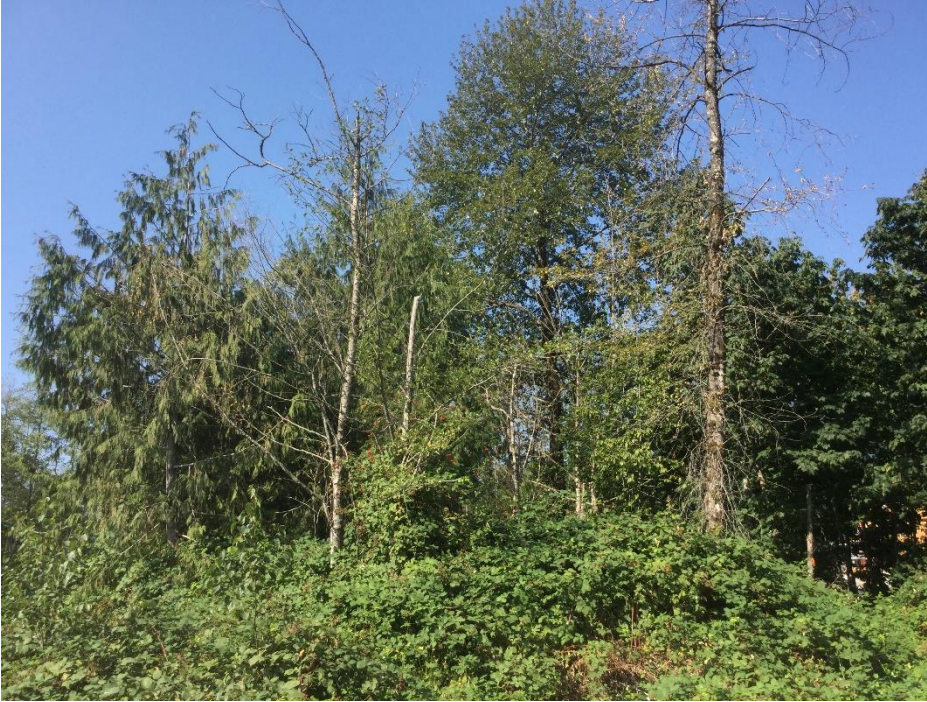
Photo 5. Trees on the site tended to poor condition.

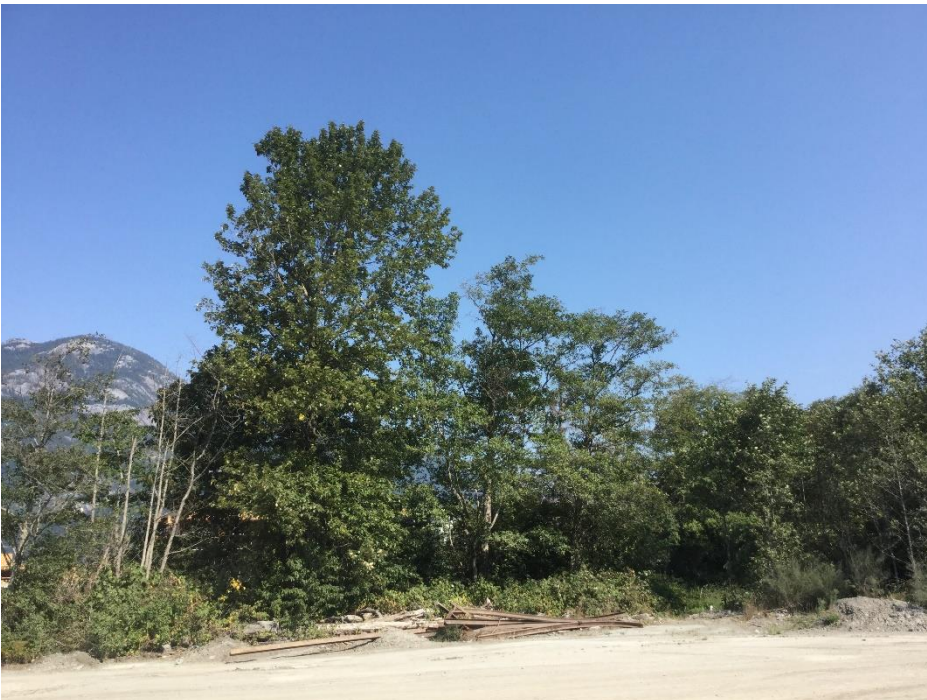
Photo 6. Some healthy specimens were also found.

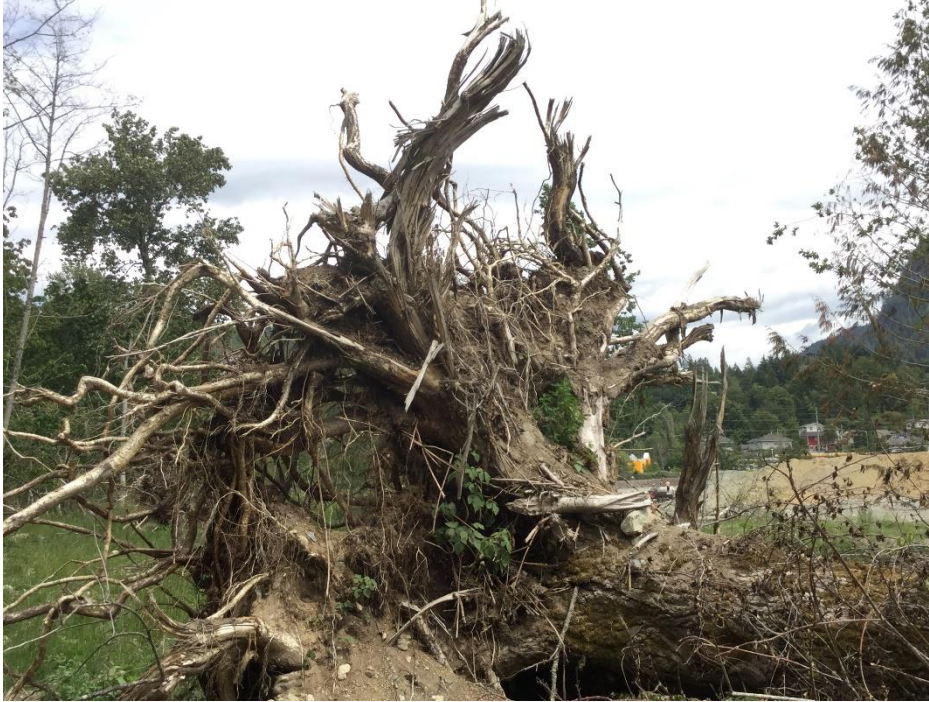
Photo 7. Evidence of historic windthrow.

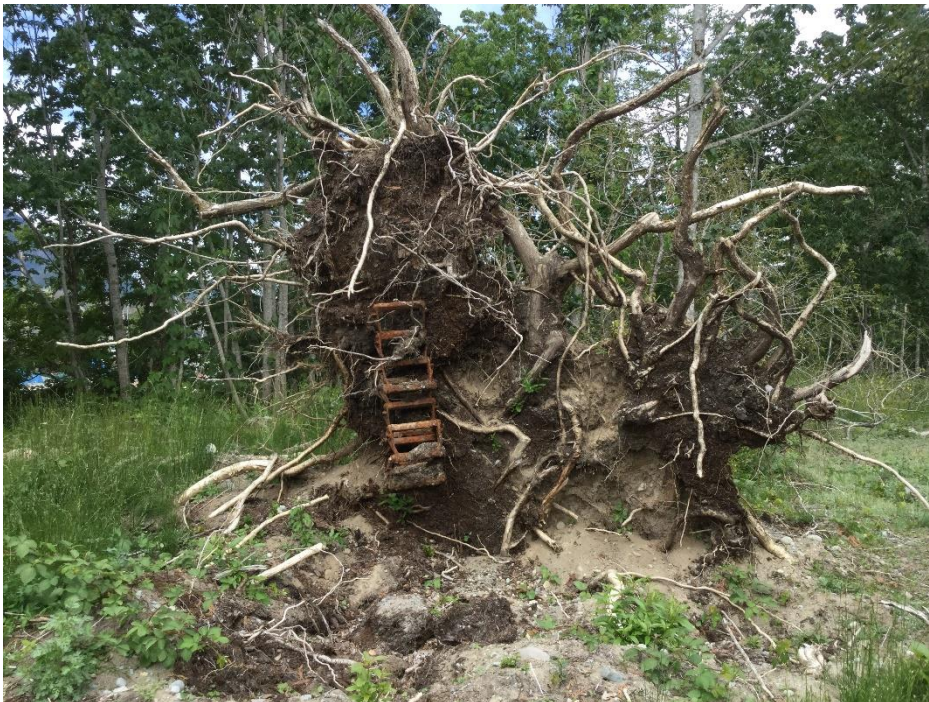
Photo 8. Heavily disturbed soil from previous industrial use.
