MEMORANDUM

DATE: November 24, 2014
TO: Deborah McQueen, Hummingbird Lane Joint Venture
Triage and Planning Unit, Fisheries and Oceans Canada
CC: Caroline Ashekian, Environmental Coordinator, District Of Squamish
Sarah McJannet, Acting Director of Planning, District of Squamish
FROM: Mike Nelson, R.P. Bio., Cascade Environmental
Karlene Loudon, B.Sc., B.T.M., Cascade Environmental
RE: Riparian Area Regulation Assessment for 1038 Finch Drive, Squamish, BC
FILE #: 604-01-01

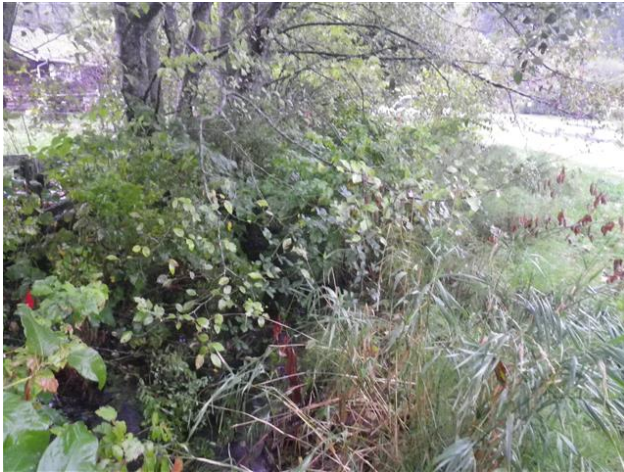
South Ditch – The south ditch is the largest of the ditches and runs just outside of the southern boundary of the property, along Finch Drive (Map 1; Photo 1). The average channel width is 1.51 m. The ditch was dry during the RAR assessment (June 27, 2014), but contained water during the follow up visits (October 23, 27 & 28, 2014), with a maximum water depth of approximately 40 cm. Water and sediment are orange in color and heavily oxidized. On October 28, 2014, the water temperature was 9.9 °C, turbidity was 7.34 NTU, pH was 4.75 and dissolved oxygen was 3.8 mg/L (34%). Bed materials are dominantly silty fines, leaf litter and organic debris. Both banks are moderately sloped. There is no large woody debris in the ditch as it is a maintained roadside ditch; however, overgrown shrubs and young coniferous trees offer cover. The southern property line and south ditch are defined by a row, approximately 1 to 6 m wide, of young western redcedar (*Thuja plicata*), Sitka spruce (*Picea sitchensis*), blue spruce (*P. Pungens*), red alder (*Alnus rubra*), salmonberry (*Rubus spectabilis*) and a large infestation of Japanese knotweed (*Fallopia japonica*; Photo 3). No fish were found during minnow trapping; however, one northern red-legged frog (*Rana aurora*) was caught (Photo 2). The northern red-legged frog is Blue listed in BC and listed as a species of Special Concern by the Committee on the Status of Endangered Wildlife in Canada (COSEWIC).

Photo 1: Looking east along Finch Drive at south ditch. October 23, 2014.

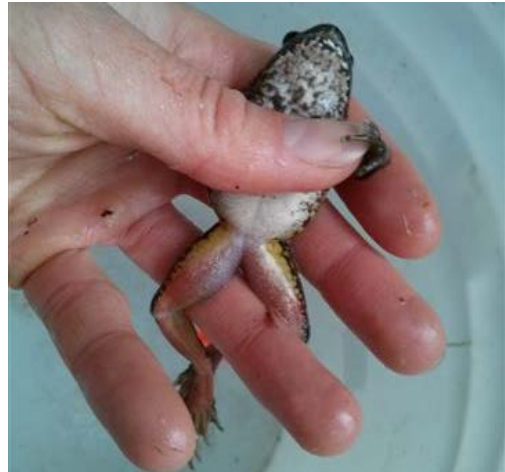
Photo 2: Northern red-legged frog found in a minnow trap in south ditch. October 28, 2014.

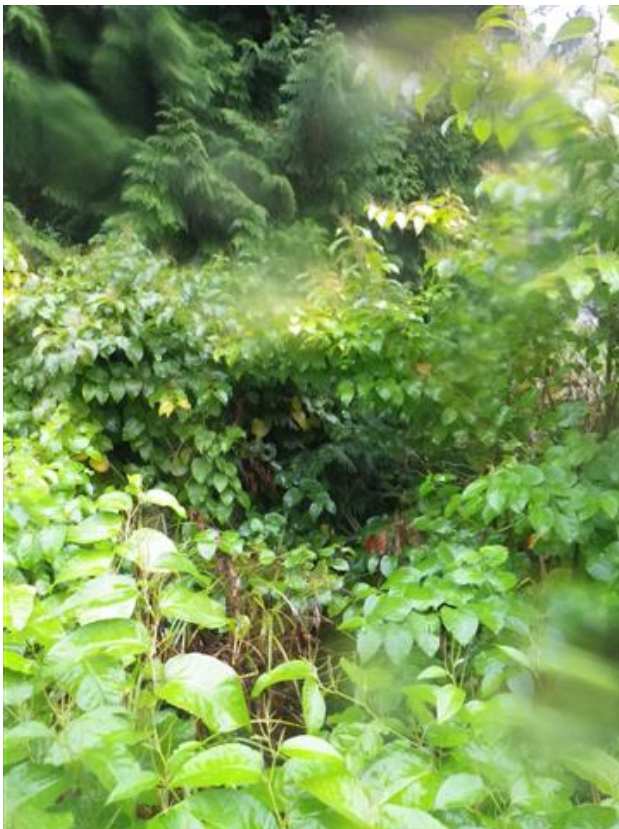
Photo 3: Japanese knotweed along south and east ditch, to be removed as part of the compensation project. October 23, 2014.

Multiple copses of Japanese knotweed (*Fallopia japonica*) have been observed on site. Japanese knotweed is an aggressive, persistent, invasive species that “spreads rapidly through root systems that may extend from a parent plant up to 20 metres laterally and up to a depth of 3 metres. They thrive on freshly disturbed soil in moist locations. Knotweeds are dispersed by human activities or by water to downstream areas, and are of particular concern in riparian areas and areas prone to seasonal high water or flooding. Plants emerge in early spring and produce large leaves that can shade out other plant species. Infestations can dominate stream banks and reduce sight lines along roads, fences, and rights-of-way.” (IPCBC, 2014). Eradication of this species from the subject site is recommended.

Control of Japanese knotweed is difficult (a list of appropriately qualified professionals can found on the Sea to sky Invasive Species Council web site (www.ssisc.info)). Mechanical Control (mowing and cutting) can be effective if done close to the ground, twice per month between April and August, then monthly until the first frost. This treatment needs to be repeated for at least 5 years to exhaust root reserves. Mechanically controlled areas should be monitored throughout the growing season to ensure new infestations do not develop from root fragments. All cut plant parts need to be collected and disposed of at the Squamish Landfill. Care should be taken to ensure that plant parts are not distributed during transport (IPCBC, 2014). The Sea to Sky Invasive Species Council also notes that a combination of cutting and smothering can be used (SSISC, 2014). Chemical control, typically glyphosate, is not recommended adjacent to or within riparian areas.

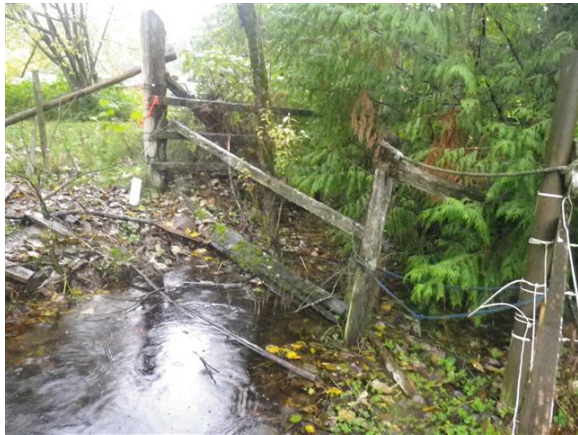
Photo 4: Looking north at the connection between west ditch and north ditch. October 23, 2014.

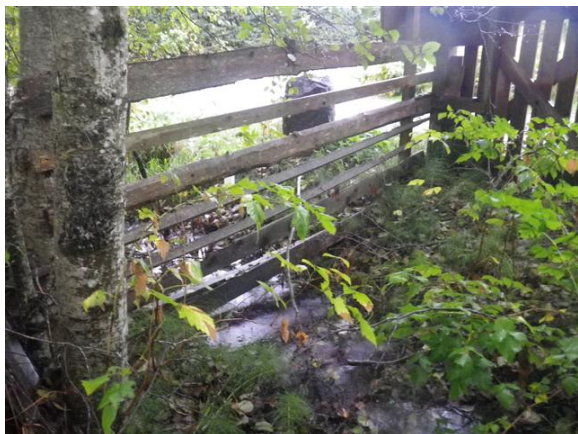
Photo 5: Looking southwest at the southwest corner of the subject property, where west ditch flows into south ditch. October 23, 2014.

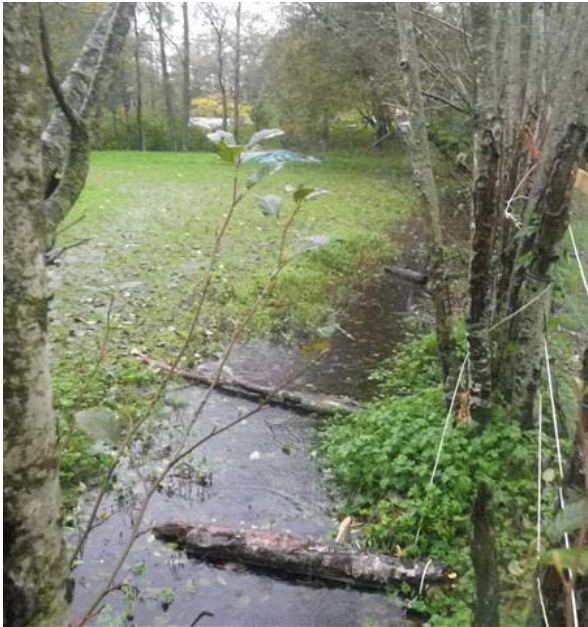
West Ditch – The west ditch straddles the western property line. It receives drainage water from neighbouring properties, as well as the western portion of north ditch (Photo 4) and an unnamed ditch that flows from the north. West ditch flows south and, during high water storm events, is connected to south ditch (Photo 5). At all but the highest water events, west ditch is interrupted by an elevated portion of ground at its midway point, creating stagnant water conditions. It has an average channel width of 1.38 m (Photo 6). West ditch was dry during the RAR assessment (June 27, 2014), but contained water during the follow up visit (October 23, 2014) with a maximum water depth of approximately 30 cm. On October 28, 2014, the water temperature was 9.8 °C, turbidity was 4.53 NTU, pH was 4.5 and dissolved oxygen was 3.2 mg/L (28%). There is no large woody debris and minimal cover for fish. Both banks are shallow. Bed materials consist of fines with a thick layer of leaf litter. Grass is well established in the bed of the ditch. West ditch is lined by a row, approximately 0 to 2 m wide, of red alder, western redcedar, small-flowered bulrush (*Scirpus microcarpus*) and grasses.

Photo 6: Looking north along west ditch at high water. October 23, 2014.

The creation of a 2.0 m wide rain-garden is proposed for west ditch, which, given the current lack of vegetation, will offer increased greening, encourage movement of storm water and decrease stagnant water onsite. The rain-garden would be planted with native, moisture absorbing riparian plant species. A 5.0 m SPEA is proposed for east ditch and north ditch, which meet RAR and DPA 11 requirements. A 5.0 m setback is proposed for south ditch, with an additional 5.0 m strip of community garden adjacent, which meets DPA 11 requirements. The 10.0 m setback preserves 330 m² of land adjacent to south ditch, which is being offered, in conjunction with extensive riparian planting (as noted below) as compensation for the reduced SPEA along west ditch and the removal of the two to three alders in the northeast corner of the property.

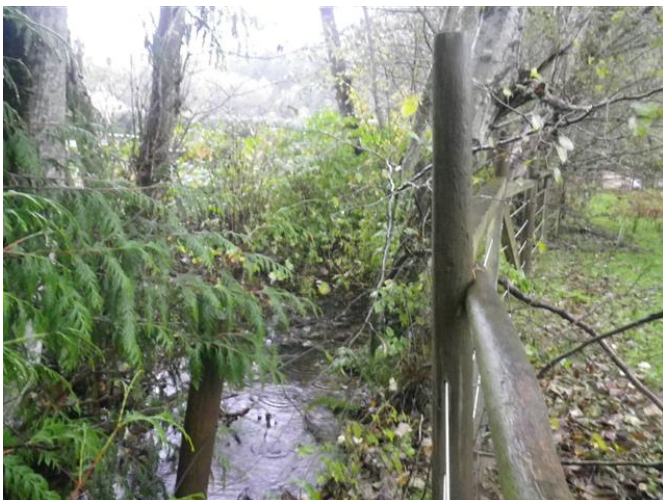
North Ditch – North ditch straddles the northern property line, with an east-west orientation (Photo 7). It receives drainage water from the neighboring properties. It is interrupted by a high point of land approximately half way along the ditch. Water flows away from the high point. North ditch is connected to west ditch and east during storm events. Detailed assessment calculations reveal the average width to be 1.89 m. The ditch was dry during the RAR assessment on June 27, 2014, but held a maximum water depth of approximately 25 cm on October 23, 2014. Water quality was tested on October 28, 2014. Water temperature was 9.8 °C, turbidity was 4.22 NTU, pH was 4.5 and dissolved oxygen was 3.3 mg/L (29%). There is no large woody debris in the ditch and minimal vegetation cover. The south bank of north ditch is shallow, while the north bank has a moderate slope. The substrate consists of organic fines with established grasses and a thick layer of leaf litter. North ditch is delineated by a strip, approximately 0 to 1 m wide, of red alder, salmonberry, hardhack (*Spiraea douglasii*), bracken fern (*Pteridium aquilinum*), red-osier dogwood (*Cornus sericea*) and willow (*Salix* spp.).

Photo 7:
Looking east along north ditch, with the high portion of land (dis-connectivity) located at the base of the alder trees at the top/centre of the photo. October 23, 2014.

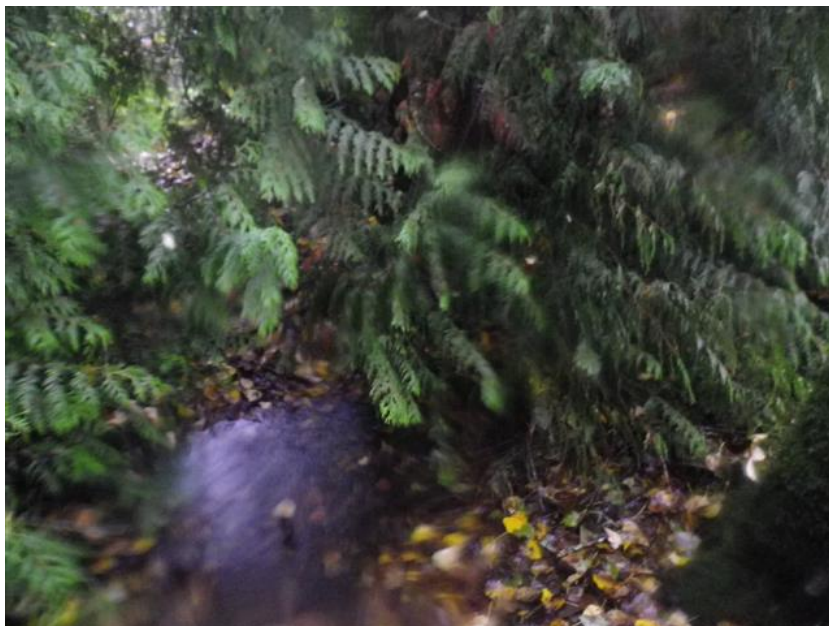
East Ditch – East ditch straddles the eastern property boundary (Photo 8). It receives drainage water from the neighbouring properties as well as a small ditch that flows in from the east at the northeast corner of the subject lot. When water is present in the ditch (e.g. October 23, 2014), it reaches a maximum depth of 20 cm, and flows to the south along the property line before discharging into south ditch. Through a detailed assessment, the average channel width was calculated as 1.84 m. Water quality on October 28, 2014 revealed a water temperature of 9.5 °C, turbidity of 11.4 NTU, pH of 4.75 and dissolved oxygen of 5.7 mg/L (50%). Both banks are shallow. The substrate consists of organic fines with a thick layer of leaf litter. There is no large woody debris in the ditch, but the riparian vegetation does offer a significant amount of cover. East ditch is delineated by a strip, approximately 1 to 8 m wide, of young red alder, western redcedar, willow and salmonberry.

Photo 8:
Looking east at east ditch during the high water event. October 23, 2014.

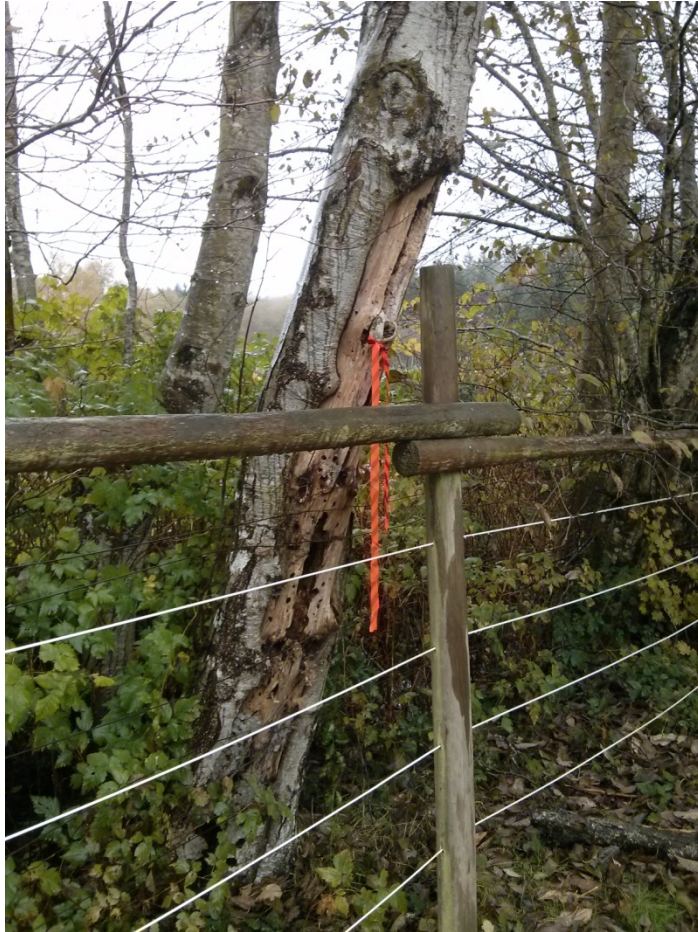
Of the trees to be fallen, one offers high wildlife value and the others are ranked as low wildlife value. All trees that were deemed to be dangerous were red alders. The wire and wood fences along the west and north ditches have scared many of these trees, leaving them susceptible to fungal infections and rot. Trees assessed as safe must be reassessed if, prior to the work activity commencing, an intervening winter or major disturbance event has occurred, or if the level of disturbance is increased, or if the trees are subject to winds above 65 km/hr.

Photo 9: Tree #15, along north ditch, was assessed as dangerous due to stem damage and internal rot. Evidence of wildlife feeding is present, making this the only tree ranked with a high wildlife value. This tree is leaning towards the development and is slated for removal.

An effort will be made to retain the existing riparian trees, especially the four large conifers present in the southeast corner of the property when finalizing the location of the site access road / driveway. The 12 hazard trees to be removed from the riparian area will be mitigated through replanting using the BC Provincial Tree Replacement (MOE, 1996), along with the trees to be removed for creation of the rain-garden along the west ditch. If the two identified trees located adjacent to the south ditch are also removed, their removal should also be mitigated through adherence to the tree replacement criteria. The BC Provincial Tree Replacement criteria is as follows:
