# Cheekeye River Fan Geohazards, risks and residential development

July 15, 2014, Squamish

DR. MATTHIAS JAKOB, P.GEO. AND DR. SCOTT MCDOUGALL, P.ENG. BGC ENGINEERING INC.

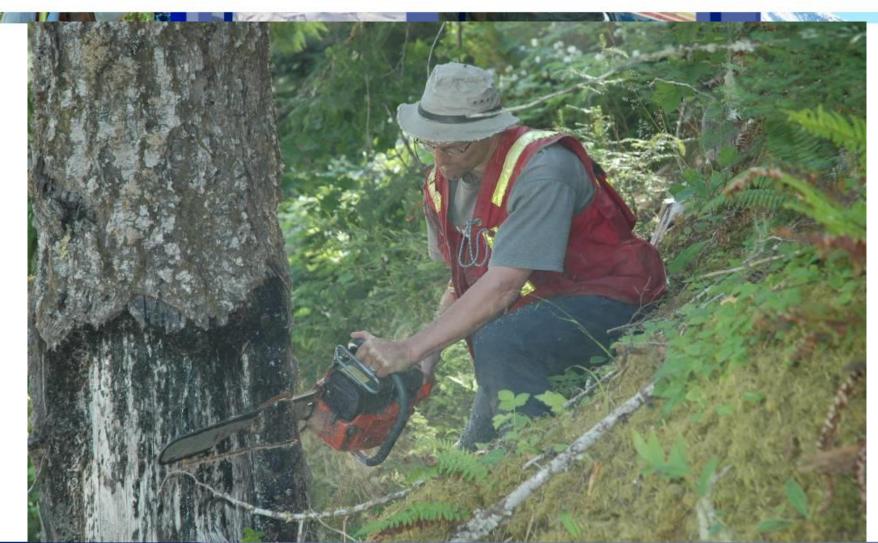
# Dendrochronolgy

### Dendrochronolgy

- Sample locations
  - 1,3 Events recorded
    - Channel cross sections

- ~60 wedges, cores, discs sampled along channel
- Cross-sections reconstituted along confined reaches
- Discharge back-calculated
