DISTRICT OF SQUAMISH  
PROJECT #: 18P-00095-00

# UPPER JIMMY-JIMMY (JUDD) SLOUGH ENHANCEMENT CULVERT FEASIBILITY MEMORANDUM

MAY 28, 2020

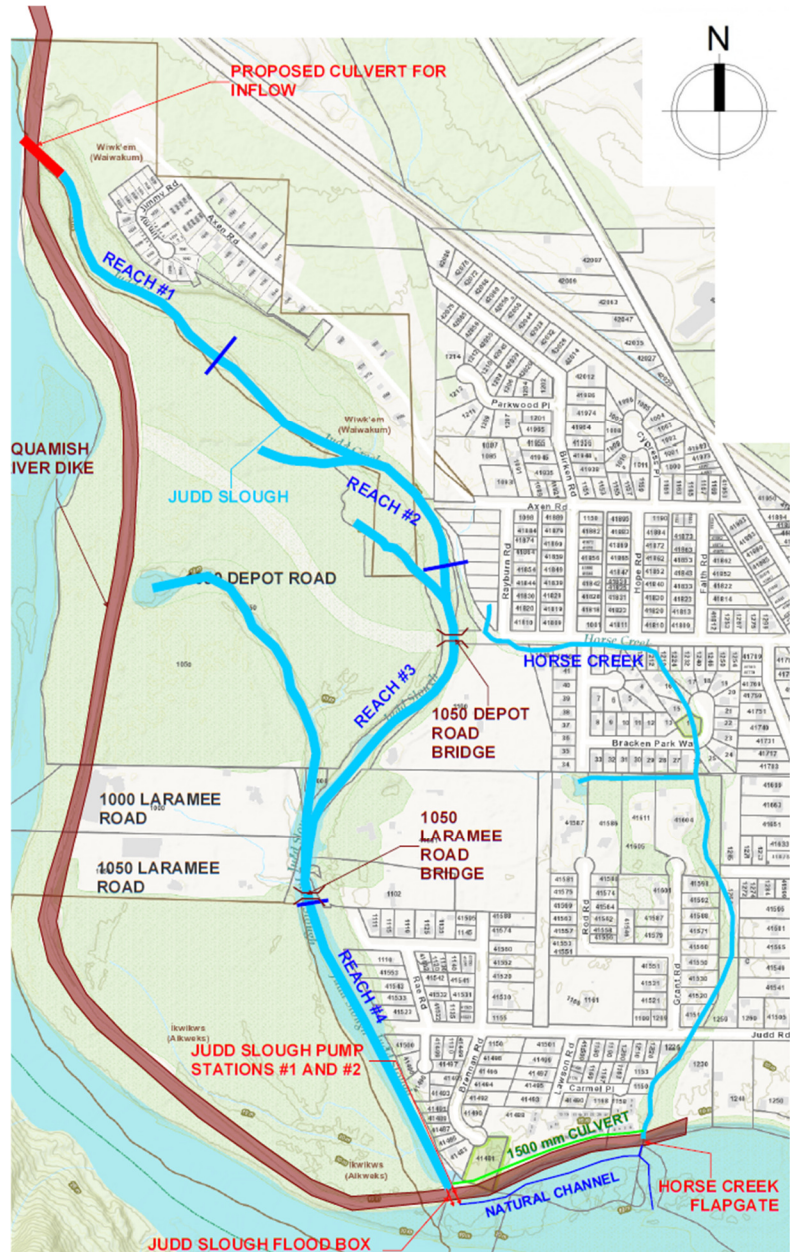
Figure 1-1: Judd Slough Overview Map

This technical memorandum evaluates the feasibility of a manual gate-controlled culvert at the north end of the Slough.

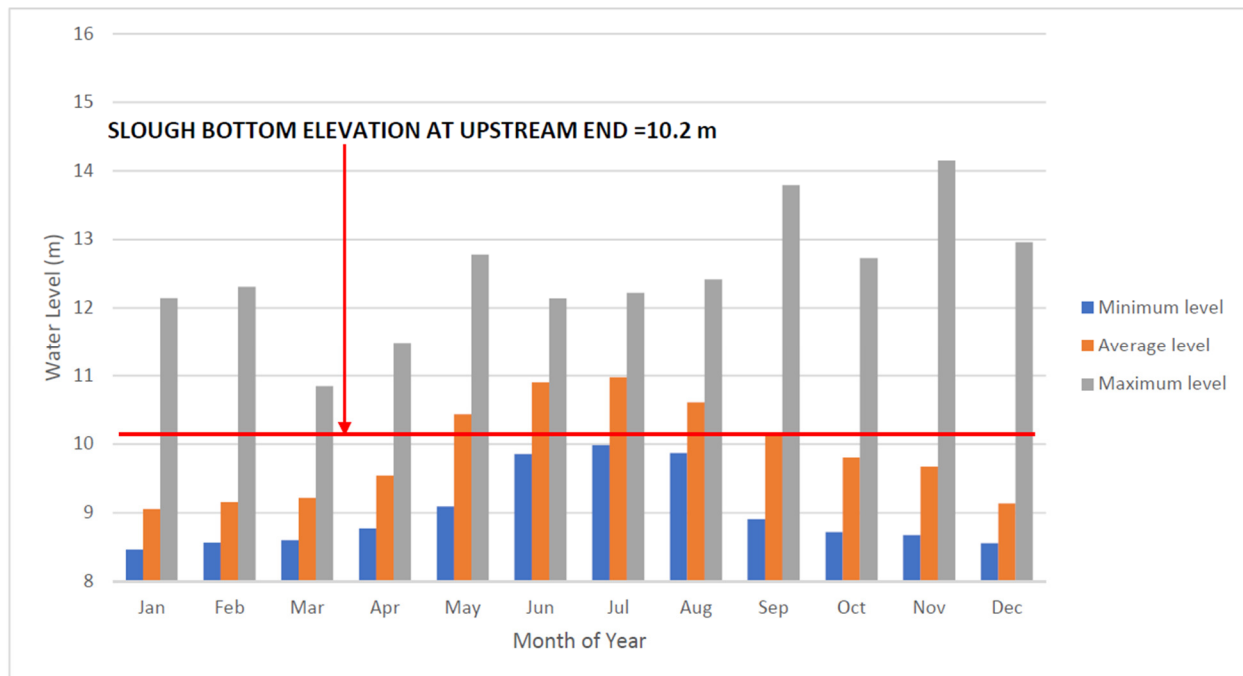
**Figure 2-2: Estimated Historical Squamish River water levels upstream of the Slough inlet (Squamish River Level at Brackendale Environment Canada Reading + 7.85 m)**

Based on the historical water level data, the average water level in the Squamish River is generally below the bottom of the proposed Slough inlet between December and March, so inflow is not feasible during these months.

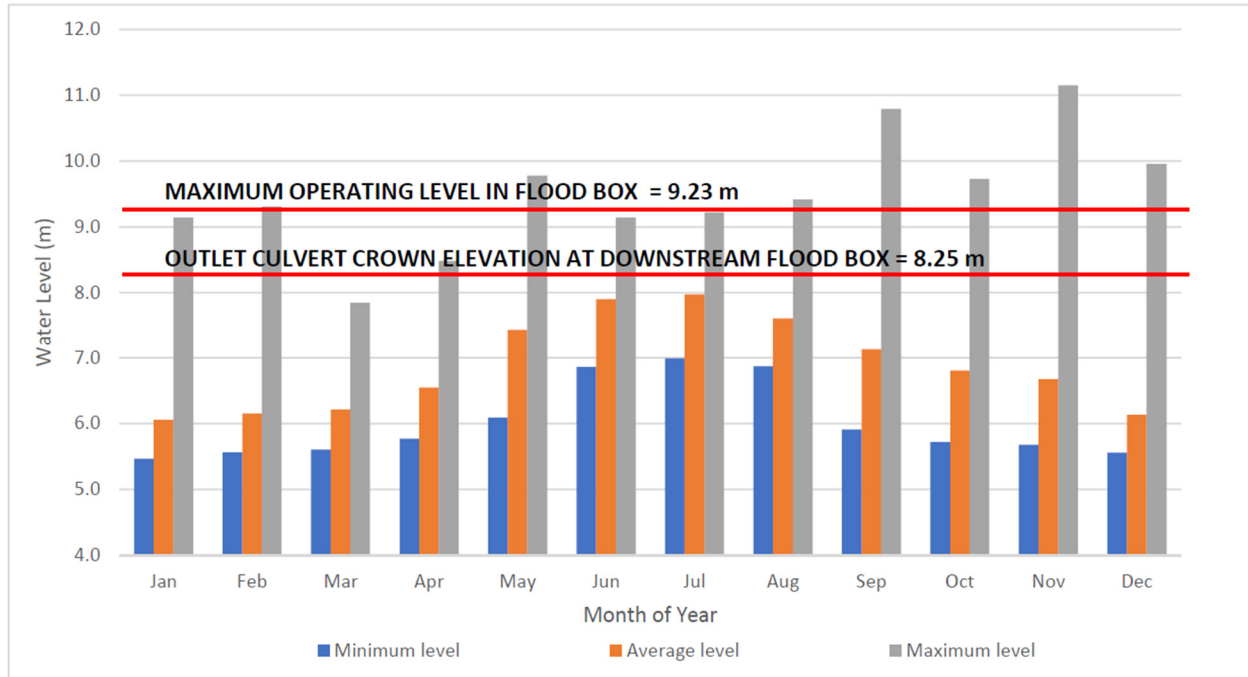
**Figure 2-3: Estimated Historical Squamish River water levels downstream of the Slough outlet (Squamish River Level at Brackendale Environment Canada Reading + 3.5 m)**

The Squamish River water levels downstream of the Slough outlet flood box are illustrated in Figure 2-3 below. The average water level in the Squamish River downstream of the Slough is below the downstream pond elevation for all months of the year. However, the maximum water level exceeds the maximum operating water level for May and September-December, indicating a chance of excessive backwater during heavy storm events. The peaks do not coincide with springtime snow melt, suggesting that they are driven primarily by rainfall. Given that major rainfall events could occur during any month of the year, the option to close the gates during a major storm event should be maintained at all times.

The maximum operating water level in the Flood Box shown in Figure 2-3 is calculated as follows:

- Maximum operating level with respect to flood box invert according to record drawings = 31.0 feet – 22.55 feet = 8.45 feet = 2.58 m
- Flood invert elevation based on January 7, 2019 survey = 6.65 m

- Maximum operating level in survey datum = 6.65 m + 2.58 m = 9.23 m.

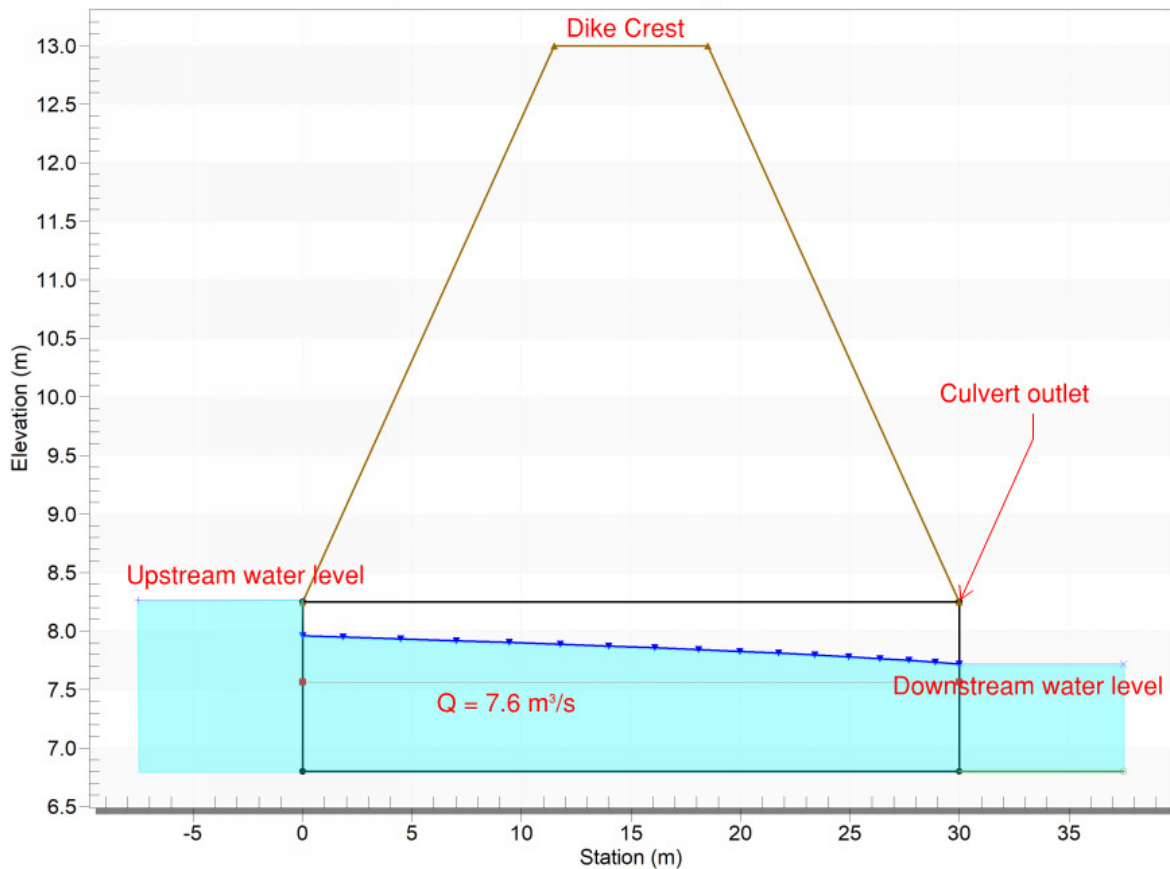
**Figure 2-4: Modelled profile of 2 downstream culverts at flood box using USDOT HY-8 software**

The capacity of the flood box outlet culverts has been modelled using the USDOT HY-8 software package. Based on the HY-8 output, the culverts can convey 7.6 m<sup>3</sup>/s of flow with the headwater level in the Slough at 8.25 m, which corresponds with the culverts' crown elevation. The flow profile is provided in the figure below.

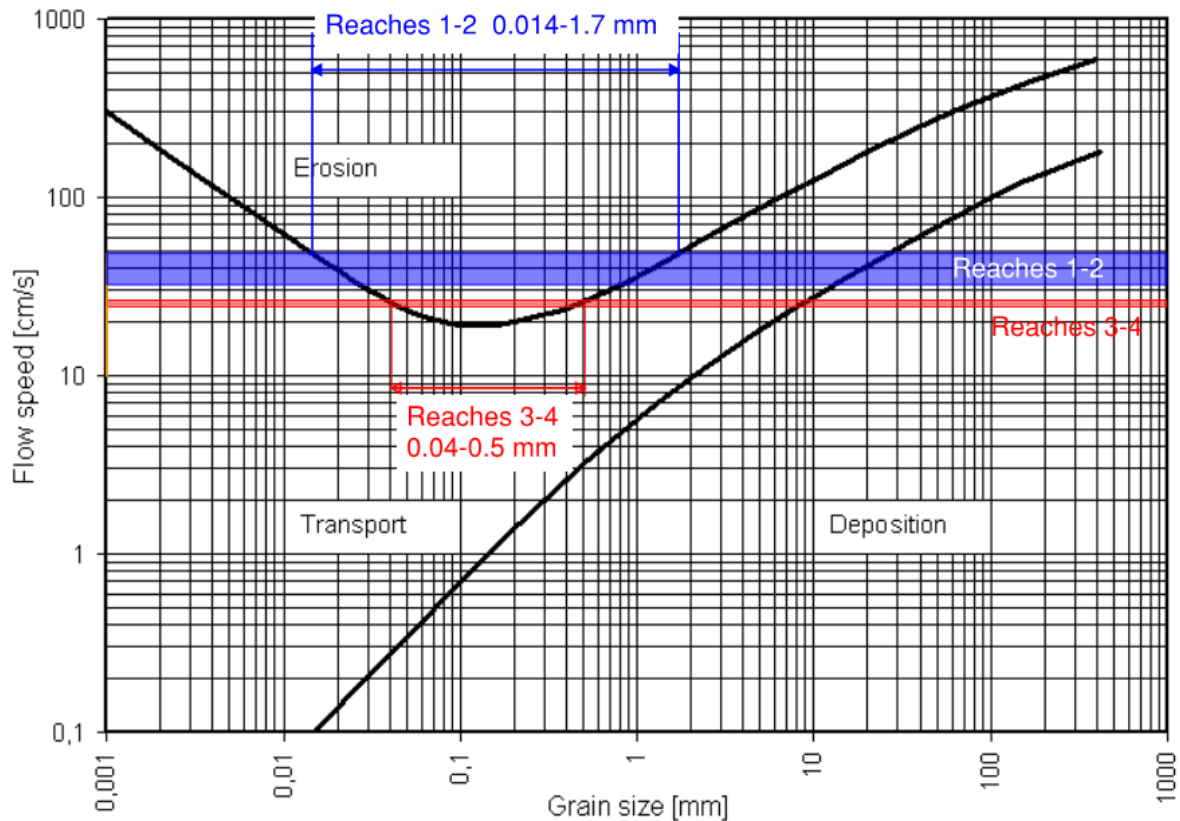
**Figure 3-1: Hjulström erosion-deposition curve**

Based on the Hjulströms curve (see Figure 3-1), there is the potential for some scouring of silts, especially in Reaches #1 and 2 of the Slough. Scour is expected to be more pronounced in the thalweg (centre of channel), where the localized flow velocities are higher.

Although the Hjulströms curve does not show the potential for deposition based on the average channel velocity, it is possible for localized velocities to be significantly lower in parts of the channel. Reach 3 would be a likely location for deposition, close to where the channel widens.

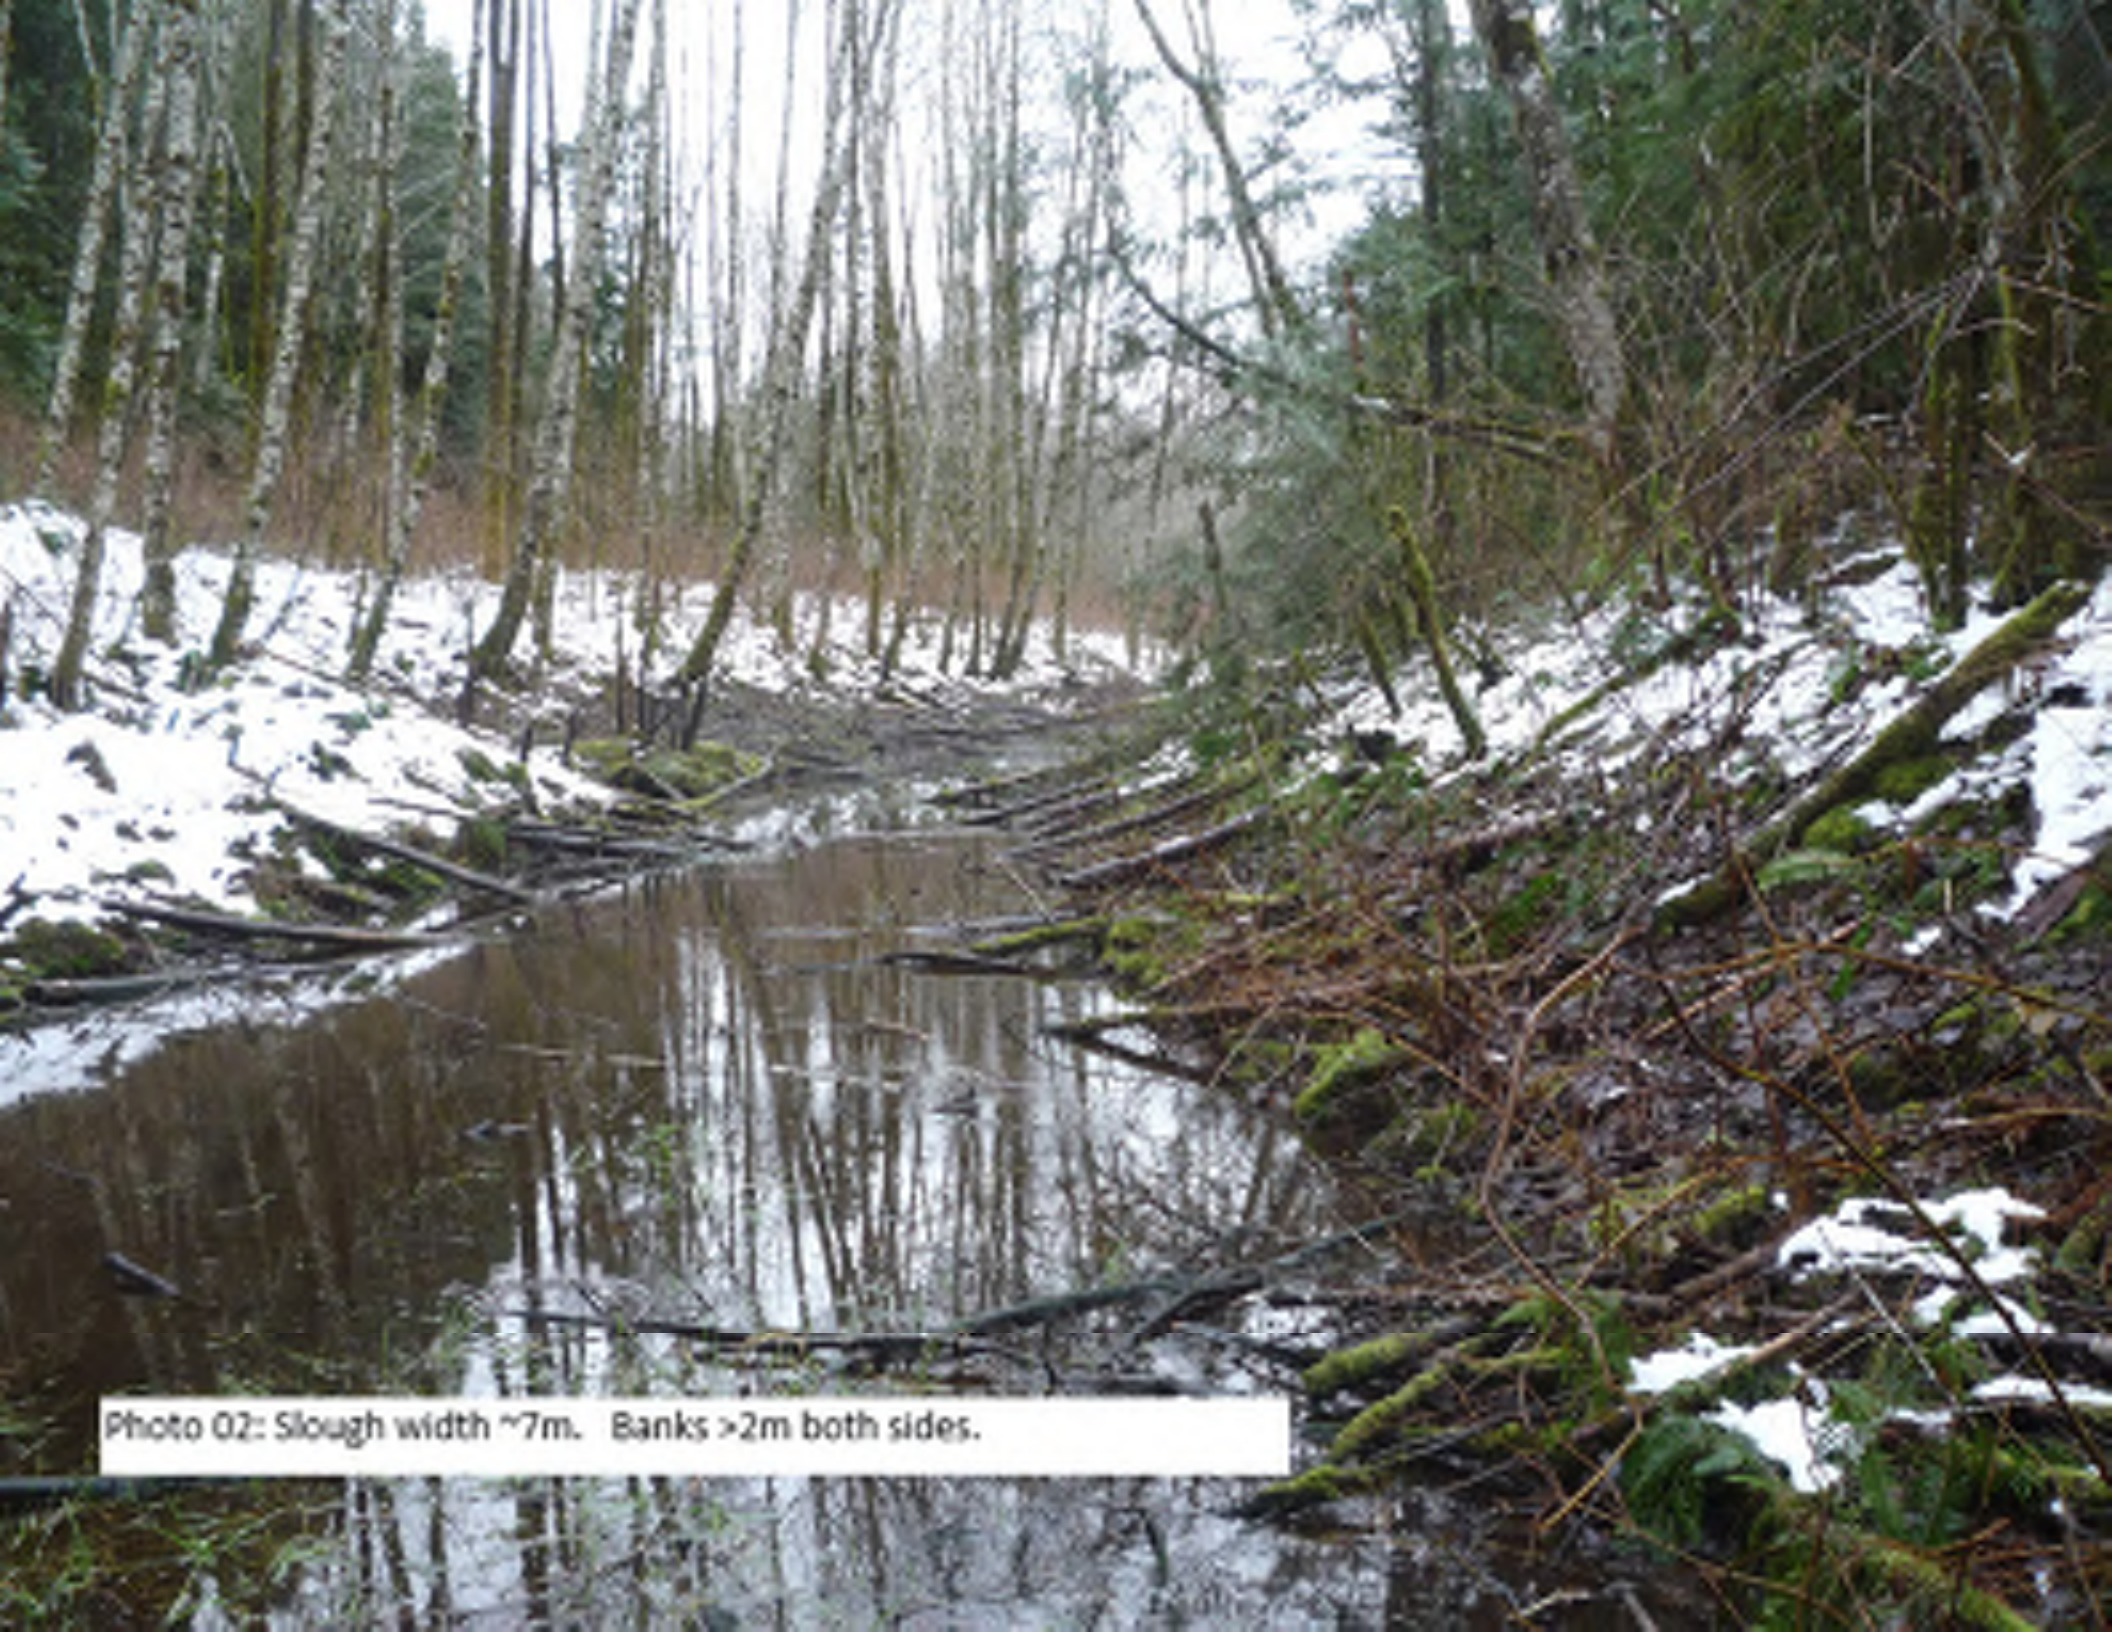
Photo 01: Looking downstream near inlet at north end.  
Approx. 10 m channel width. >2 m banks on both sides.

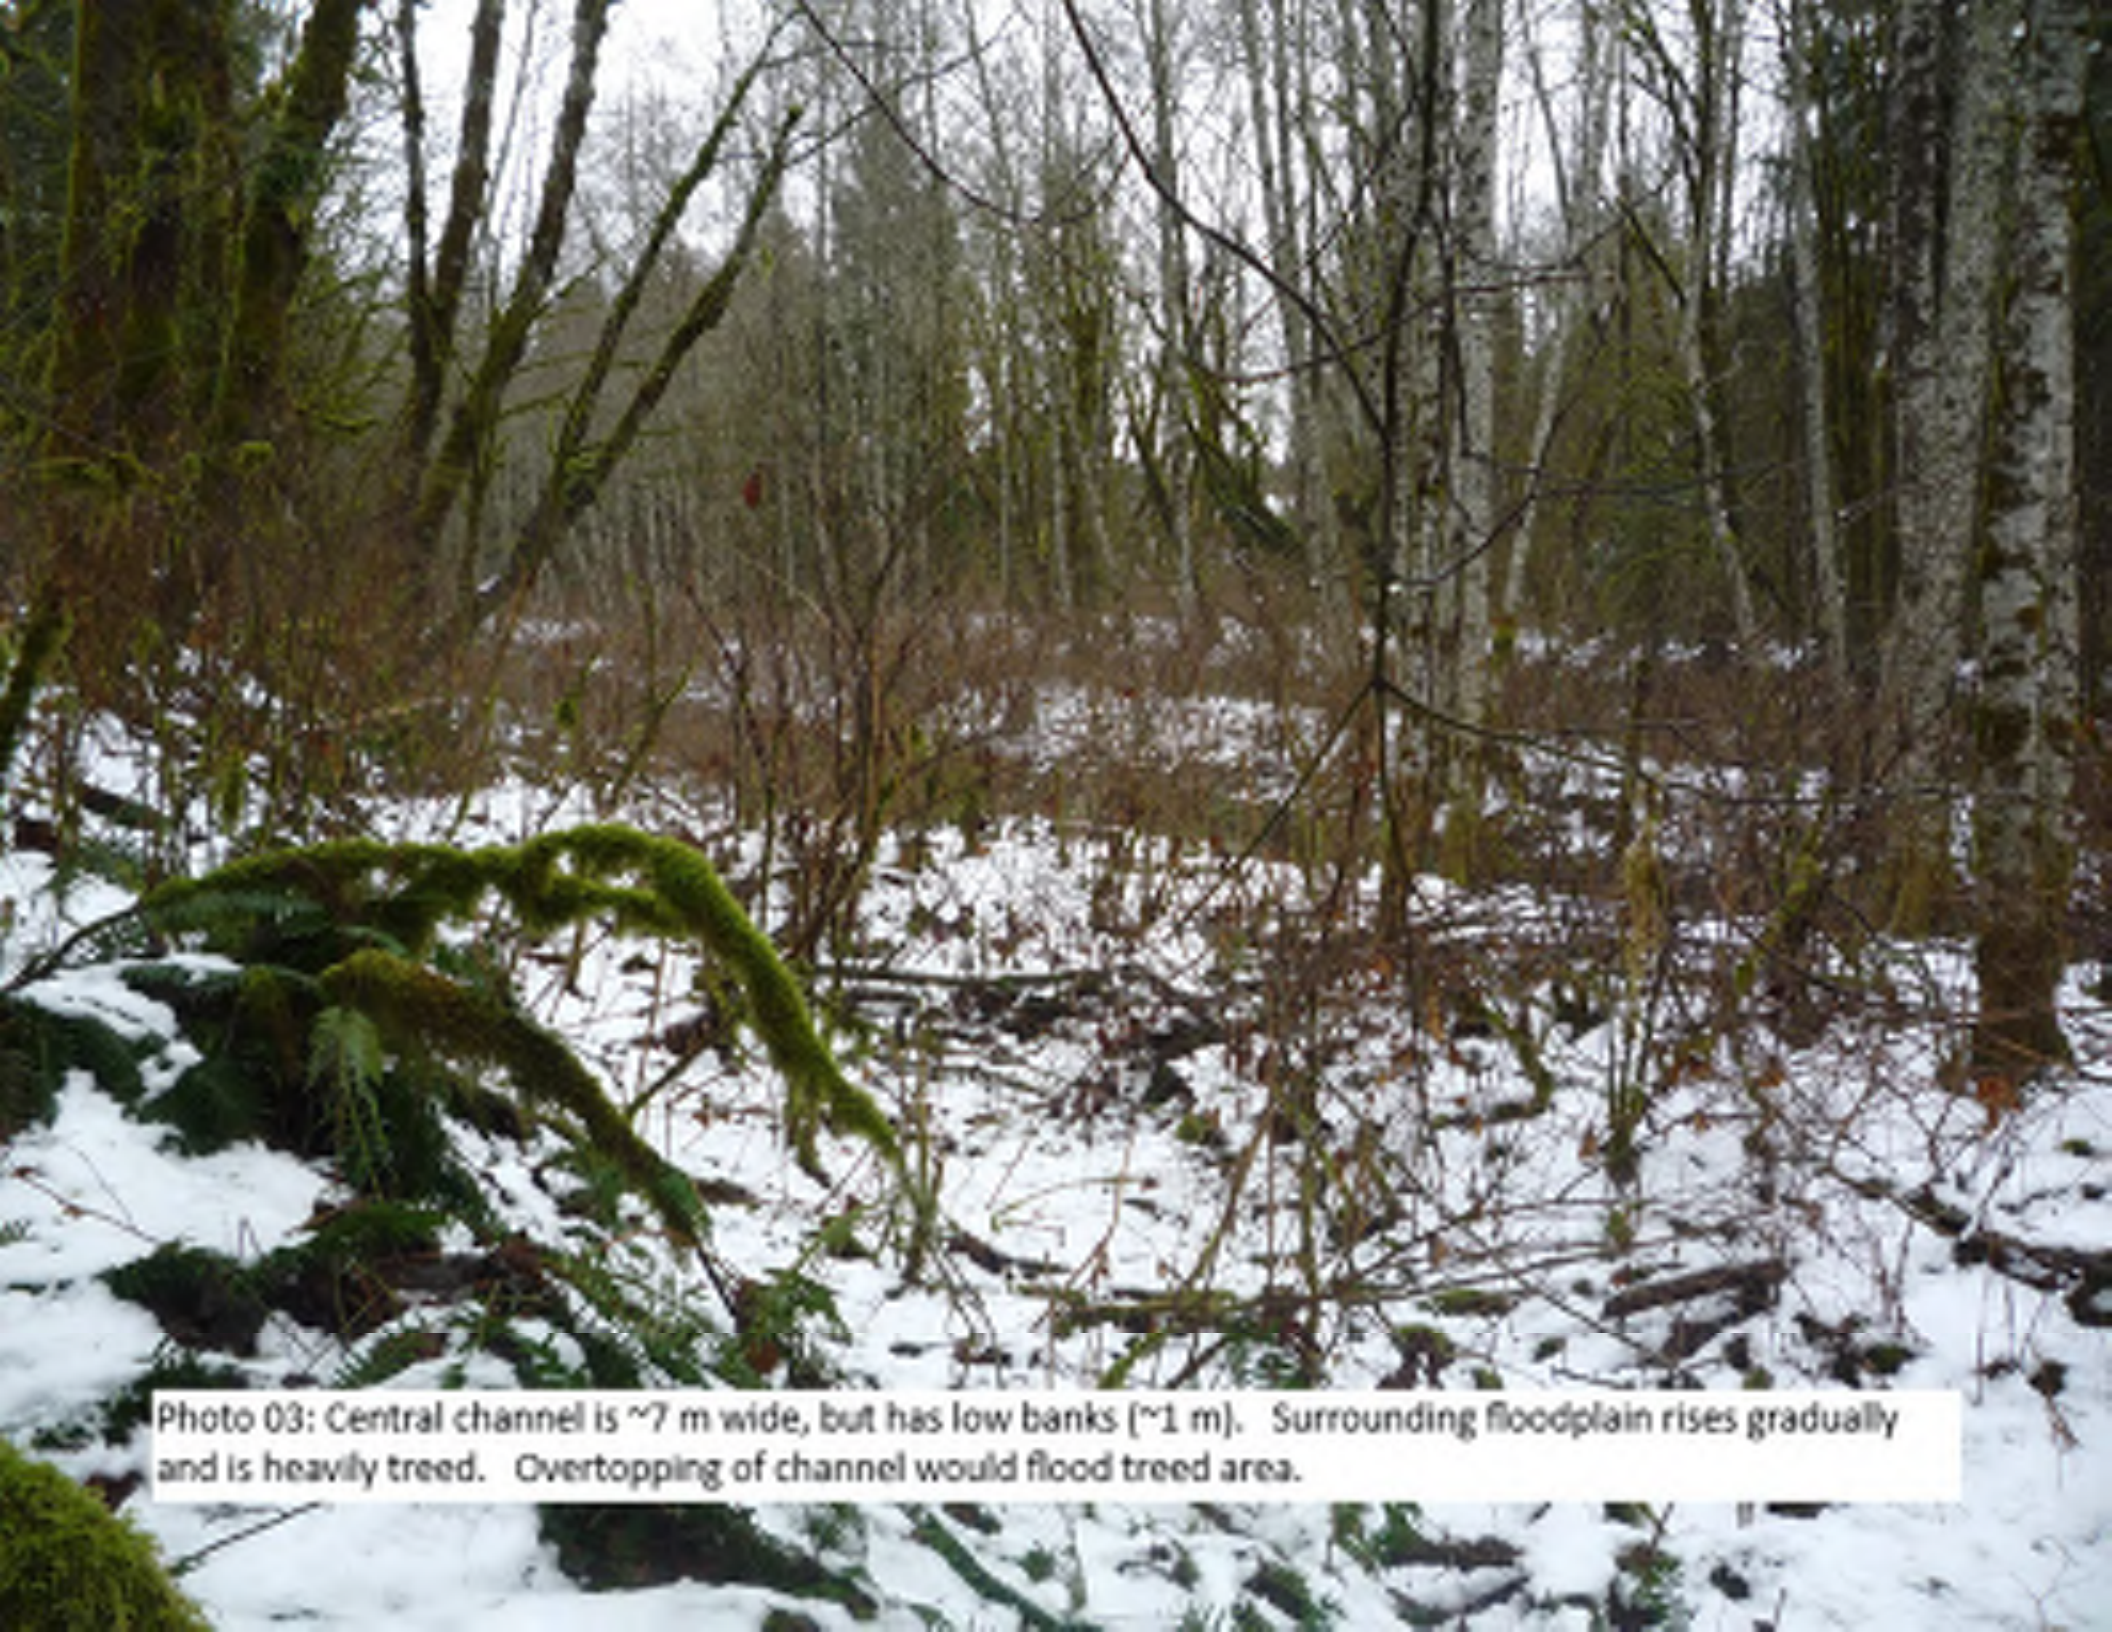
Photo 02: Slough width ~7m. Banks >2m both sides.

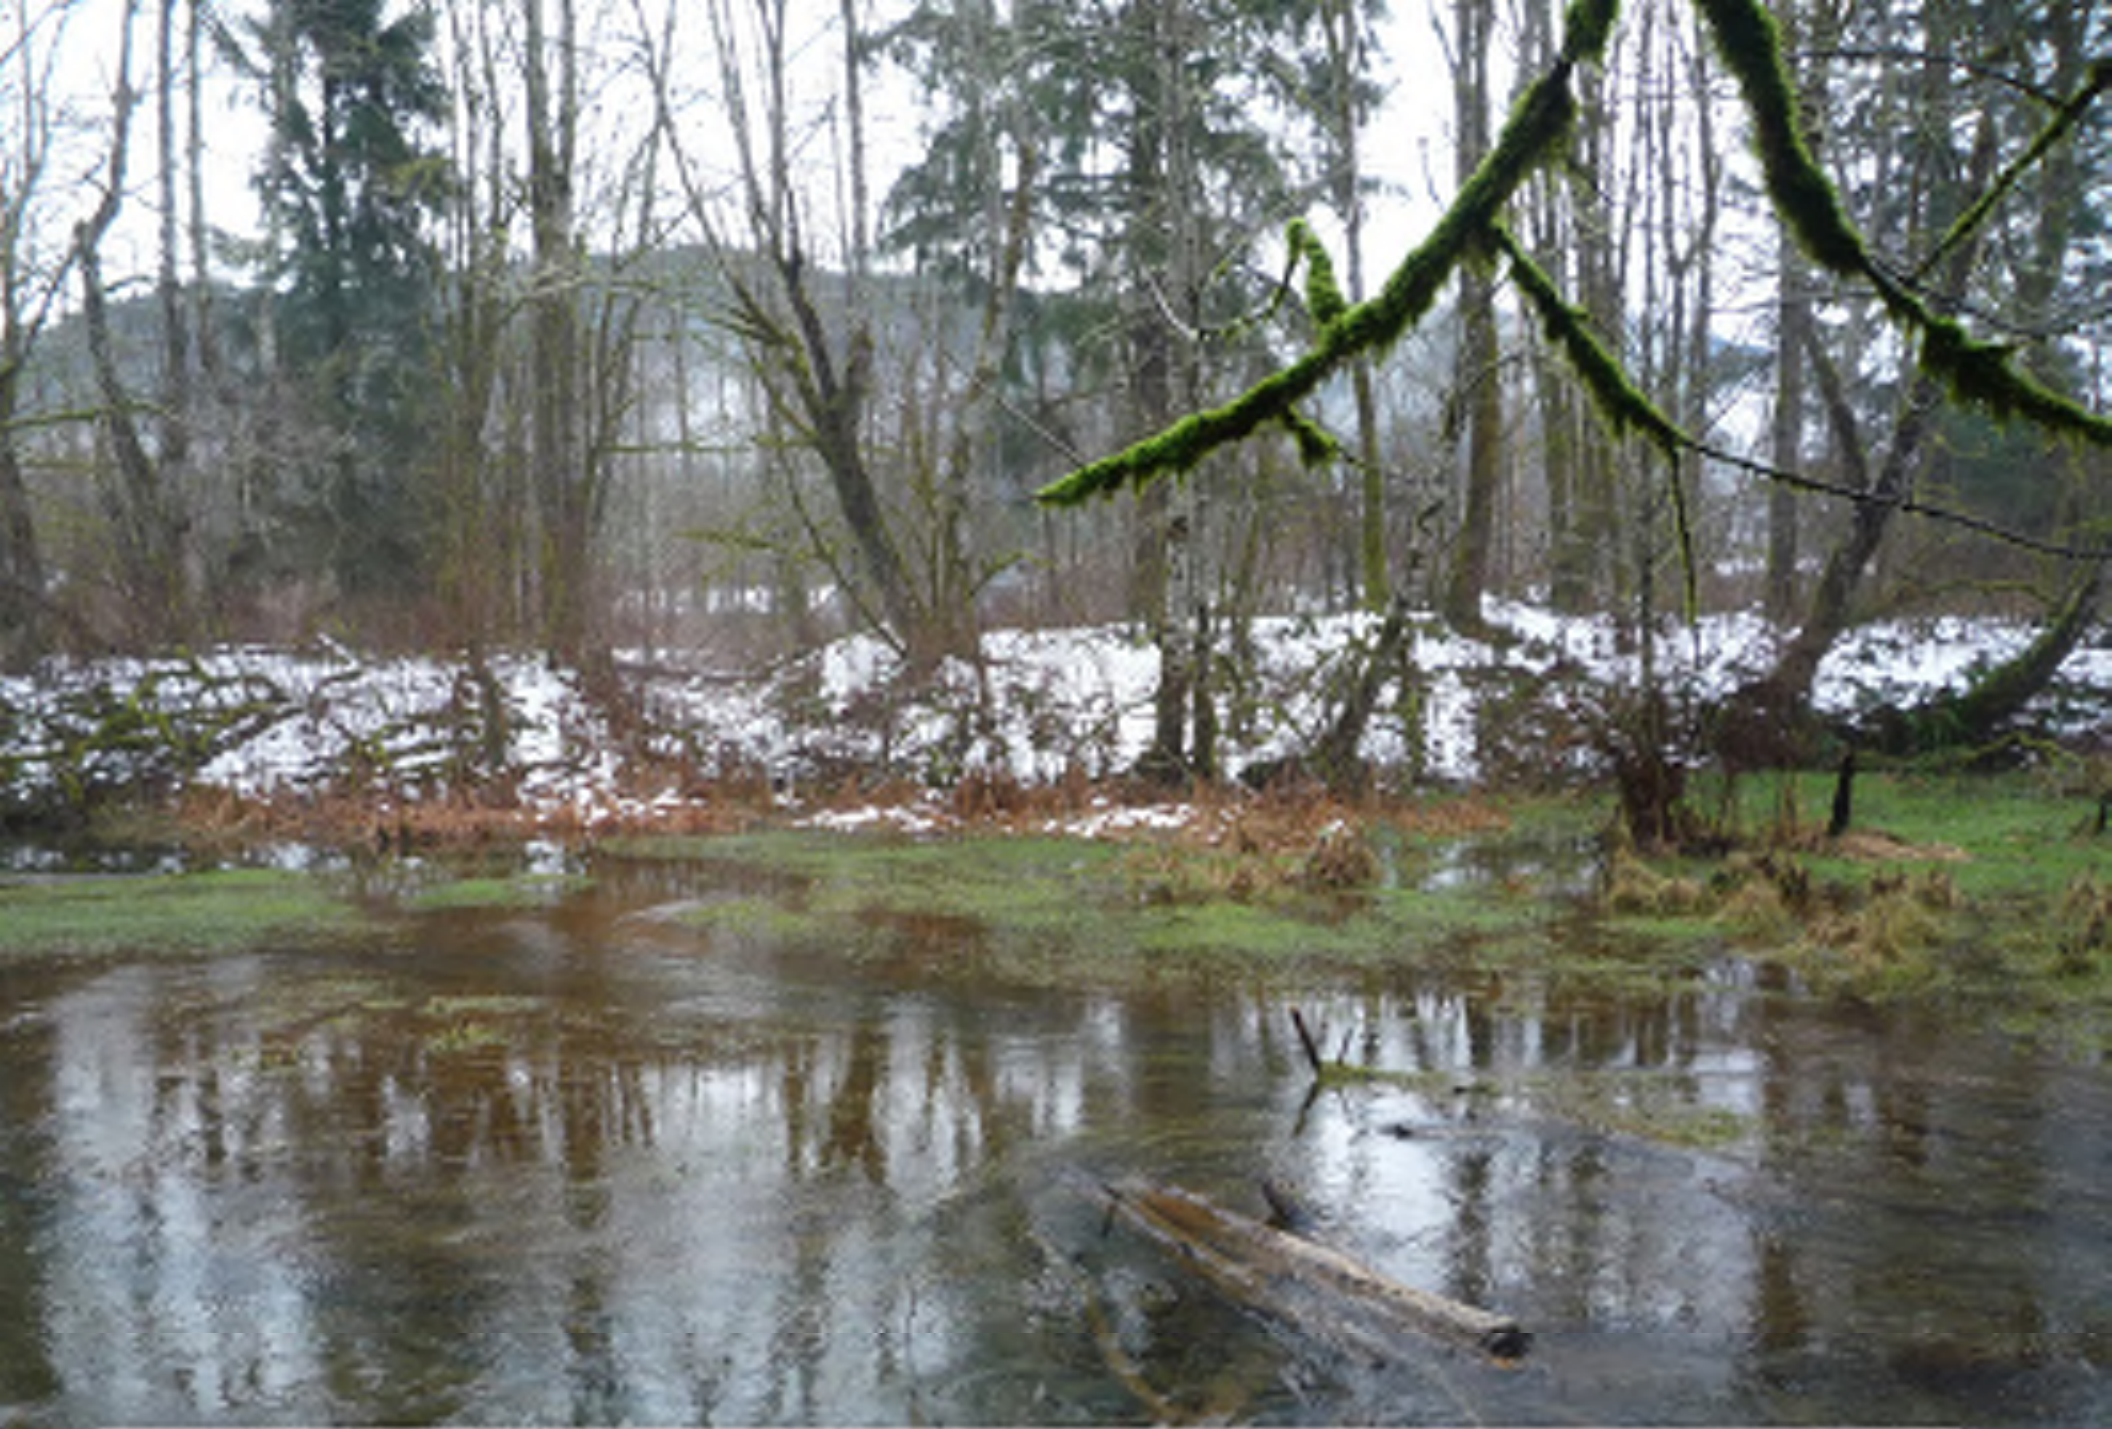
Photo 03: Central channel is ~7 m wide, but has low banks (~1 m). Surrounding floodplain rises gradually and is heavily treed. Overtopping of channel would flood treed area.

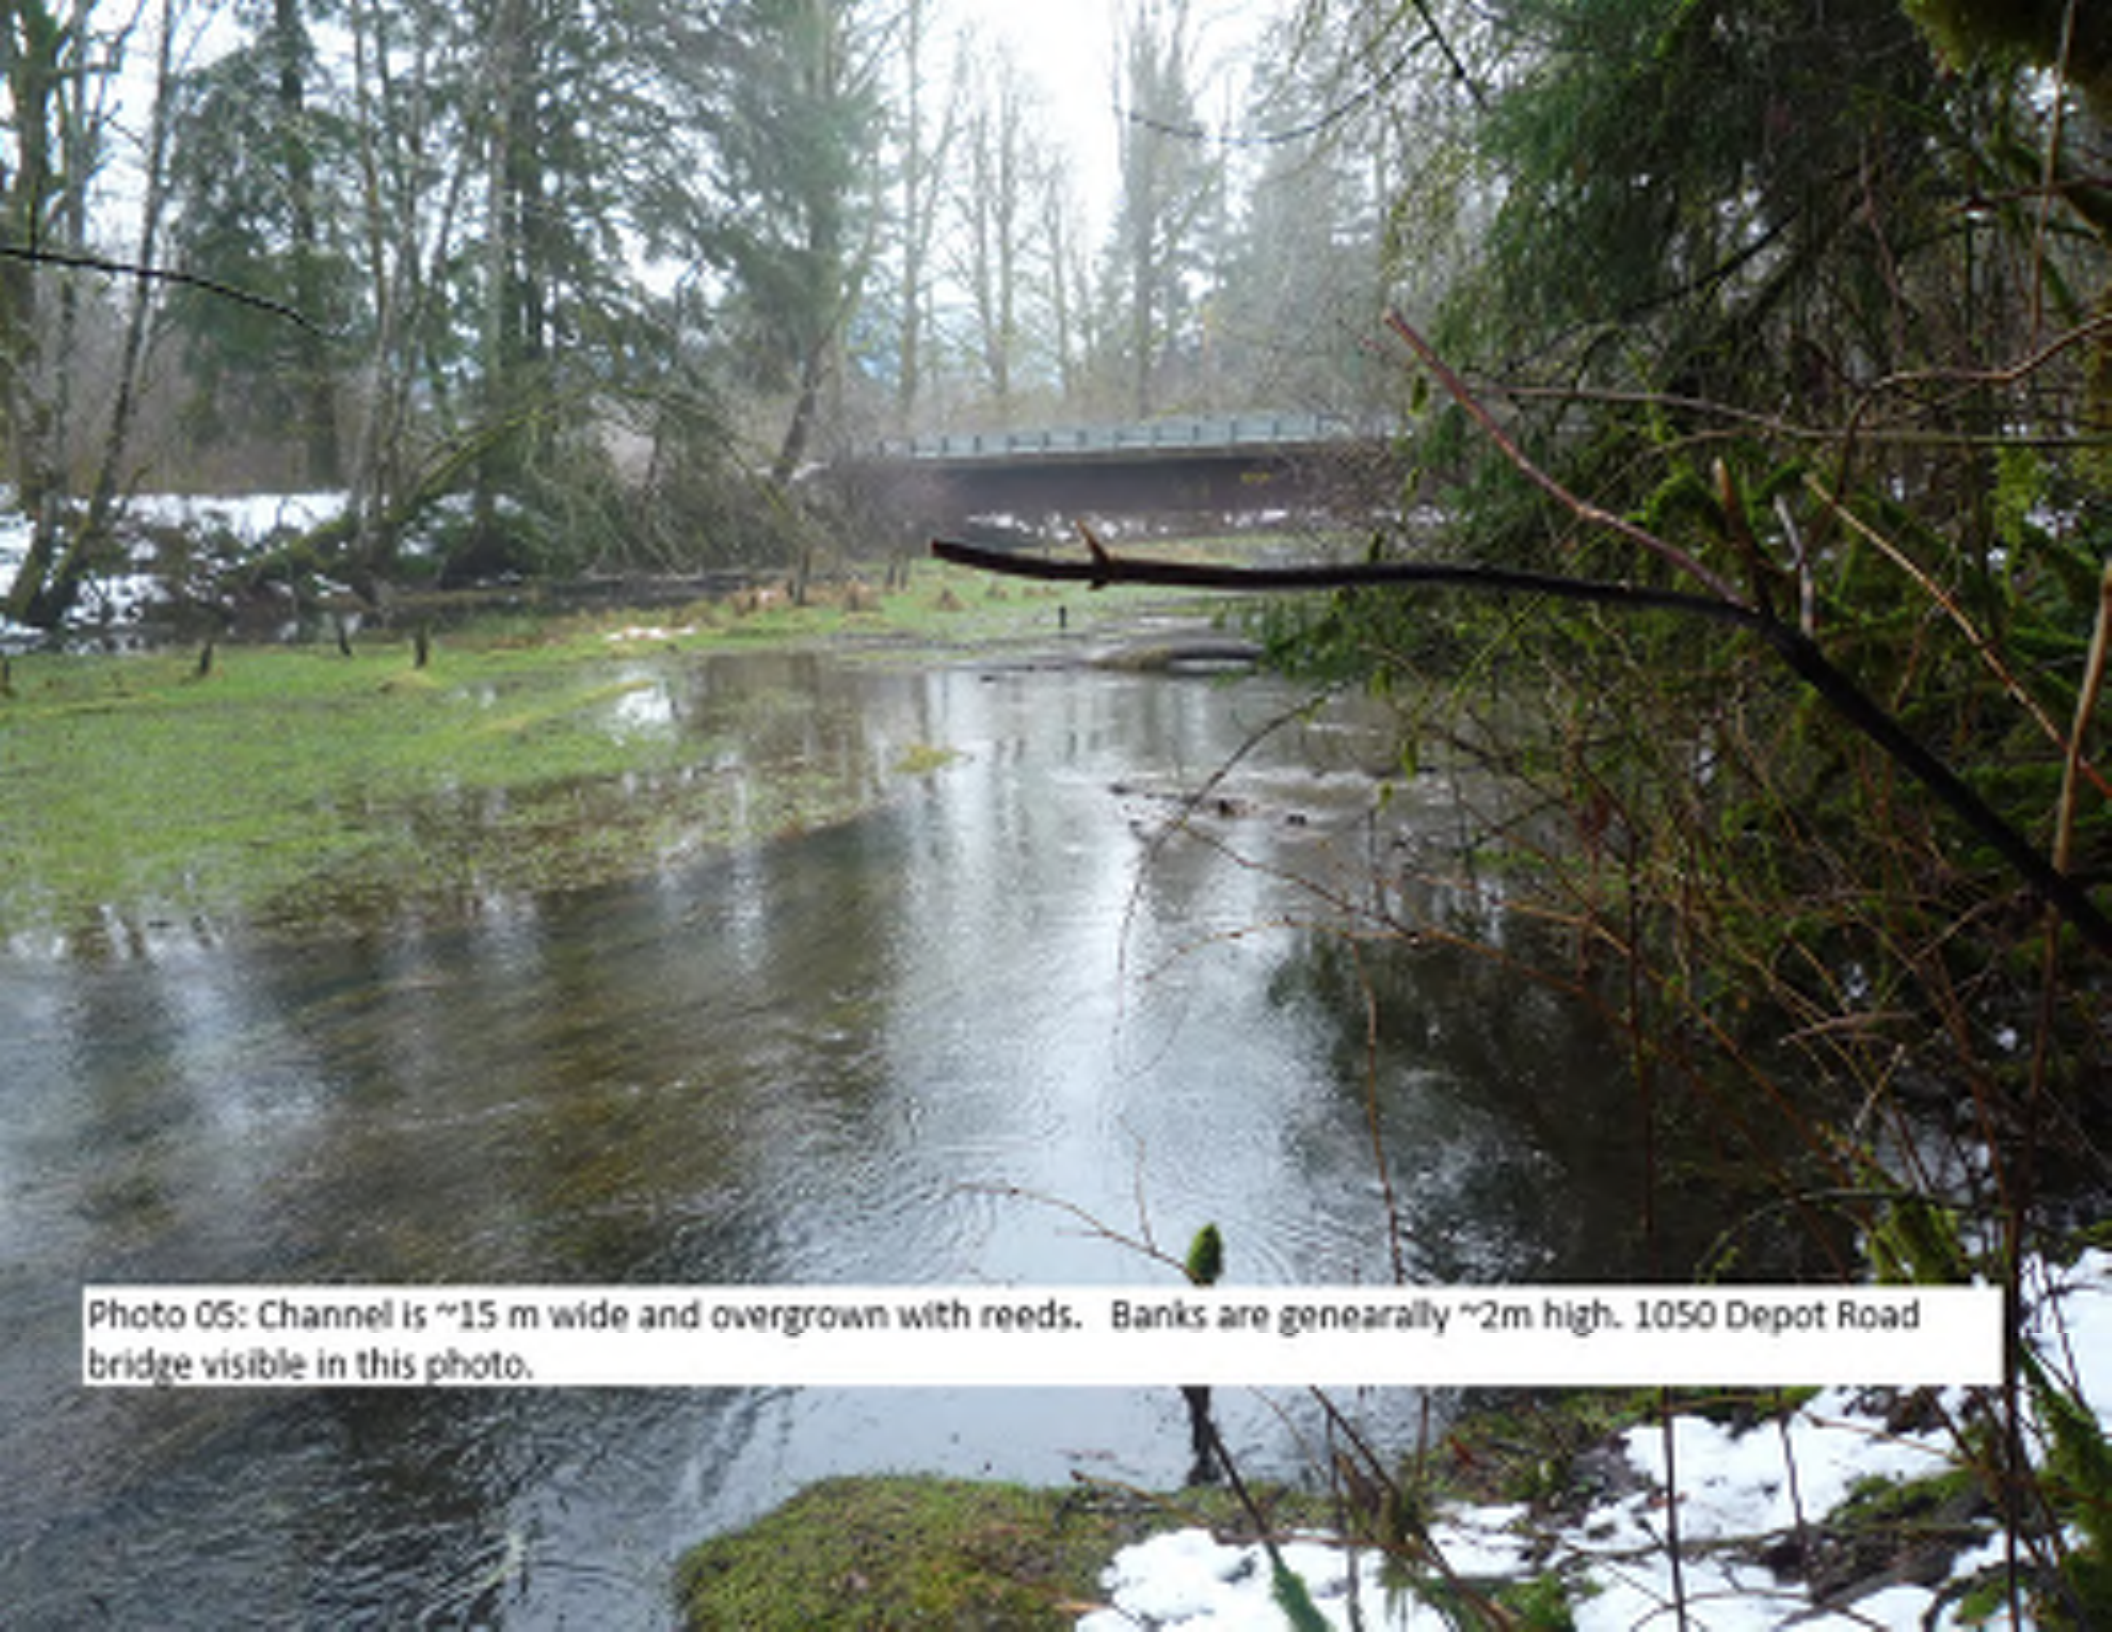
Photo 04: Channel is ~15 m wide and overgrown with reeds. Banks are generally ~2m high. Swale visible on landside bank in this photo.

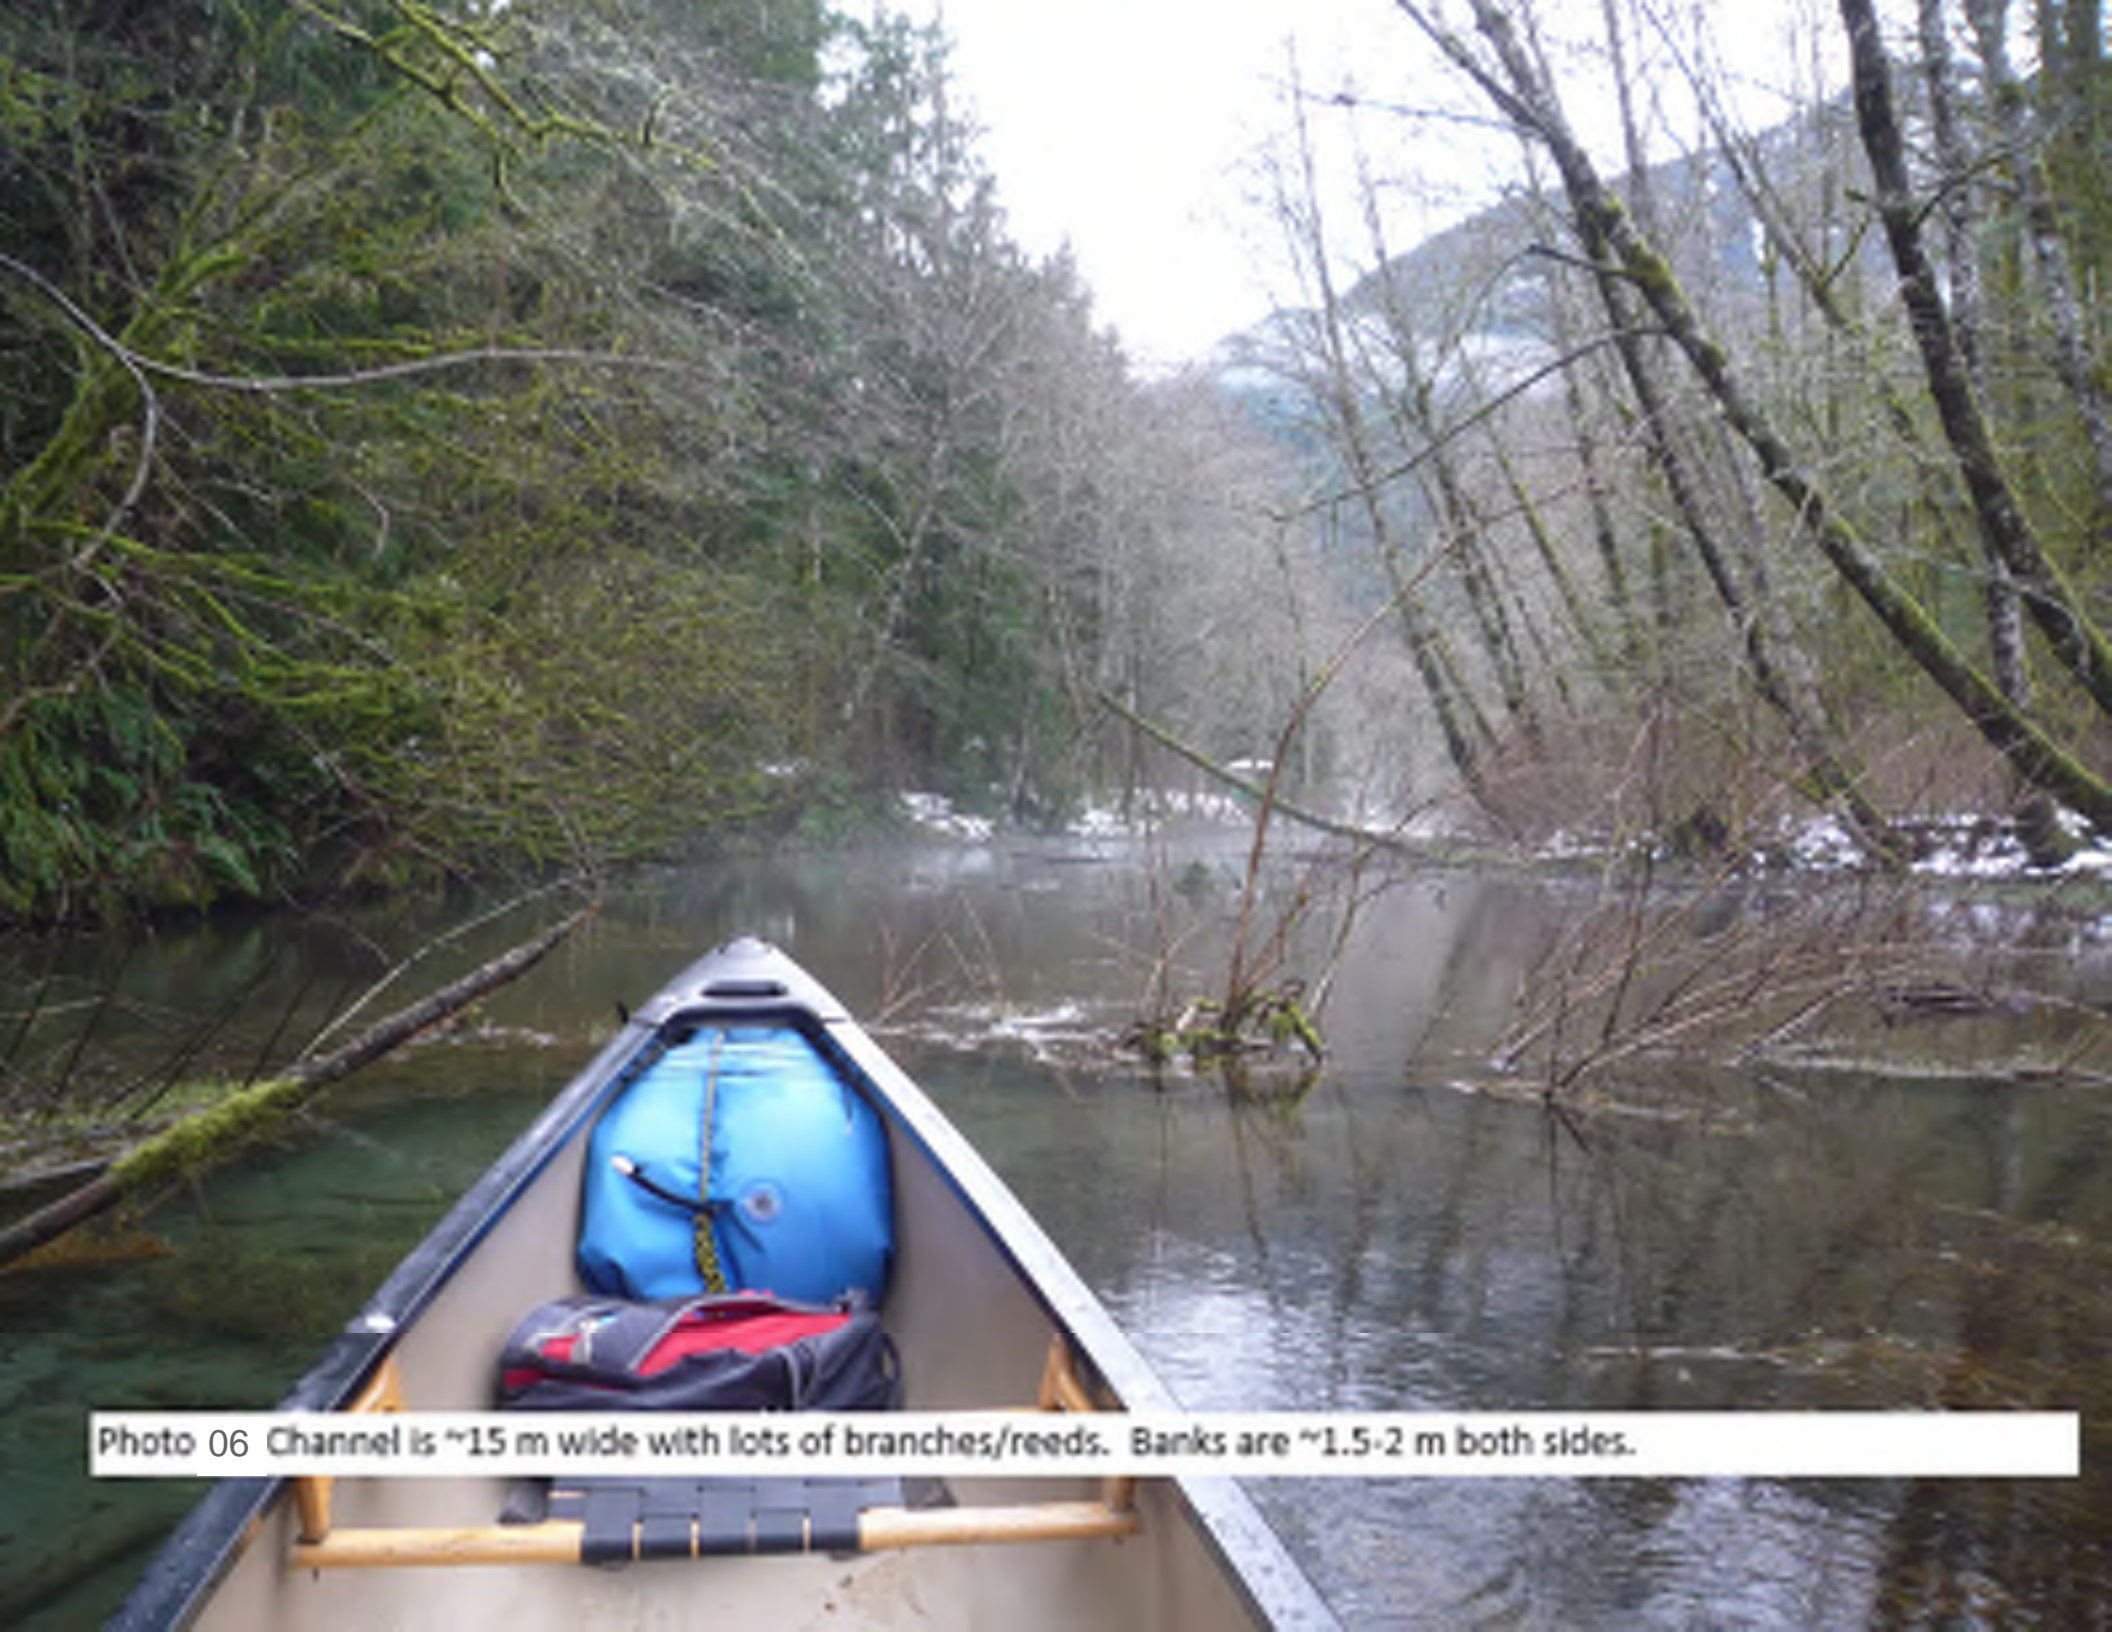
Photo 05: Channel is ~15 m wide and overgrown with reeds. Banks are generally ~2m high. 1050 Depot Road bridge visible in this photo.
