DISTRICT OF SQUAMISH  
PROJECT #: 18P-00095-00

# UPPER JIMMY-JIMMY (JUDD) SLOUGH ENHANCEMENT CULVERT FEASIBILITY MEMORANDUM

MAY 28, 2020

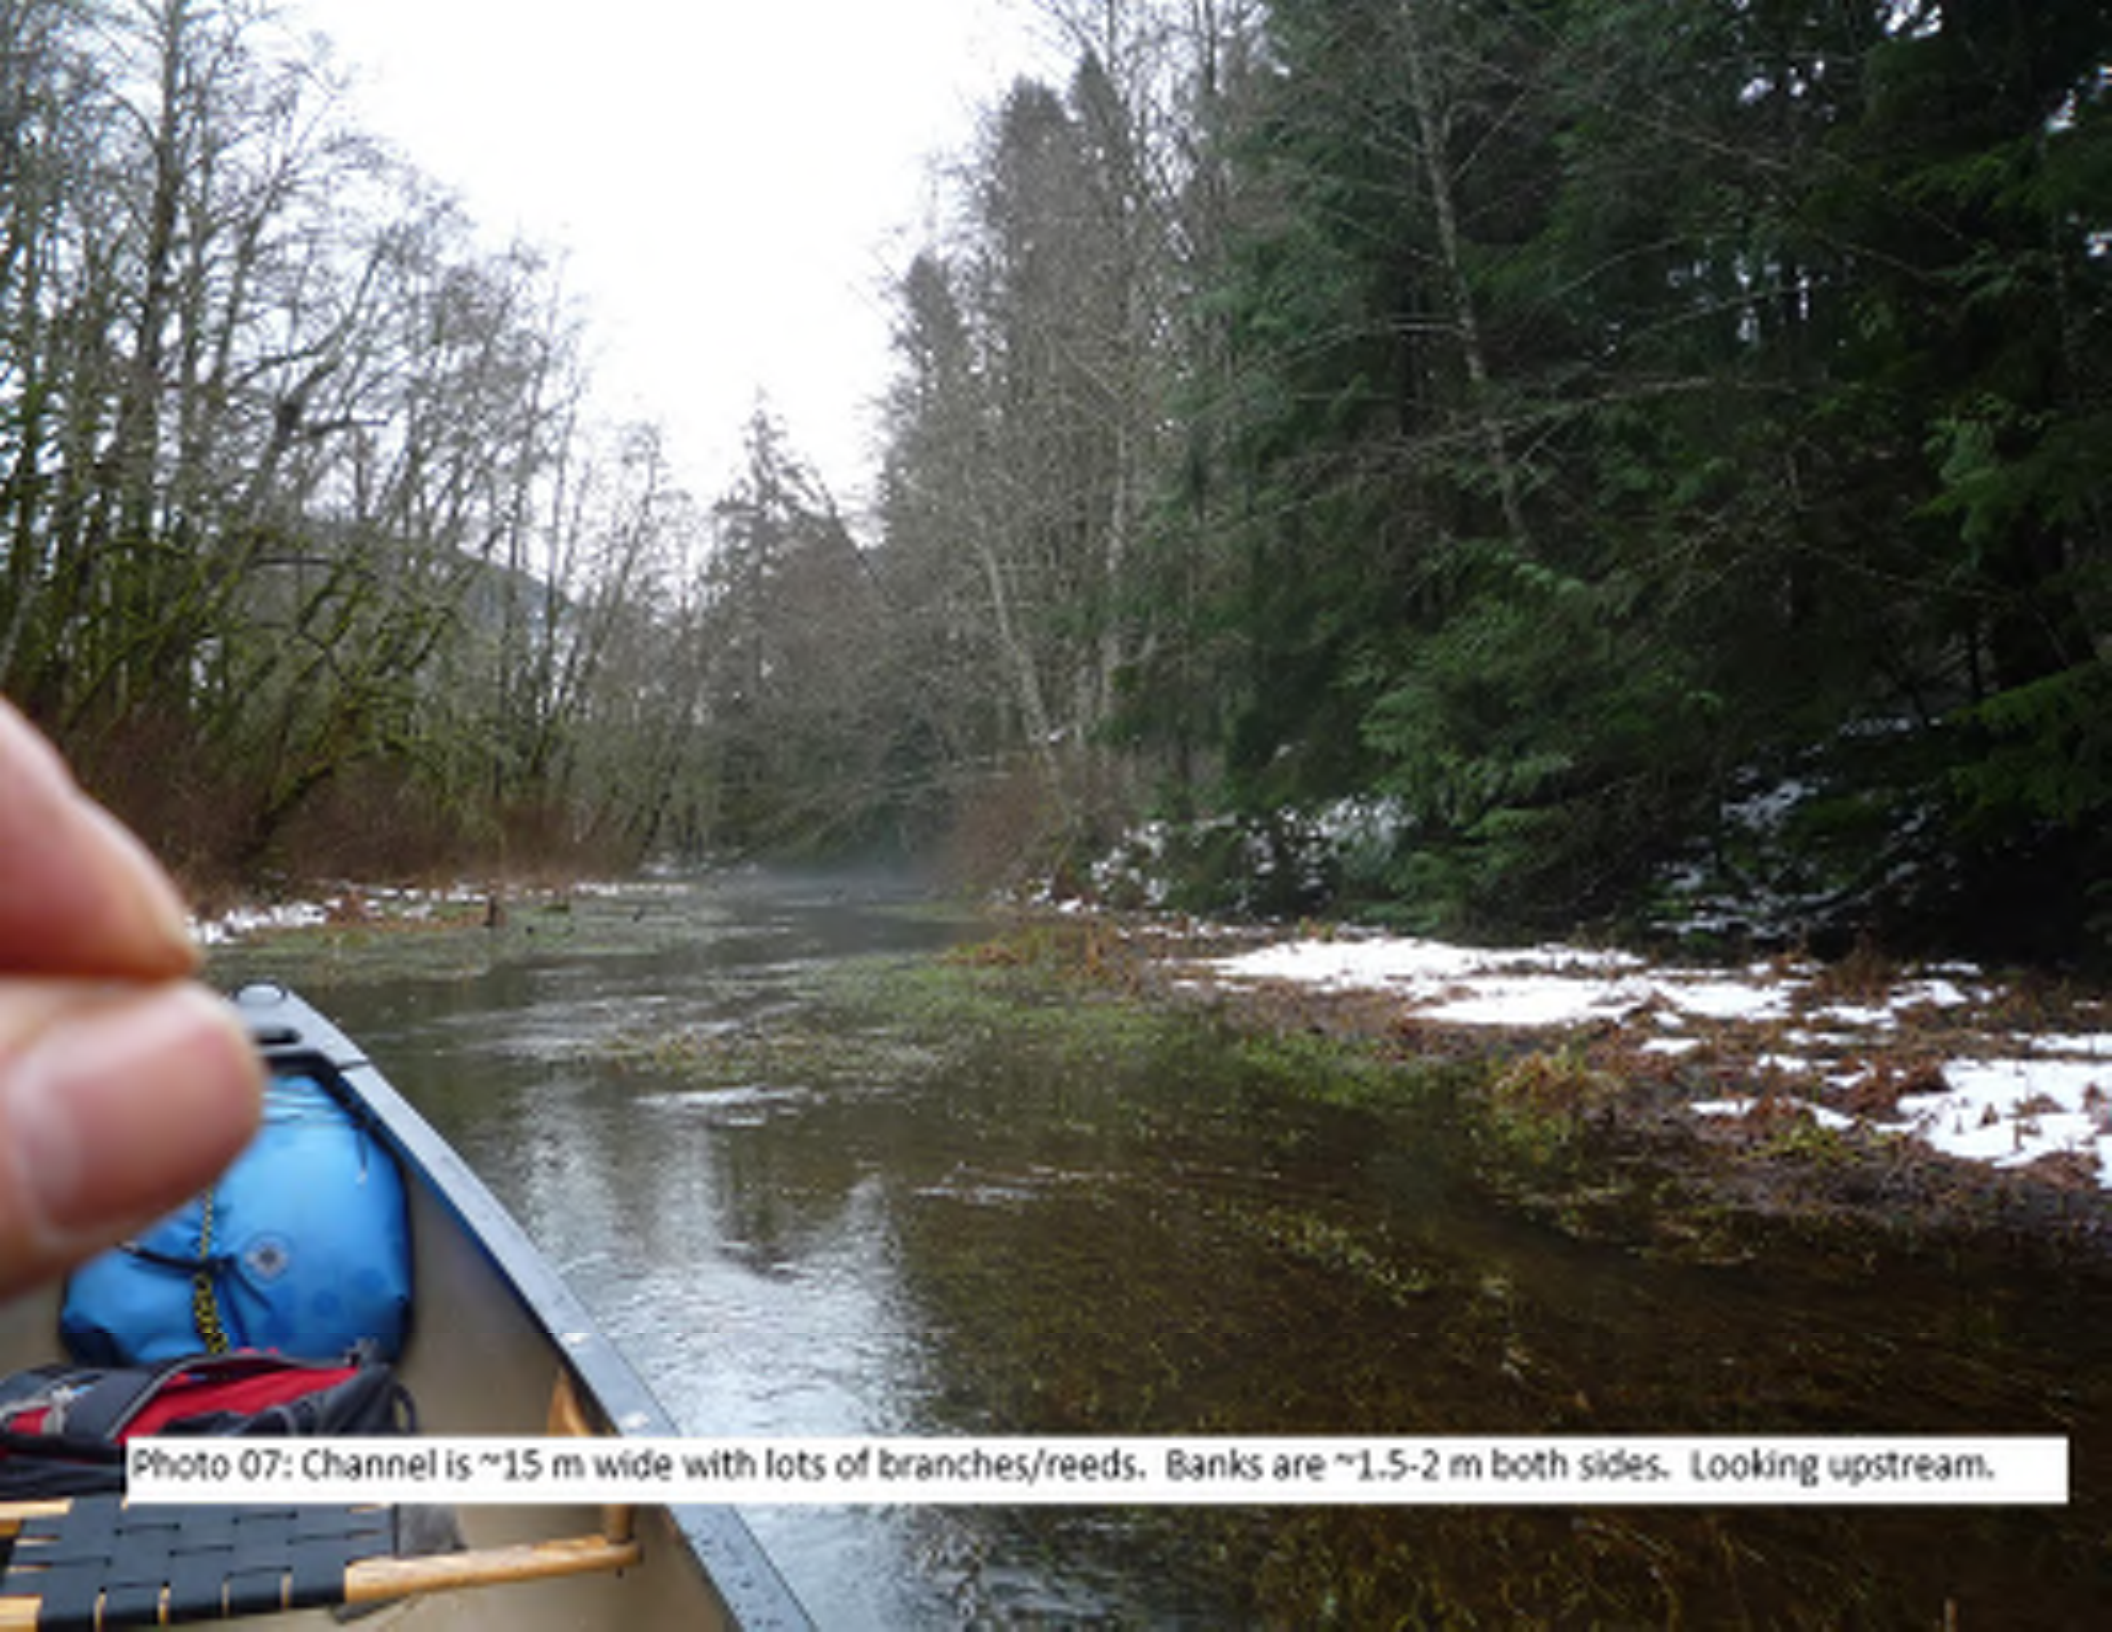
Photo 06 Channel is ~15 m wide with lots of branches/reeds. Banks are ~1.5-2 m both sides.

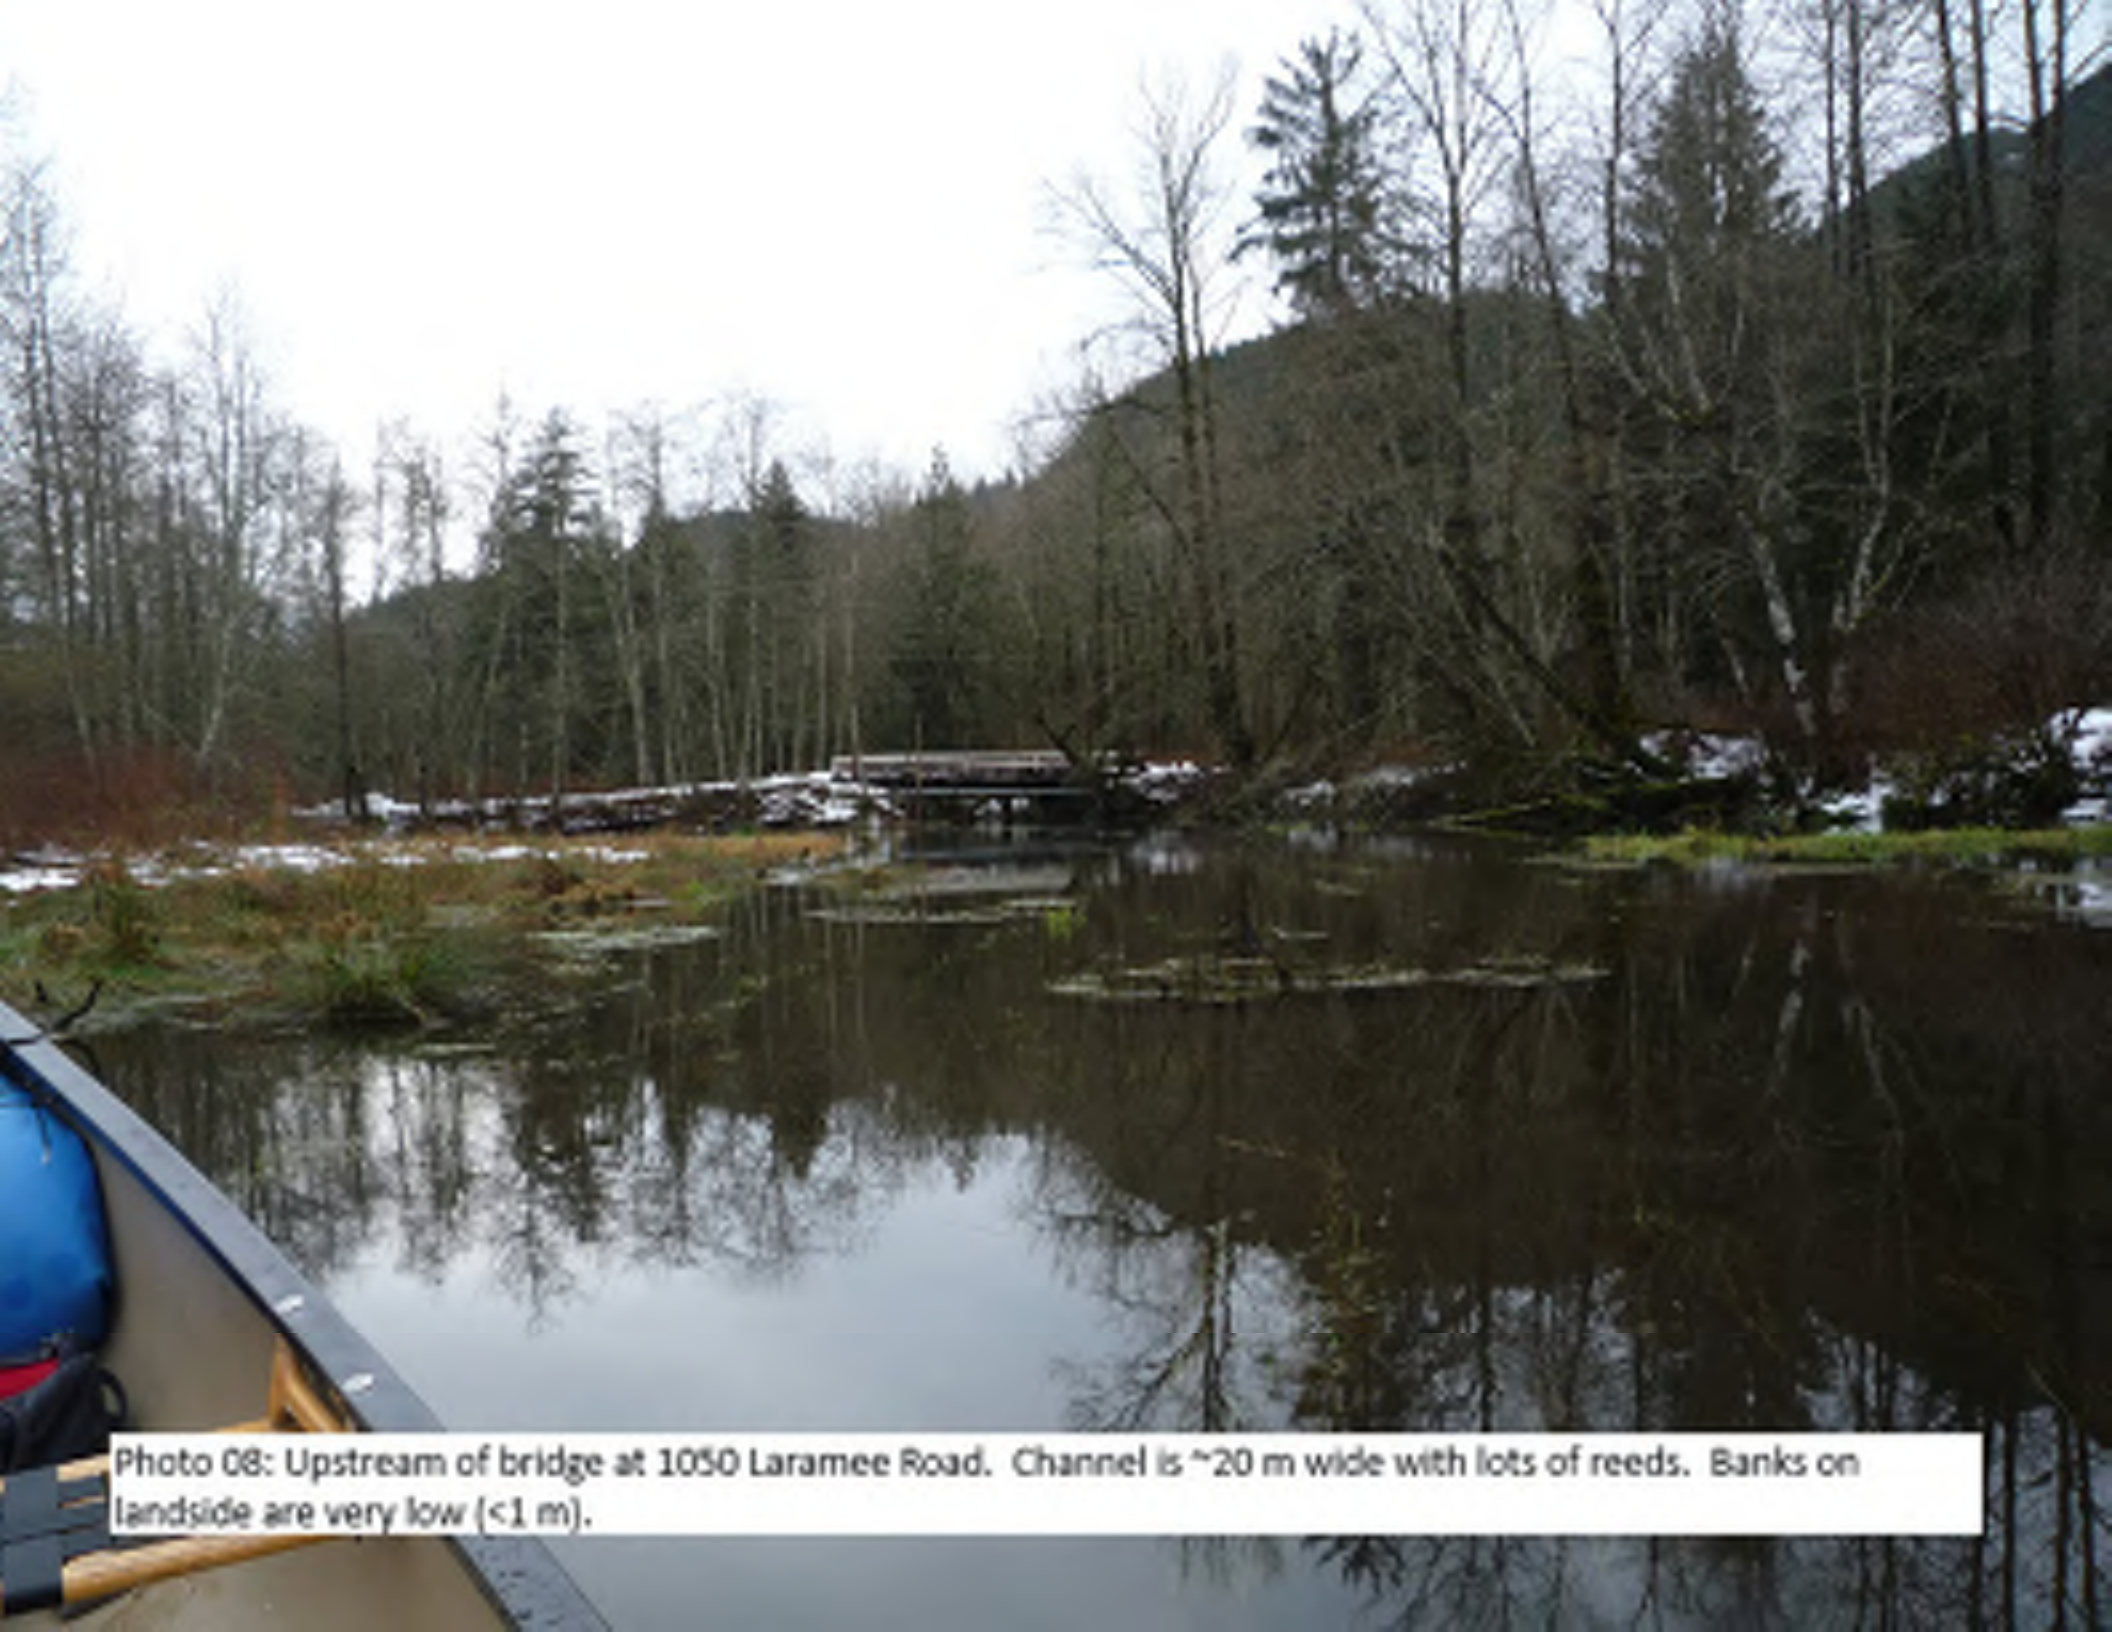
Photo 07: Channel is ~15 m wide with lots of branches/reeds. Banks are ~1.5-2 m both sides. Looking upstream.

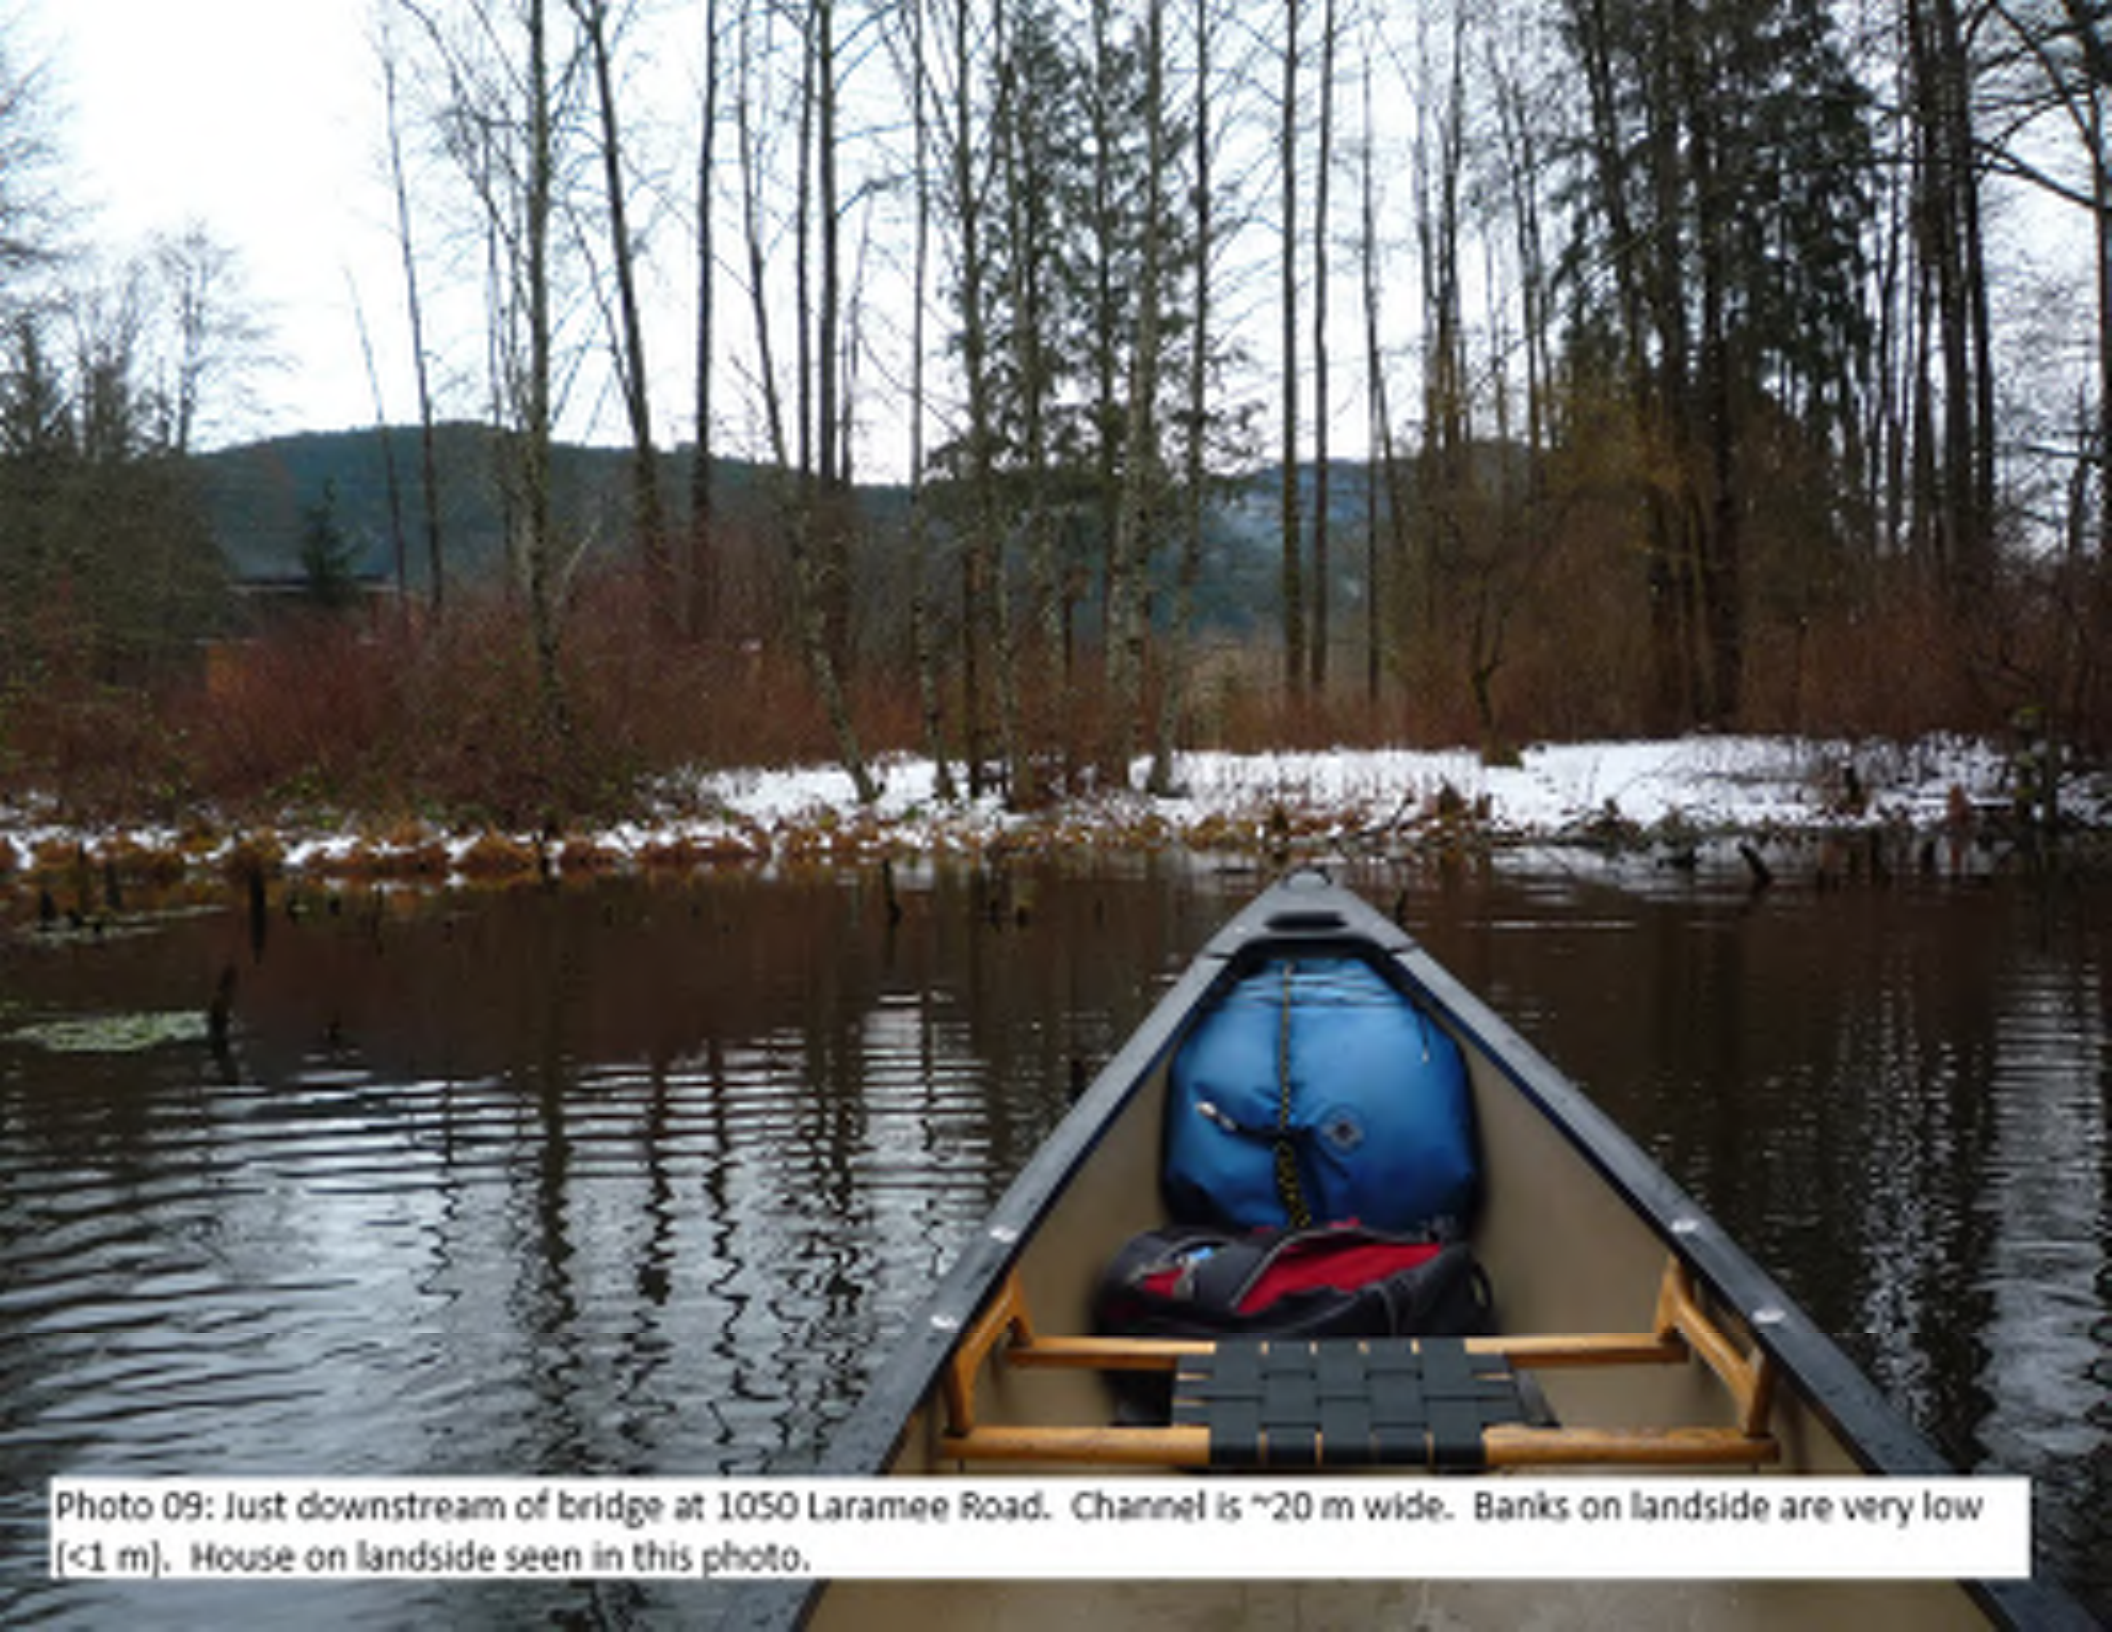
Photo 08: Upstream of bridge at 1050 Laramie Road. Channel is ~20 m wide with lots of reeds. Banks on landside are very low (<1 m).

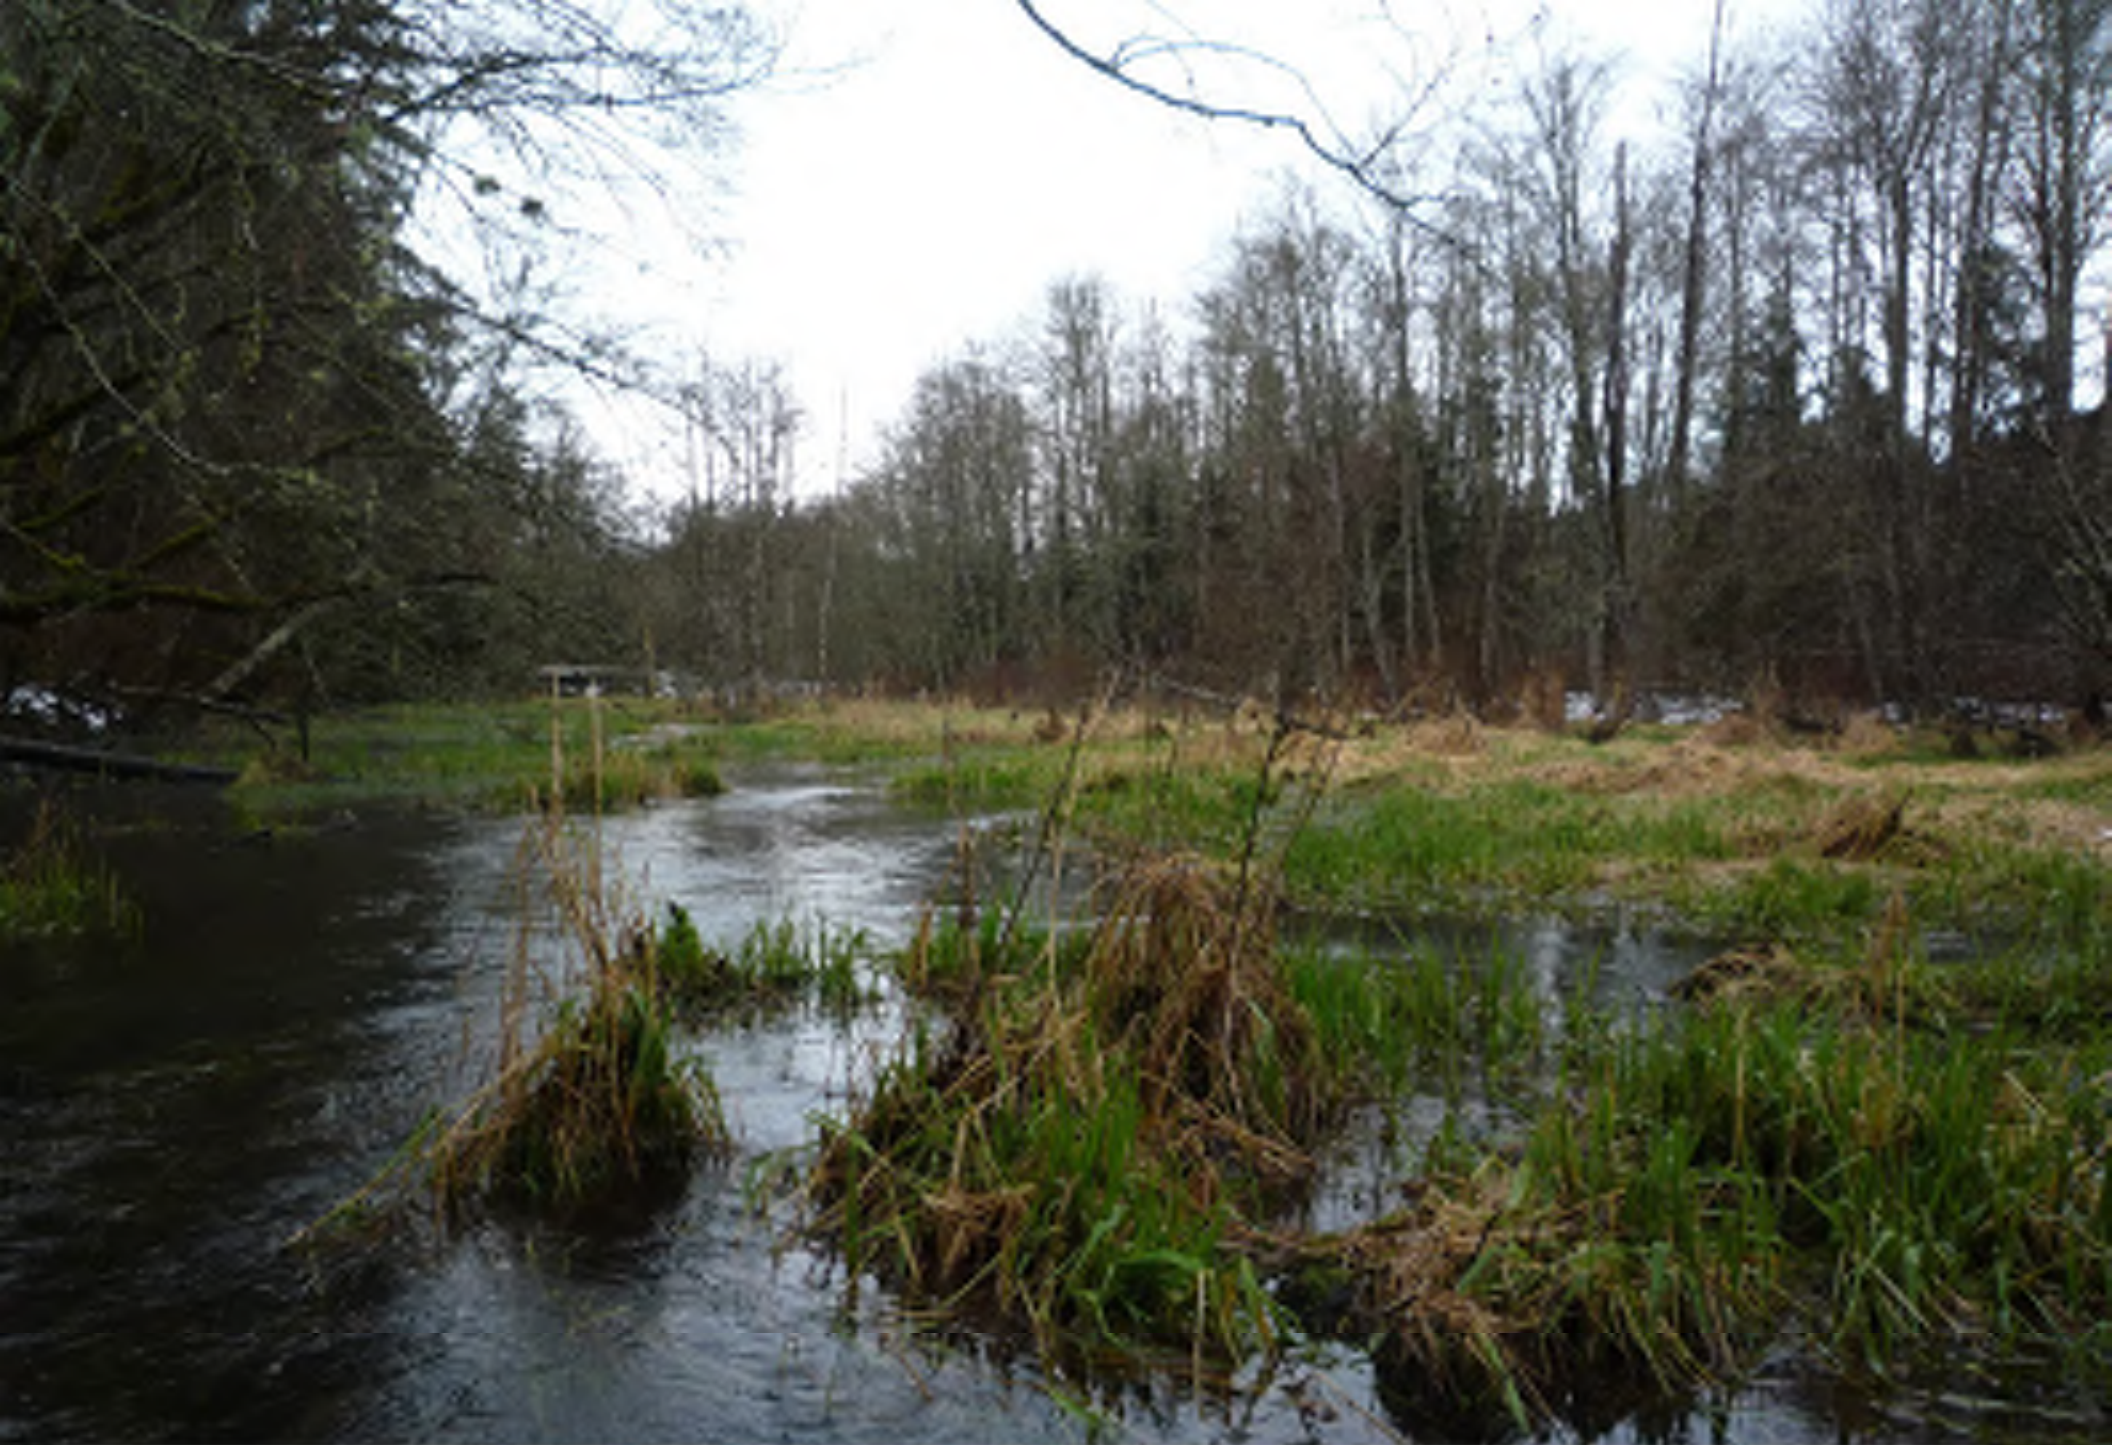
Photo 09: Just downstream of bridge at 1050 Laramie Road. Channel is ~20 m wide. Banks on landside are very low (<1 m). House on landside seen in this photo.

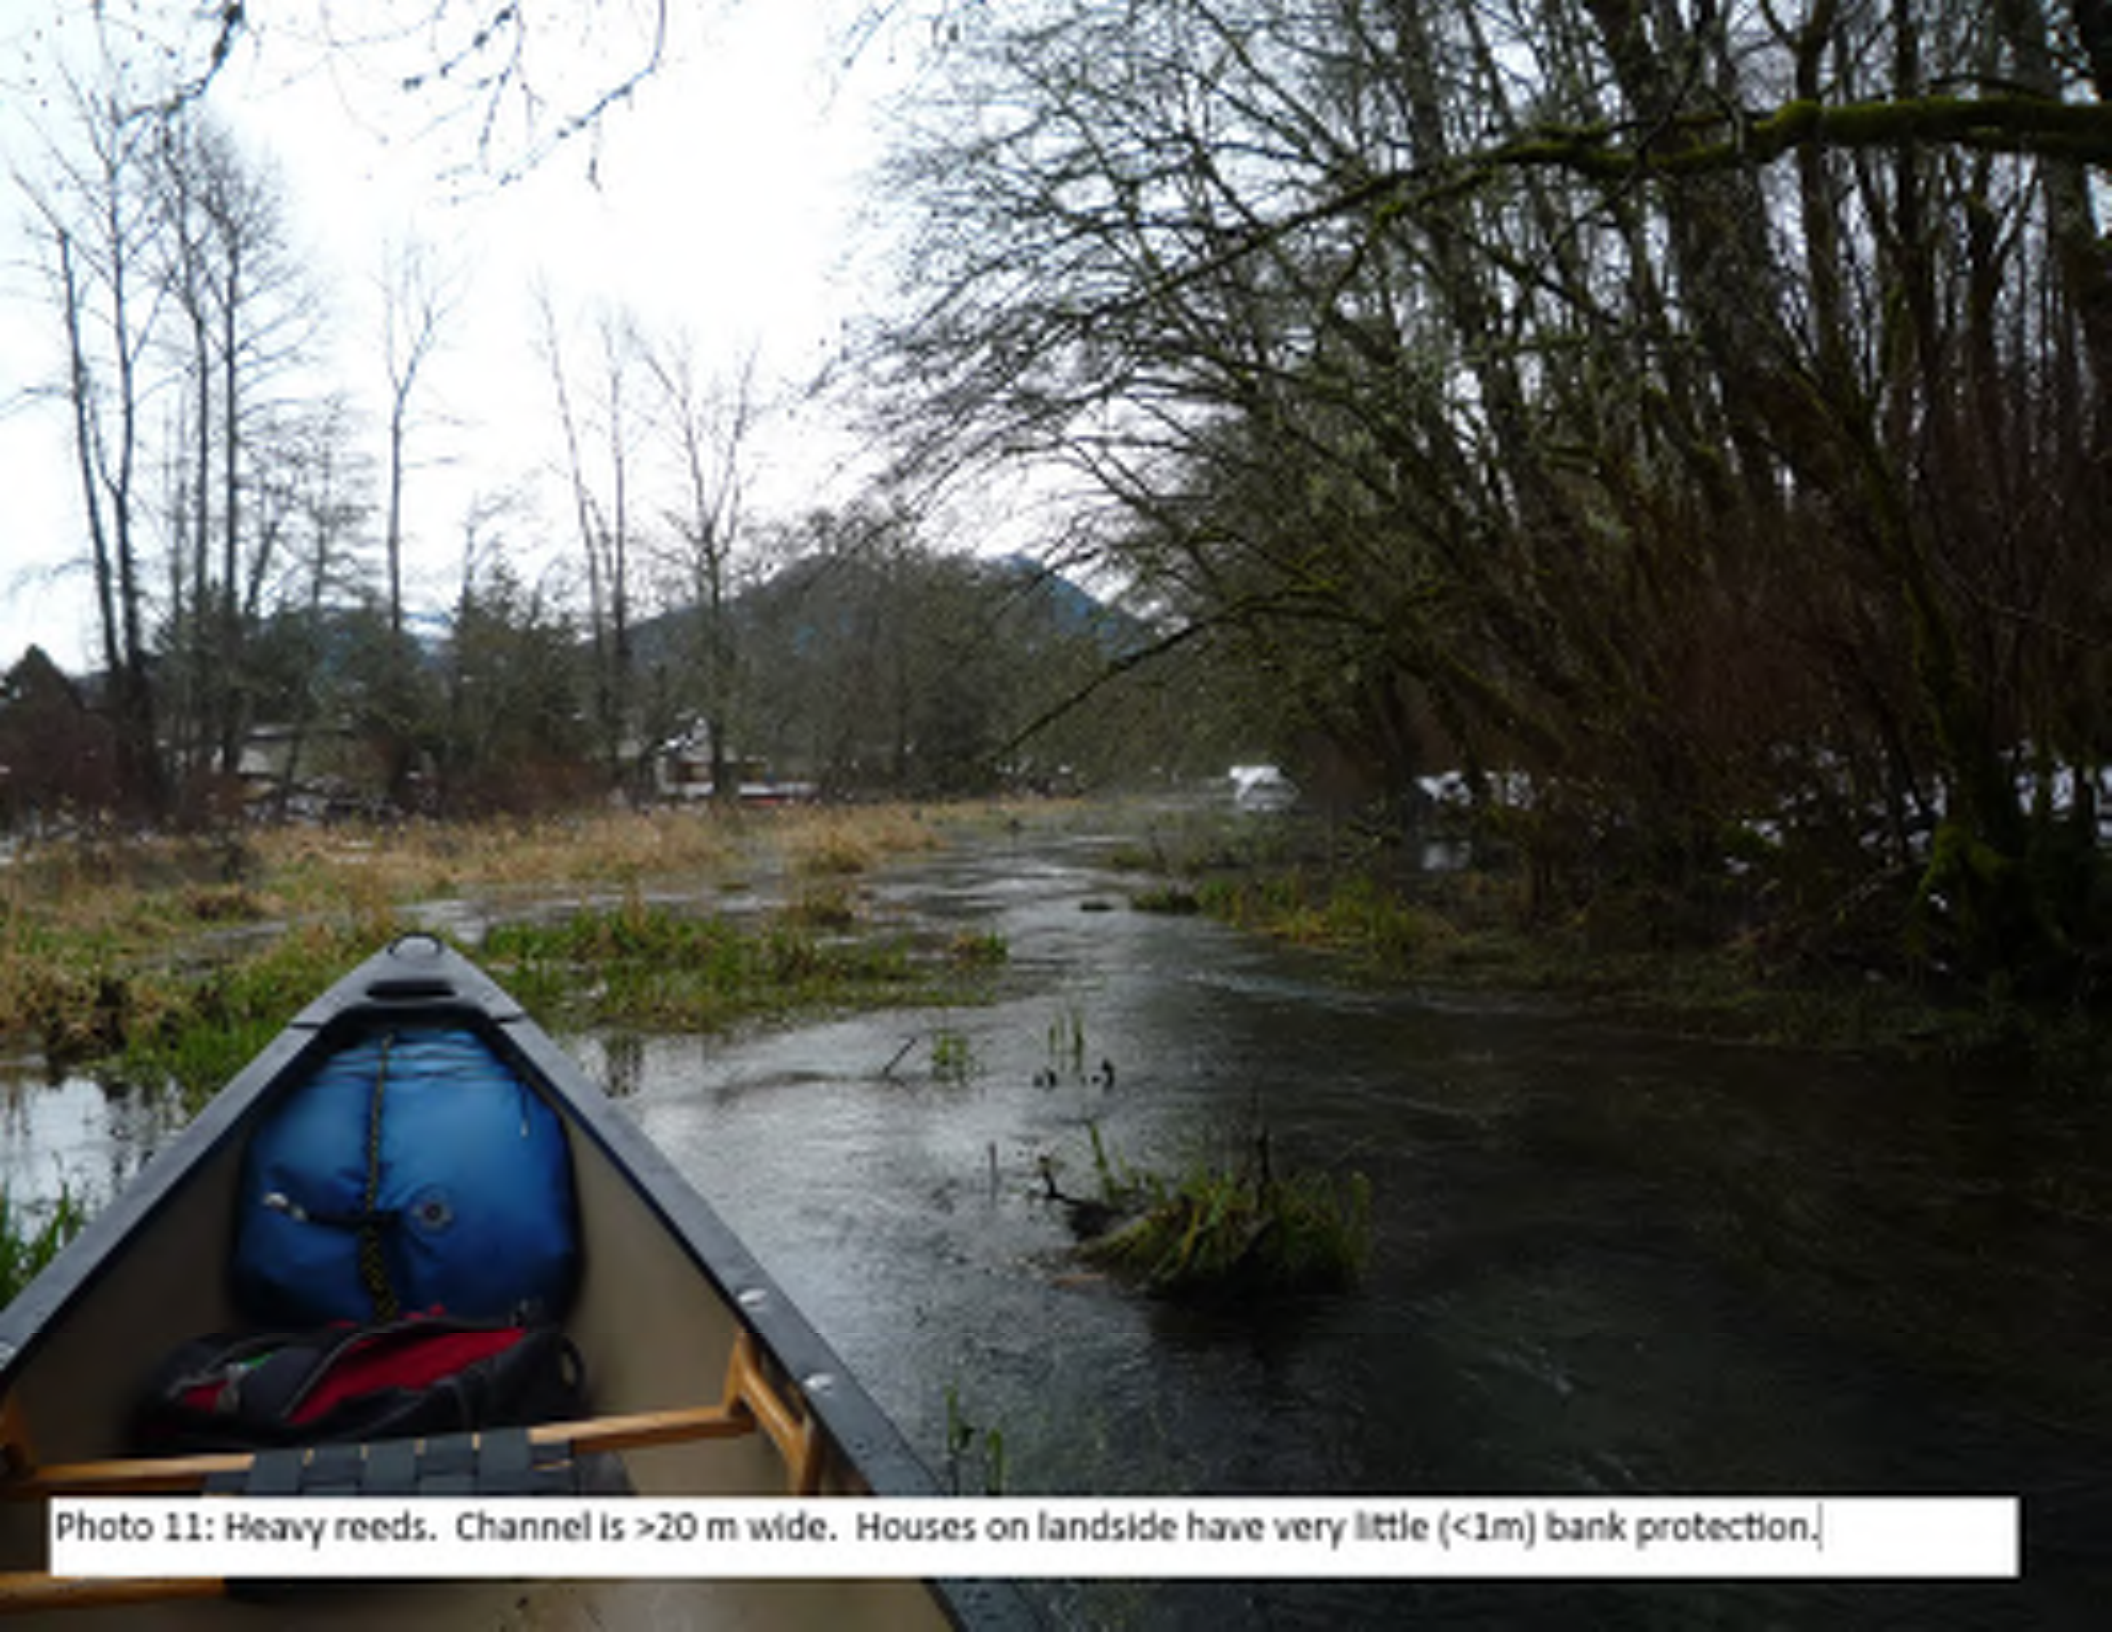
Photo 10: Just downstream of bridge at 1050 Laramie Road. Heavy growth of reeds across channel. Looking upstream. Channel is >20 m wide. Banks are very low on landside.

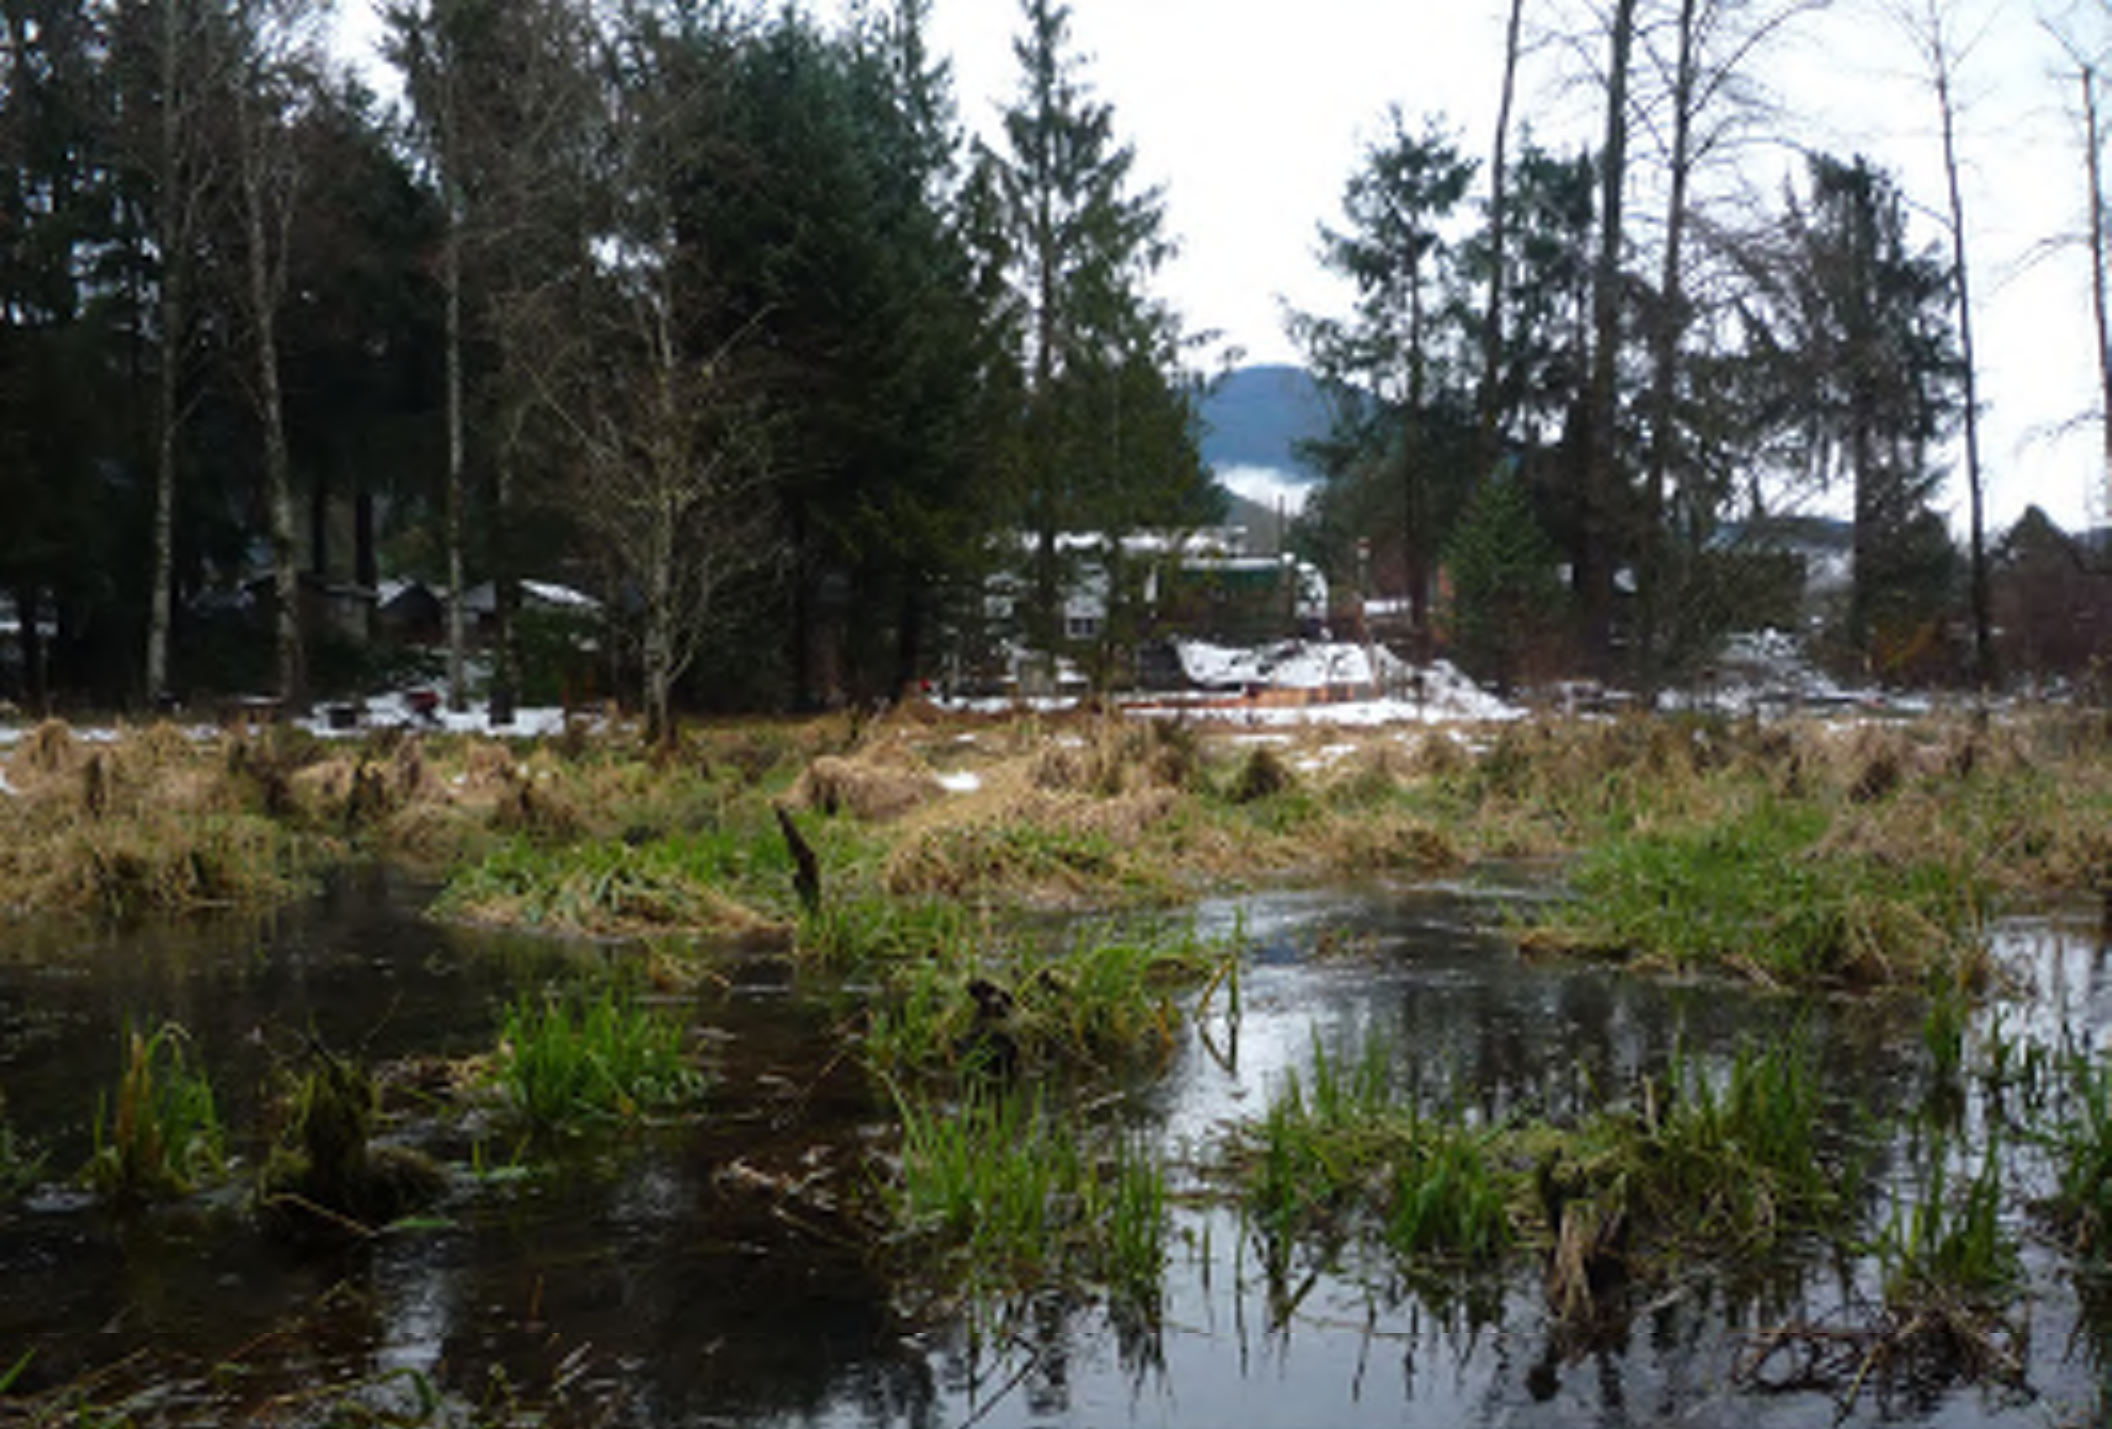
Photo 11: Heavy reeds. Channel is >20 m wide. Houses on landside have very little (<1m) bank protection.

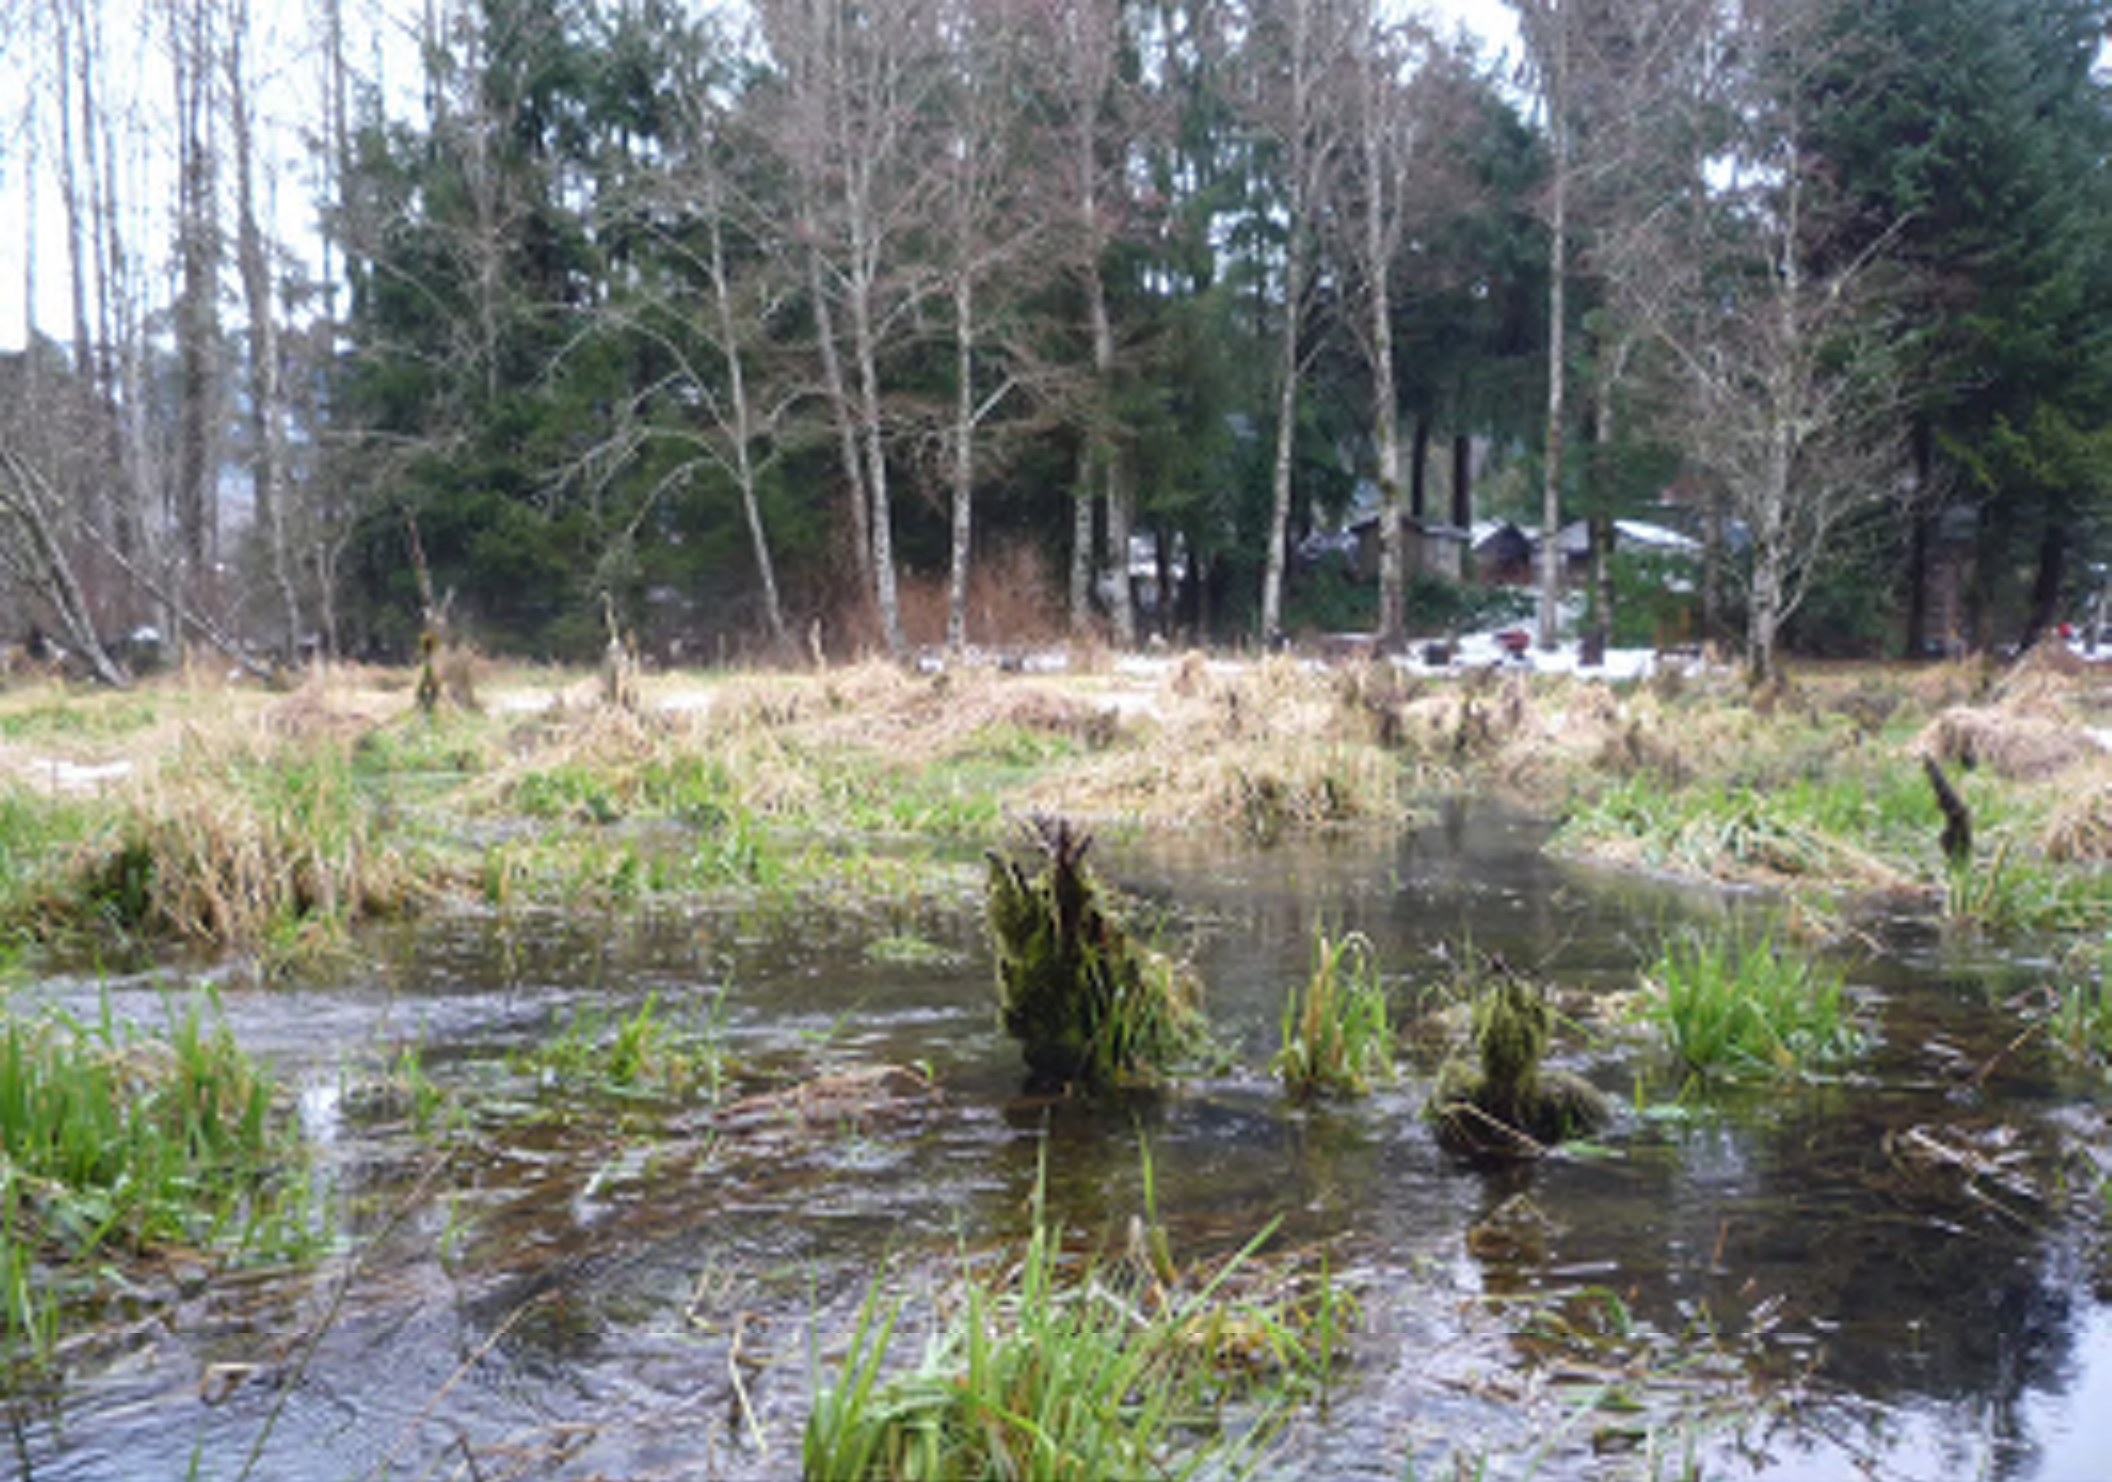
Photo 12: Channel is >20 m wide. Houses on landside have very little (<1m) bank protection.
