DISTRICT OF SQUAMISH  
PROJECT #: 18P-00095-00

# UPPER JIMMY-JIMMY (JUDD) SLOUGH ENHANCEMENT CULVERT FEASIBILITY MEMORANDUM

MAY 28, 2020

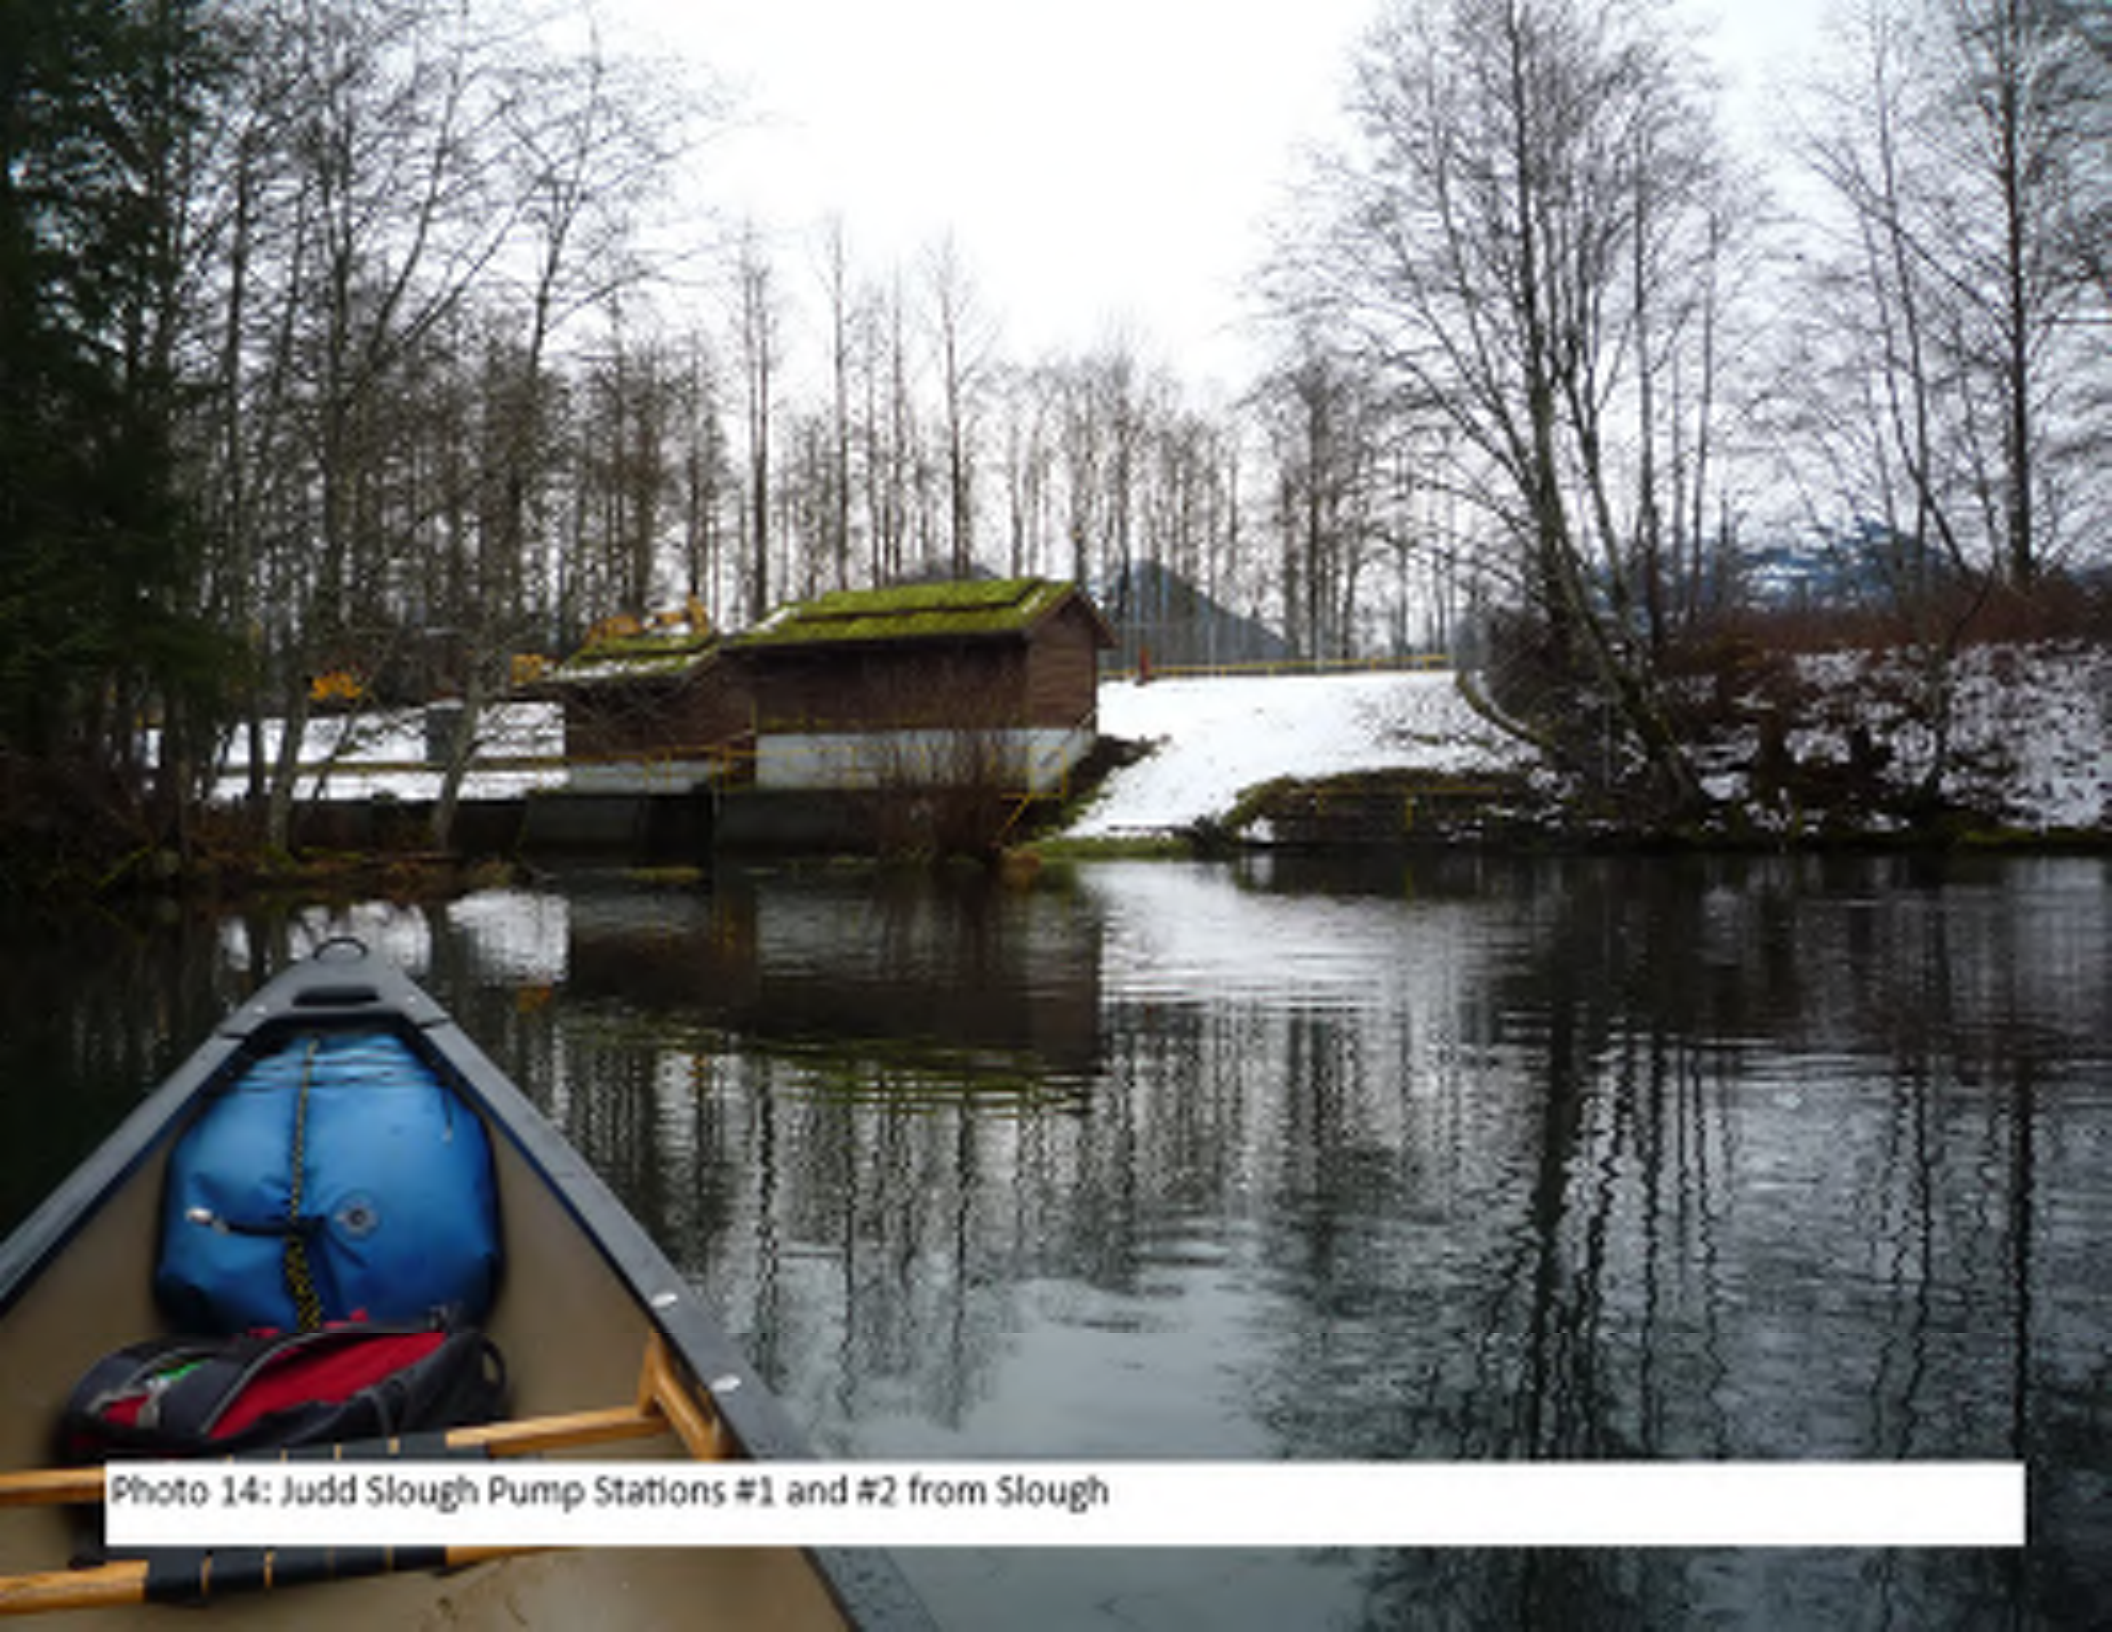
Photo 13: Channel is >20 m wide. Houses on landside have very little (<1m) bank protection. Some houses have furnishings near Slough.

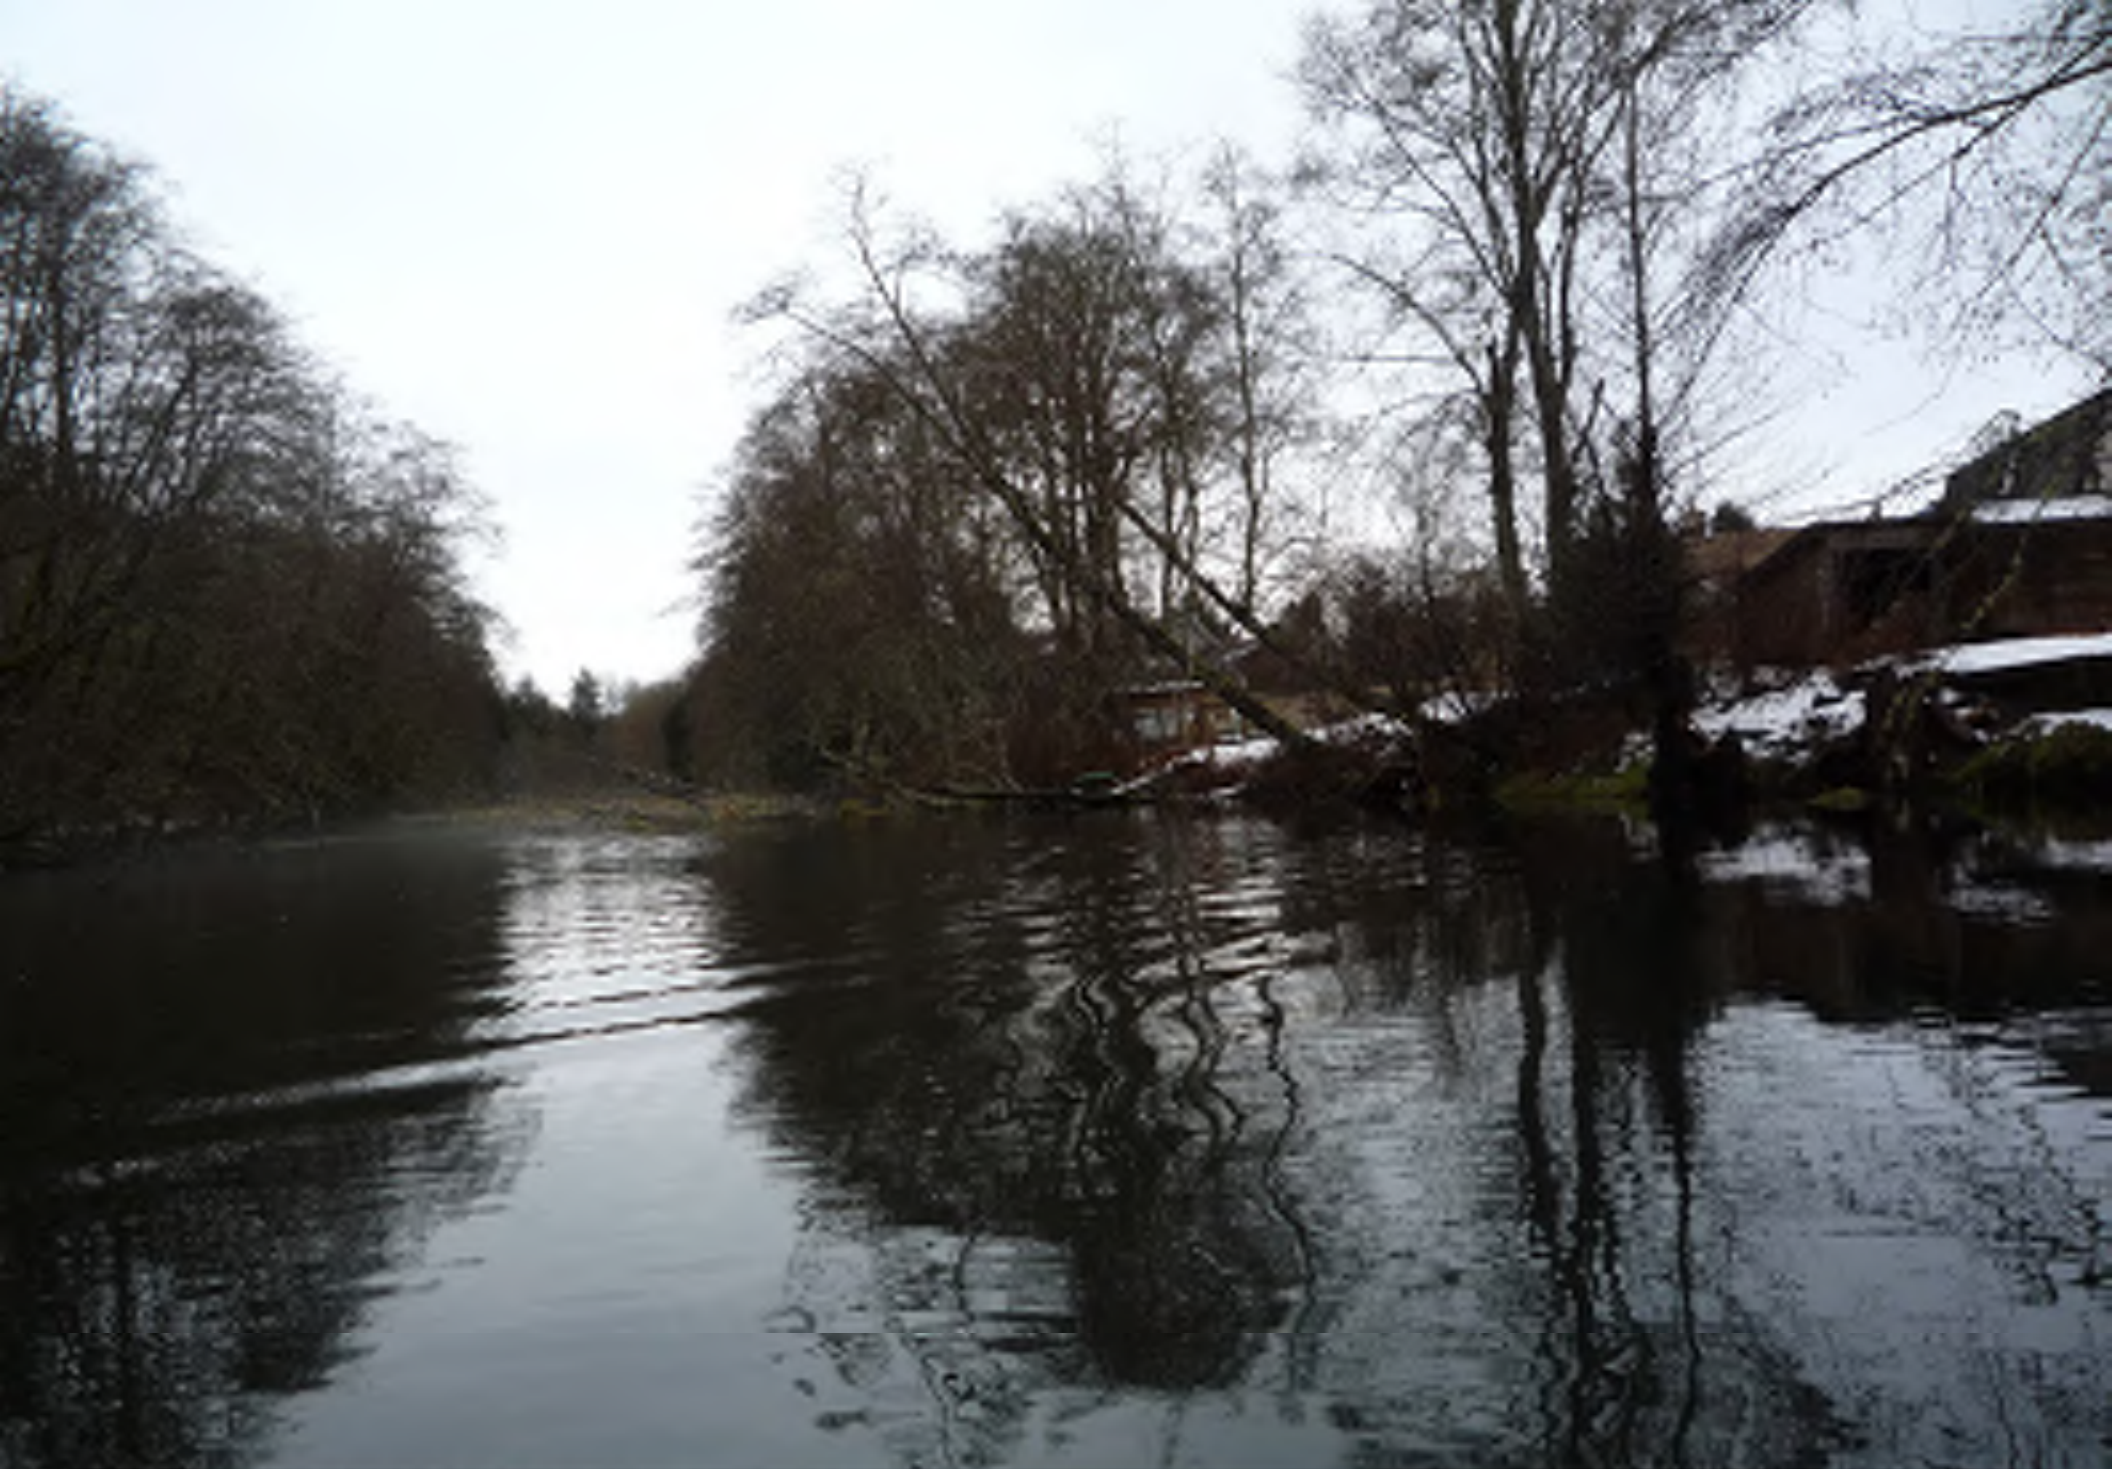
Photo 14: Judd Slough Pump Stations #1 and #2 from Slough

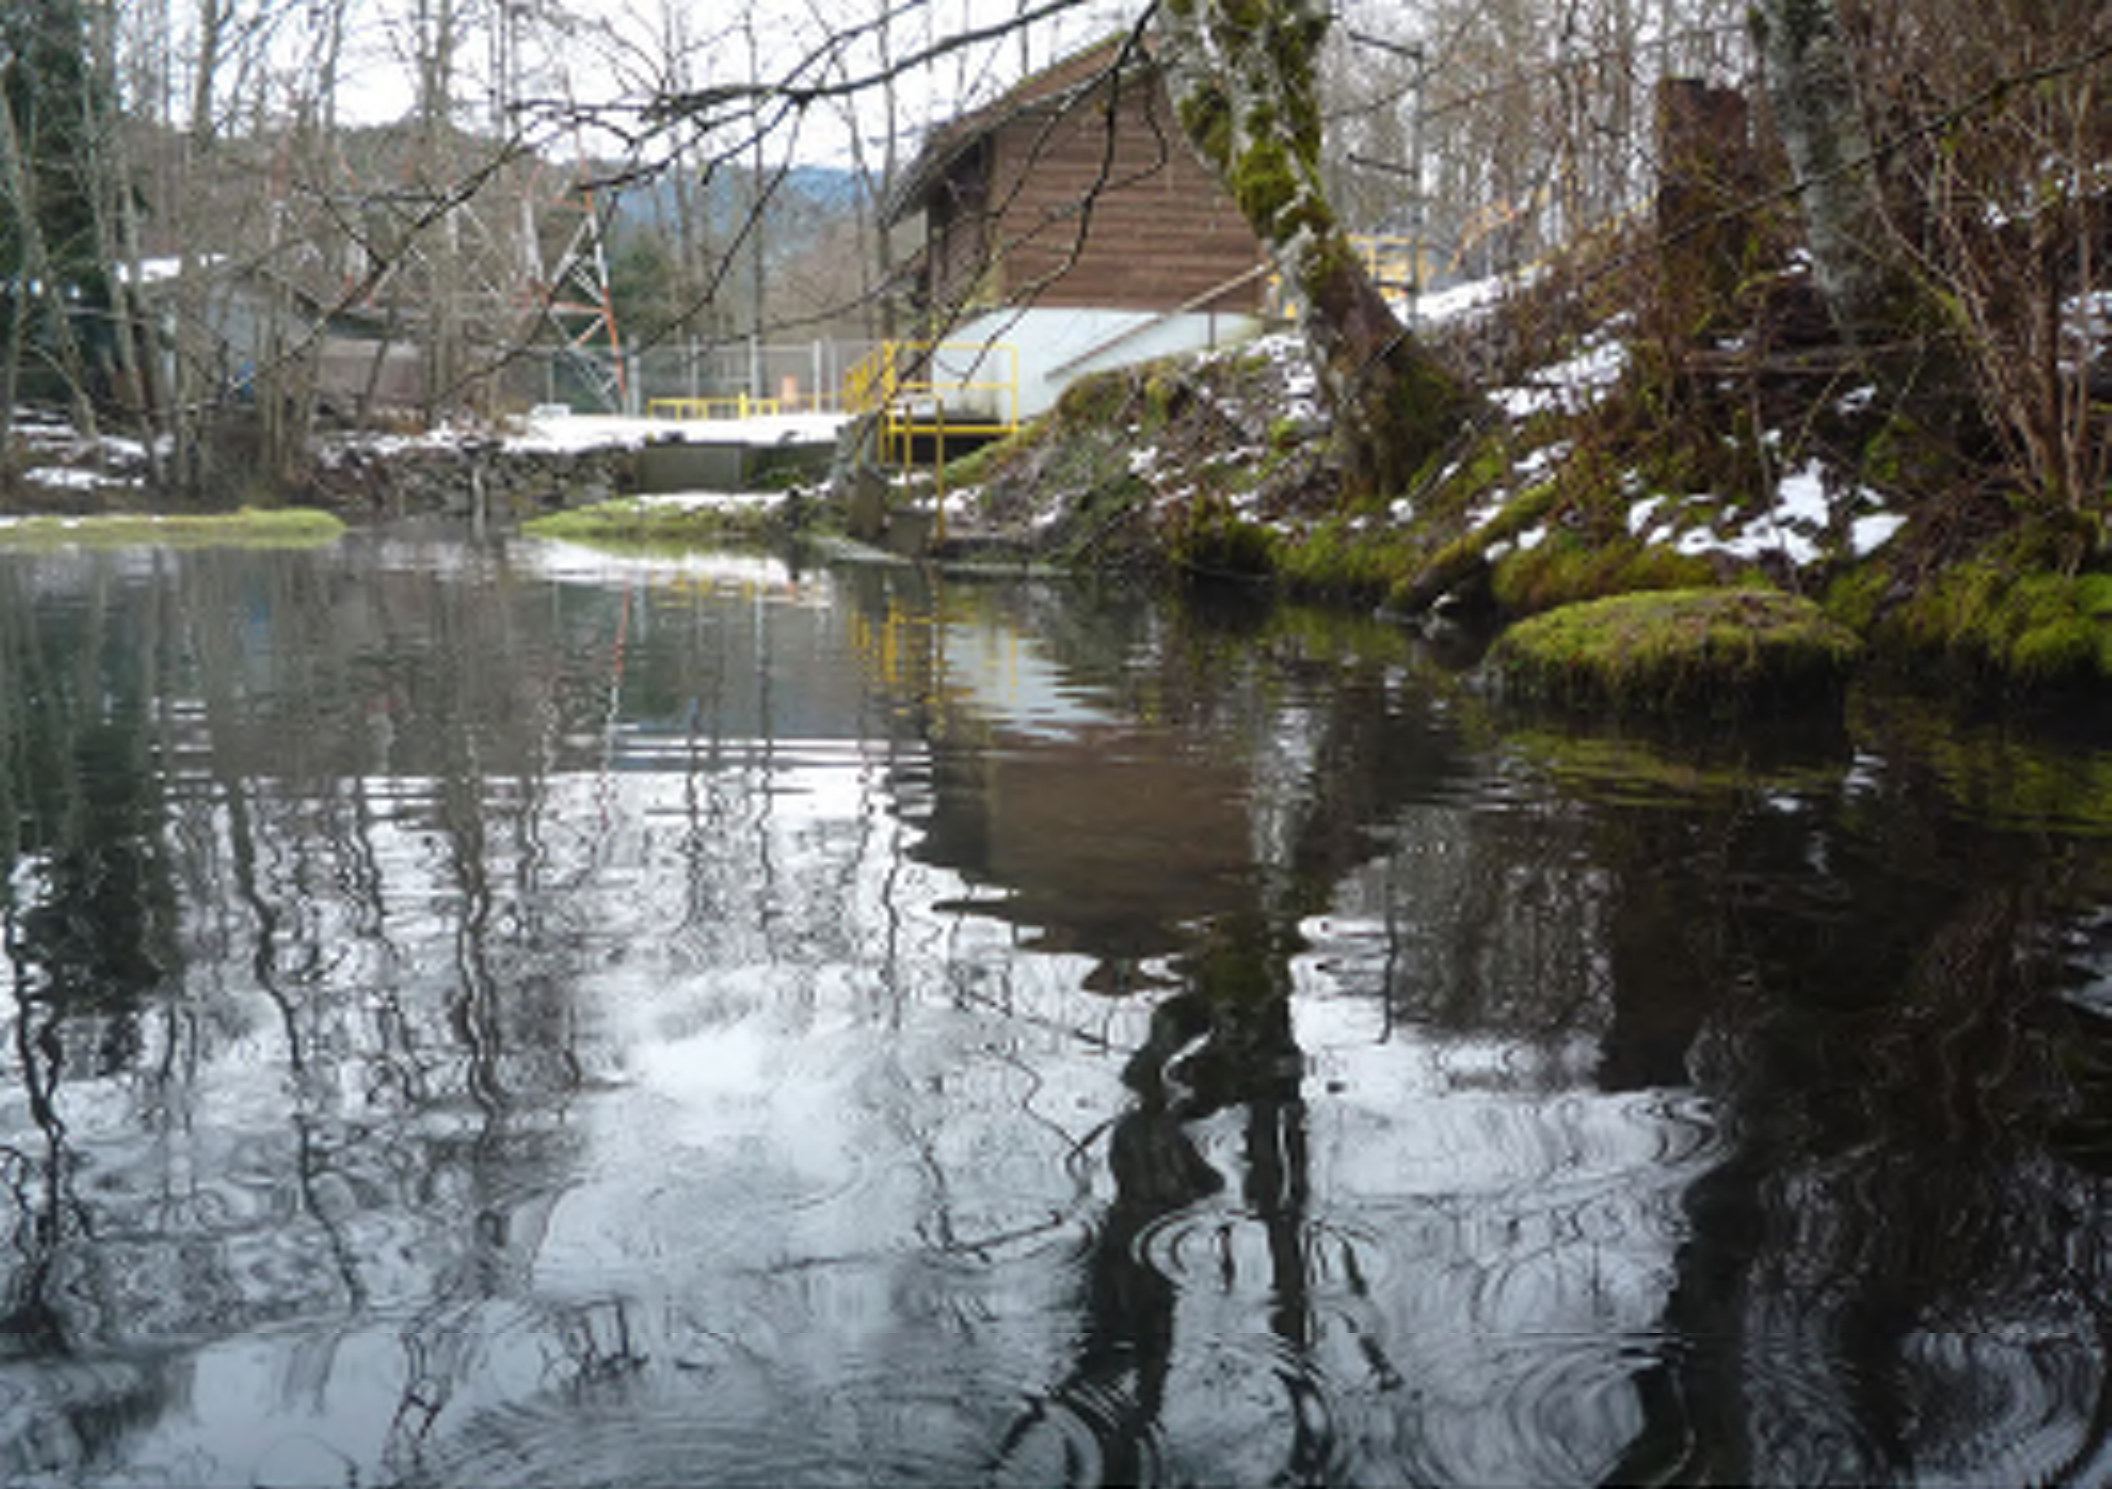
Photo 15: Judd Slough looking upstream from outlet end.

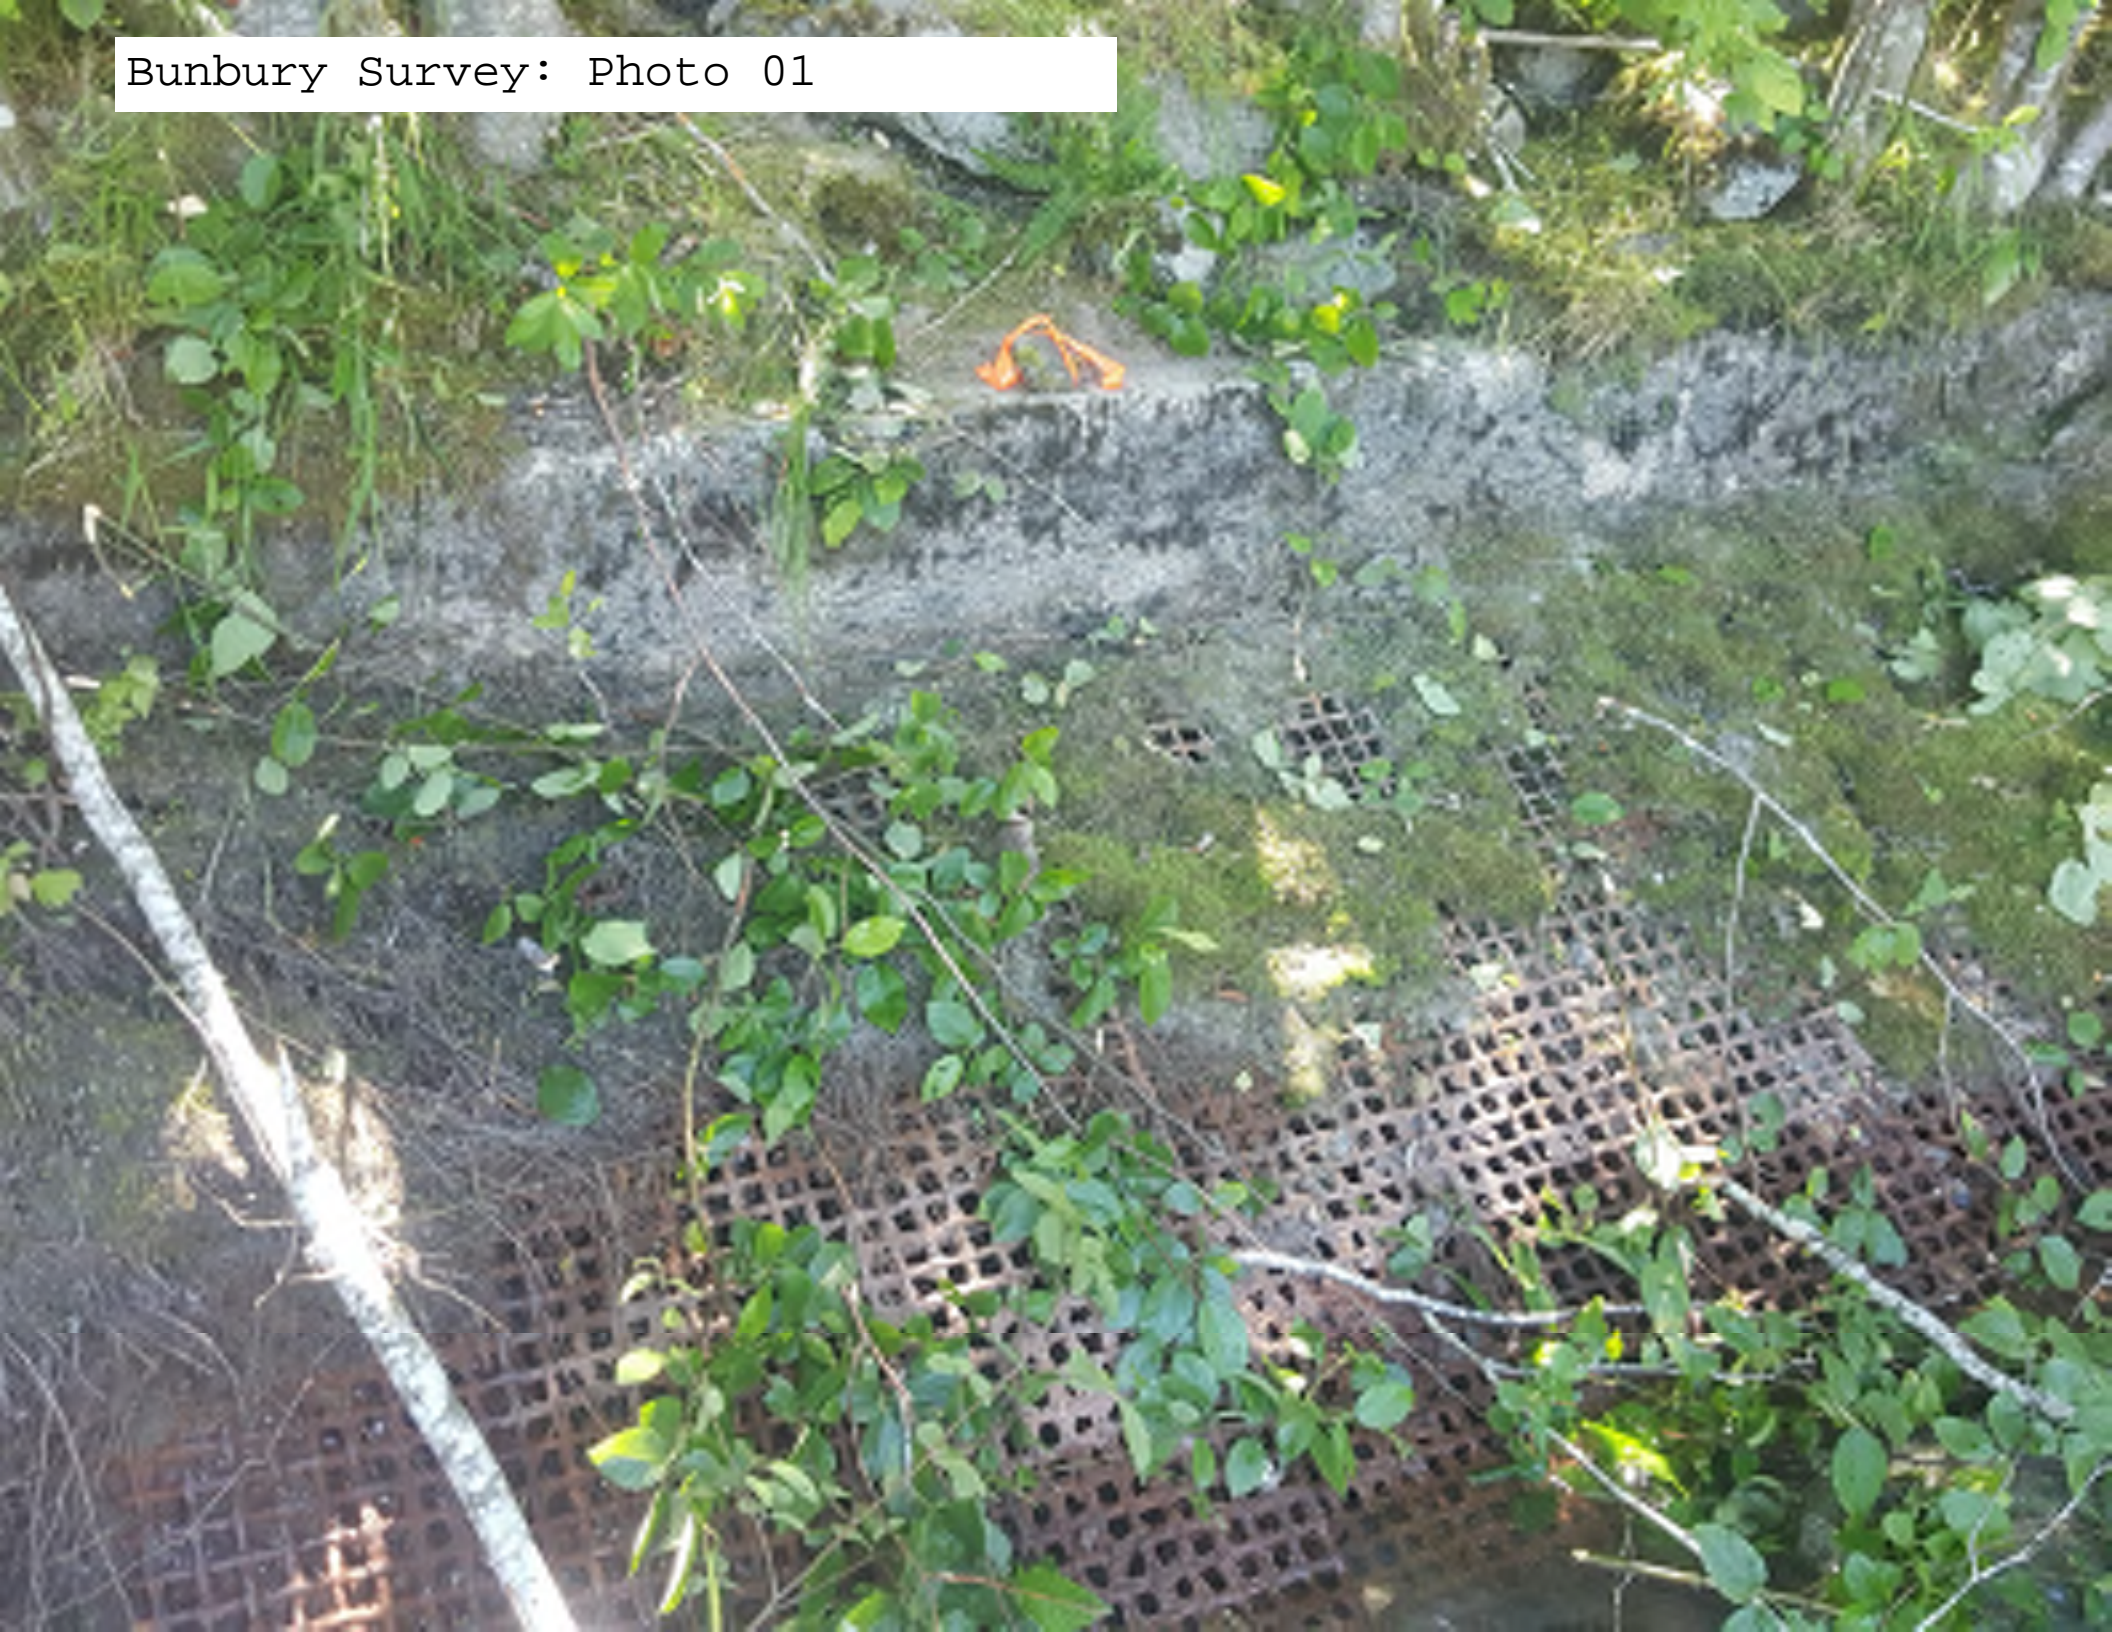
Photo 16: Flood box and Pump Stations. Looking East within Slough.
