DISTRICT OF SQUAMISH  
PROJECT #: 18P-00095-00

# UPPER JIMMY-JIMMY (JUDD) SLOUGH ENHANCEMENT CULVERT FEASIBILITY MEMORANDUM

MAY 28, 2020

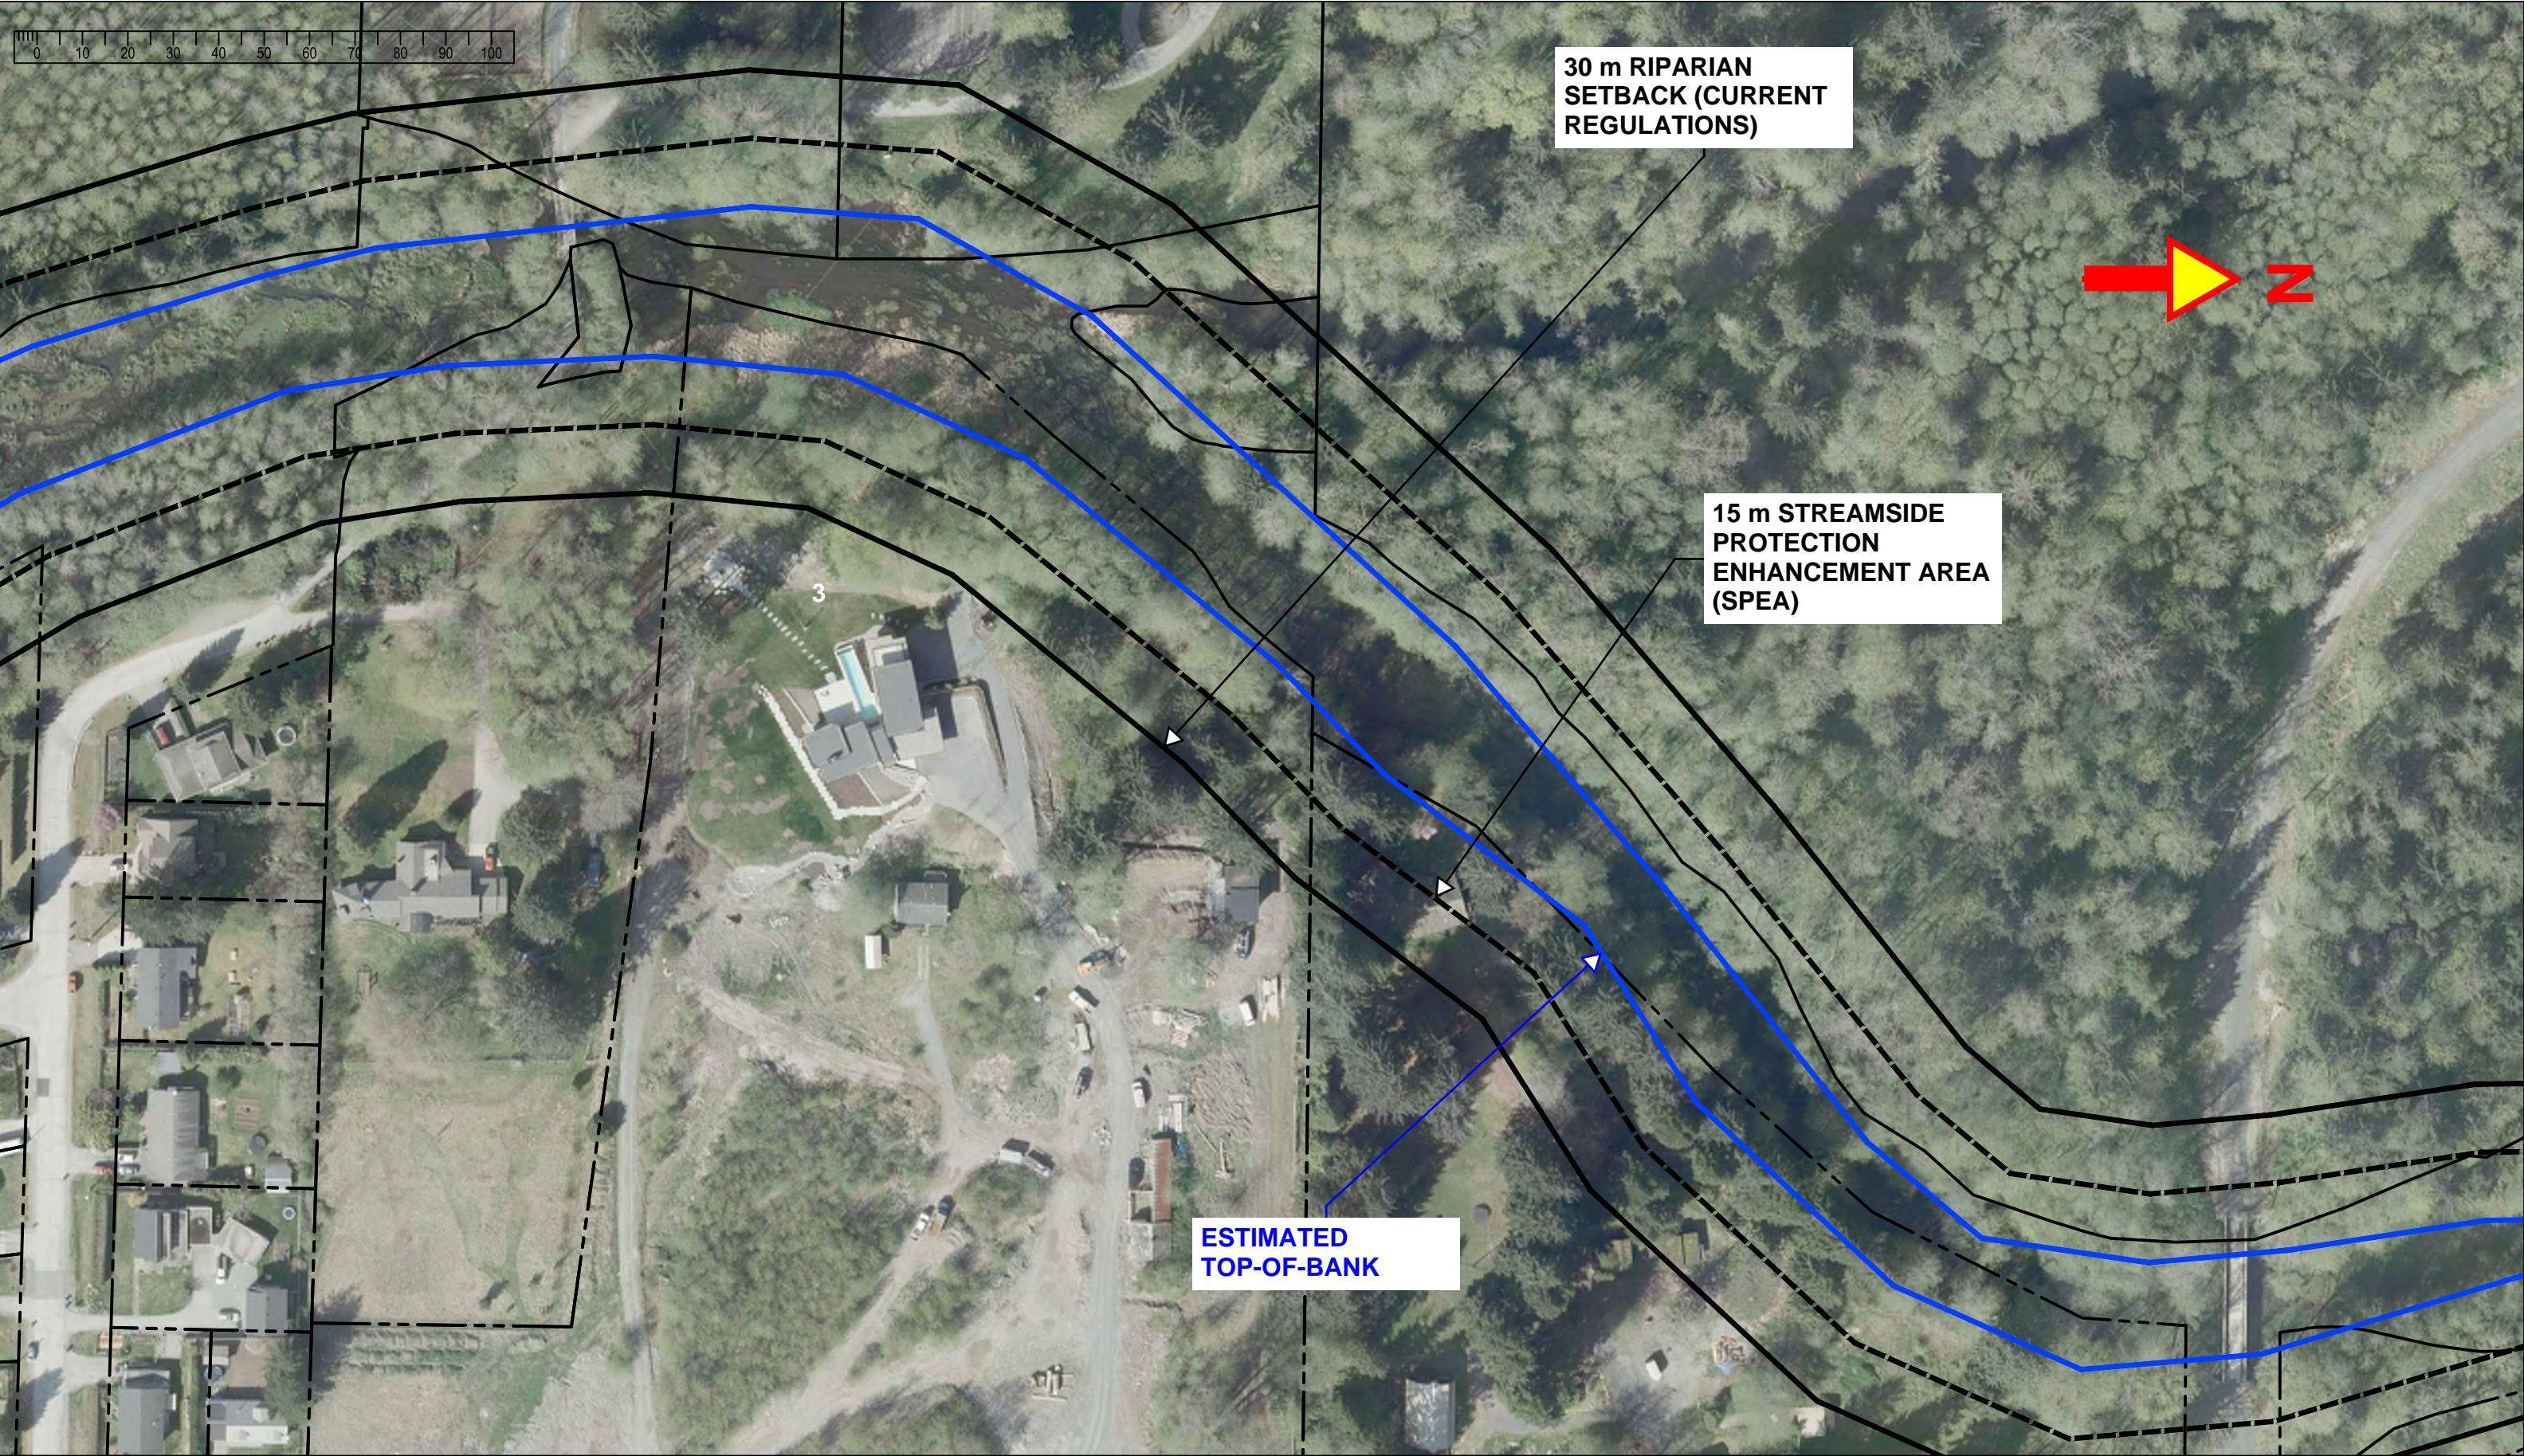
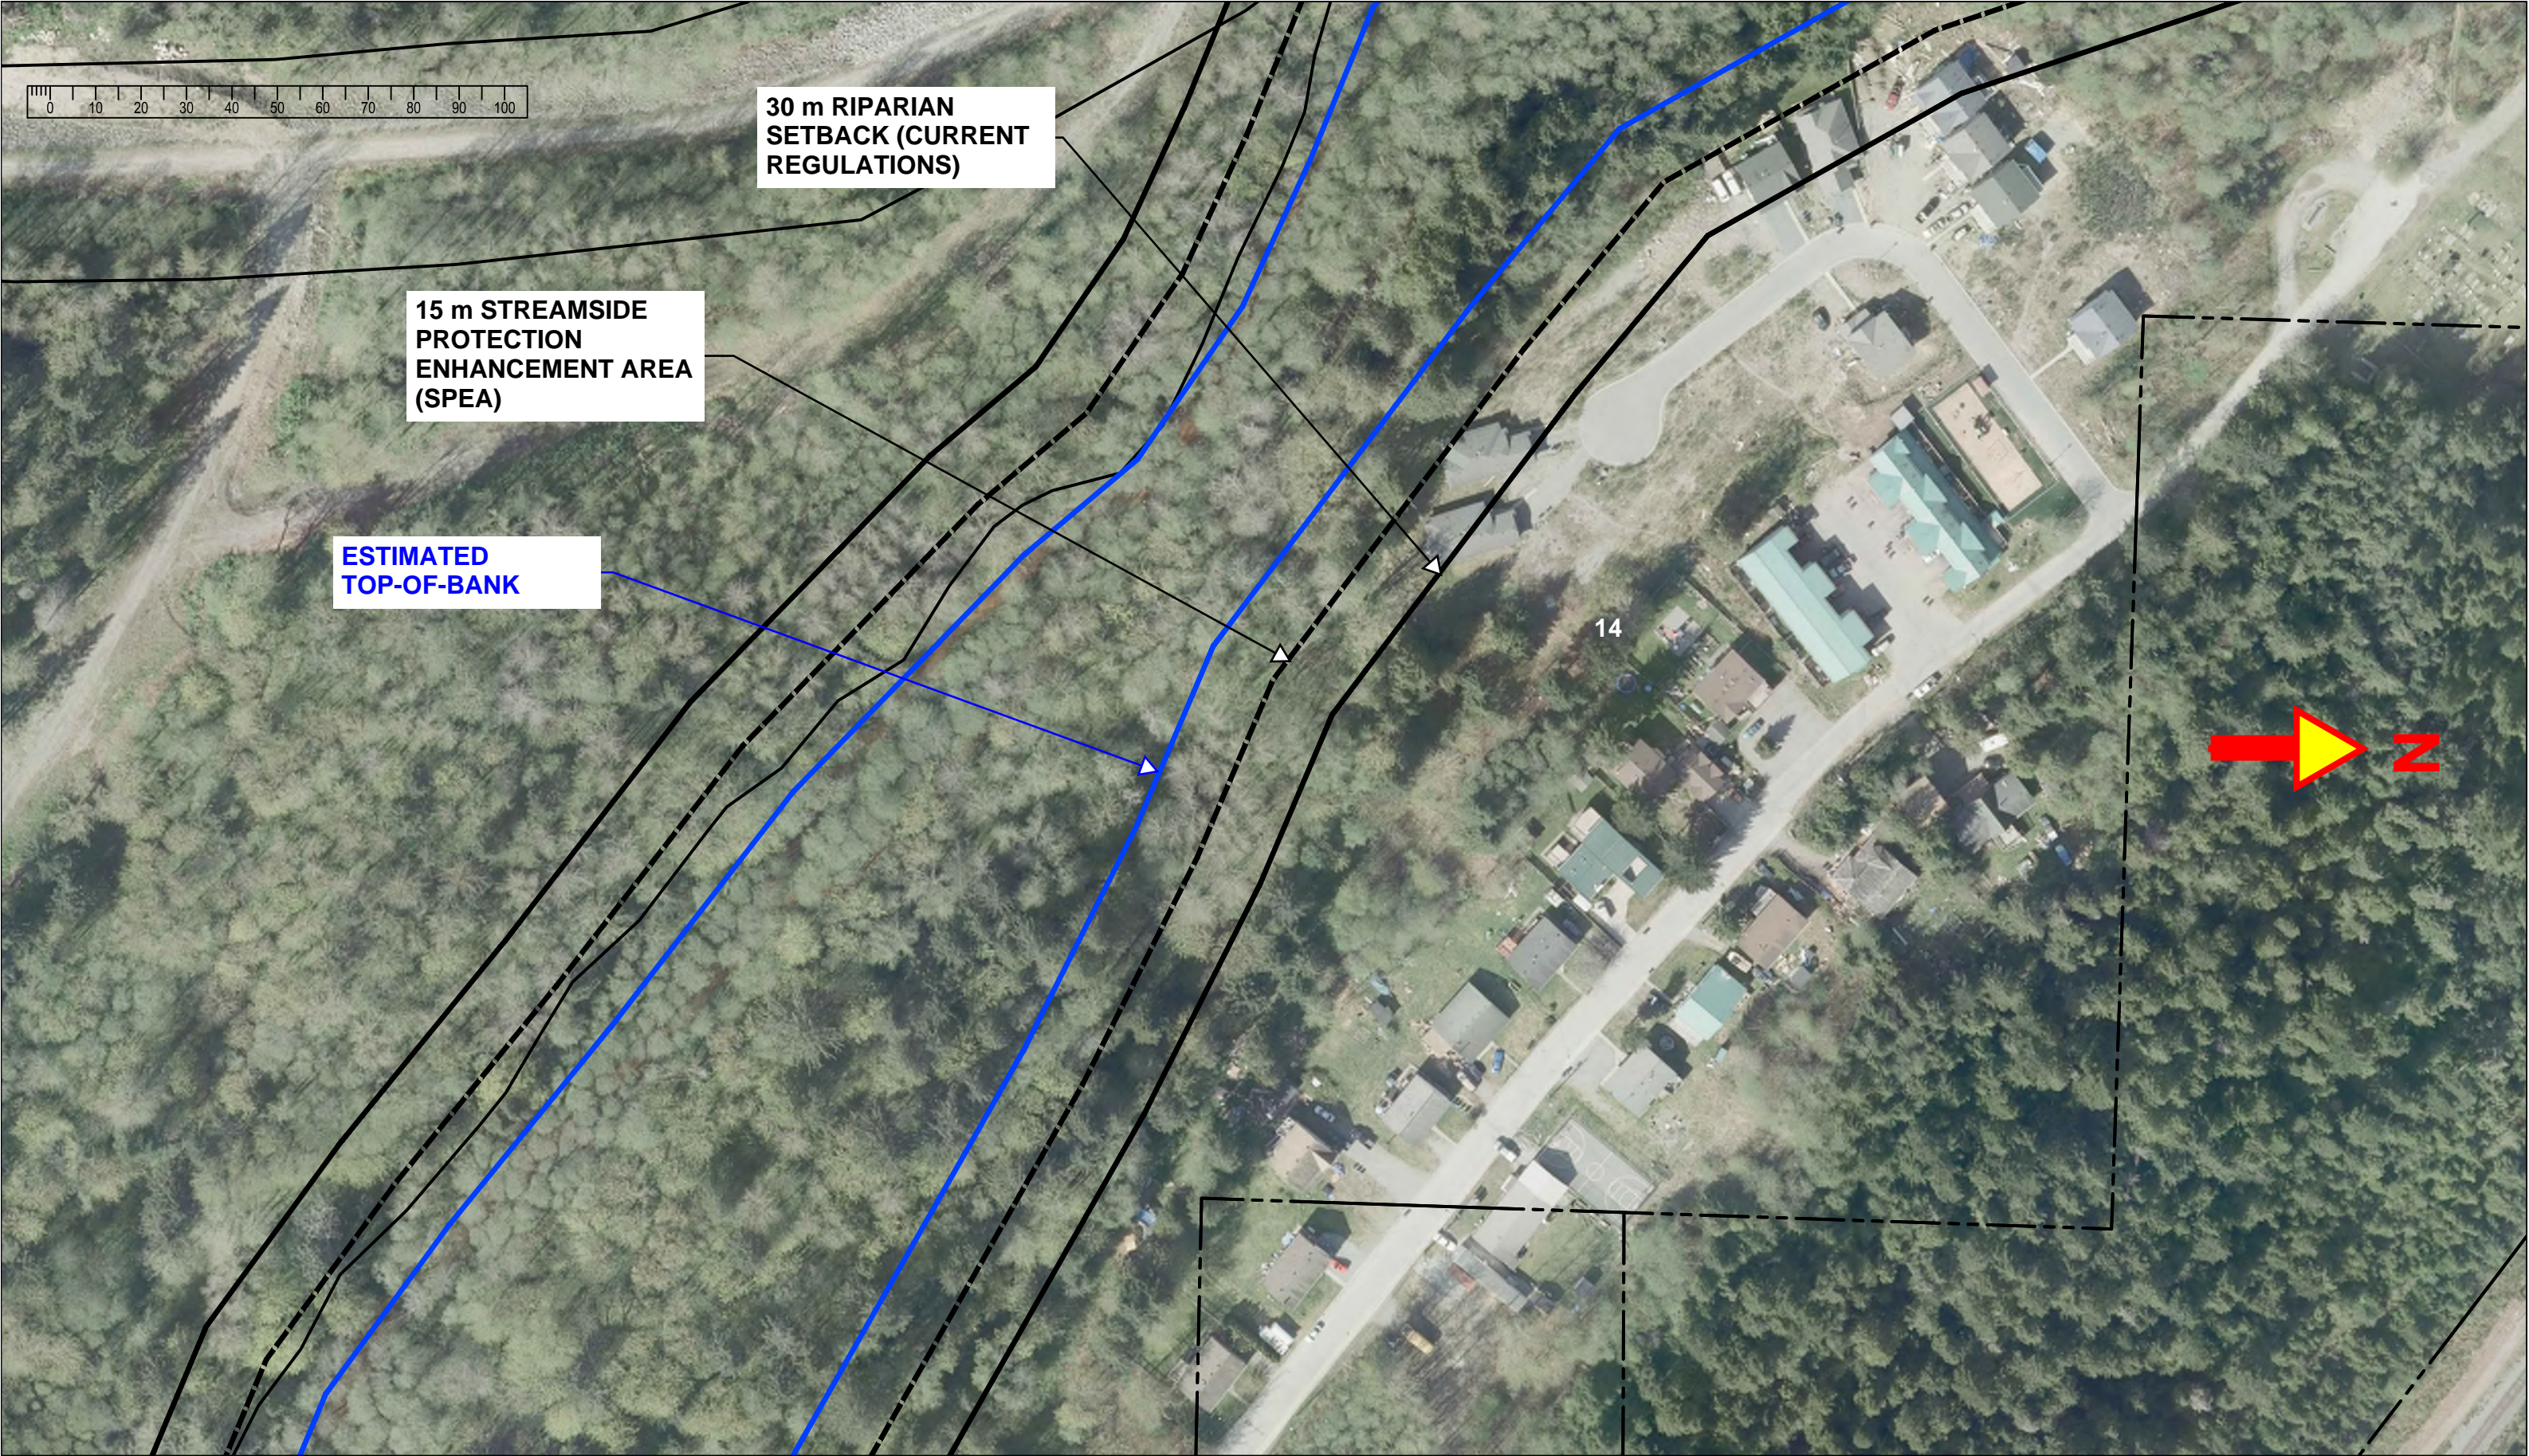
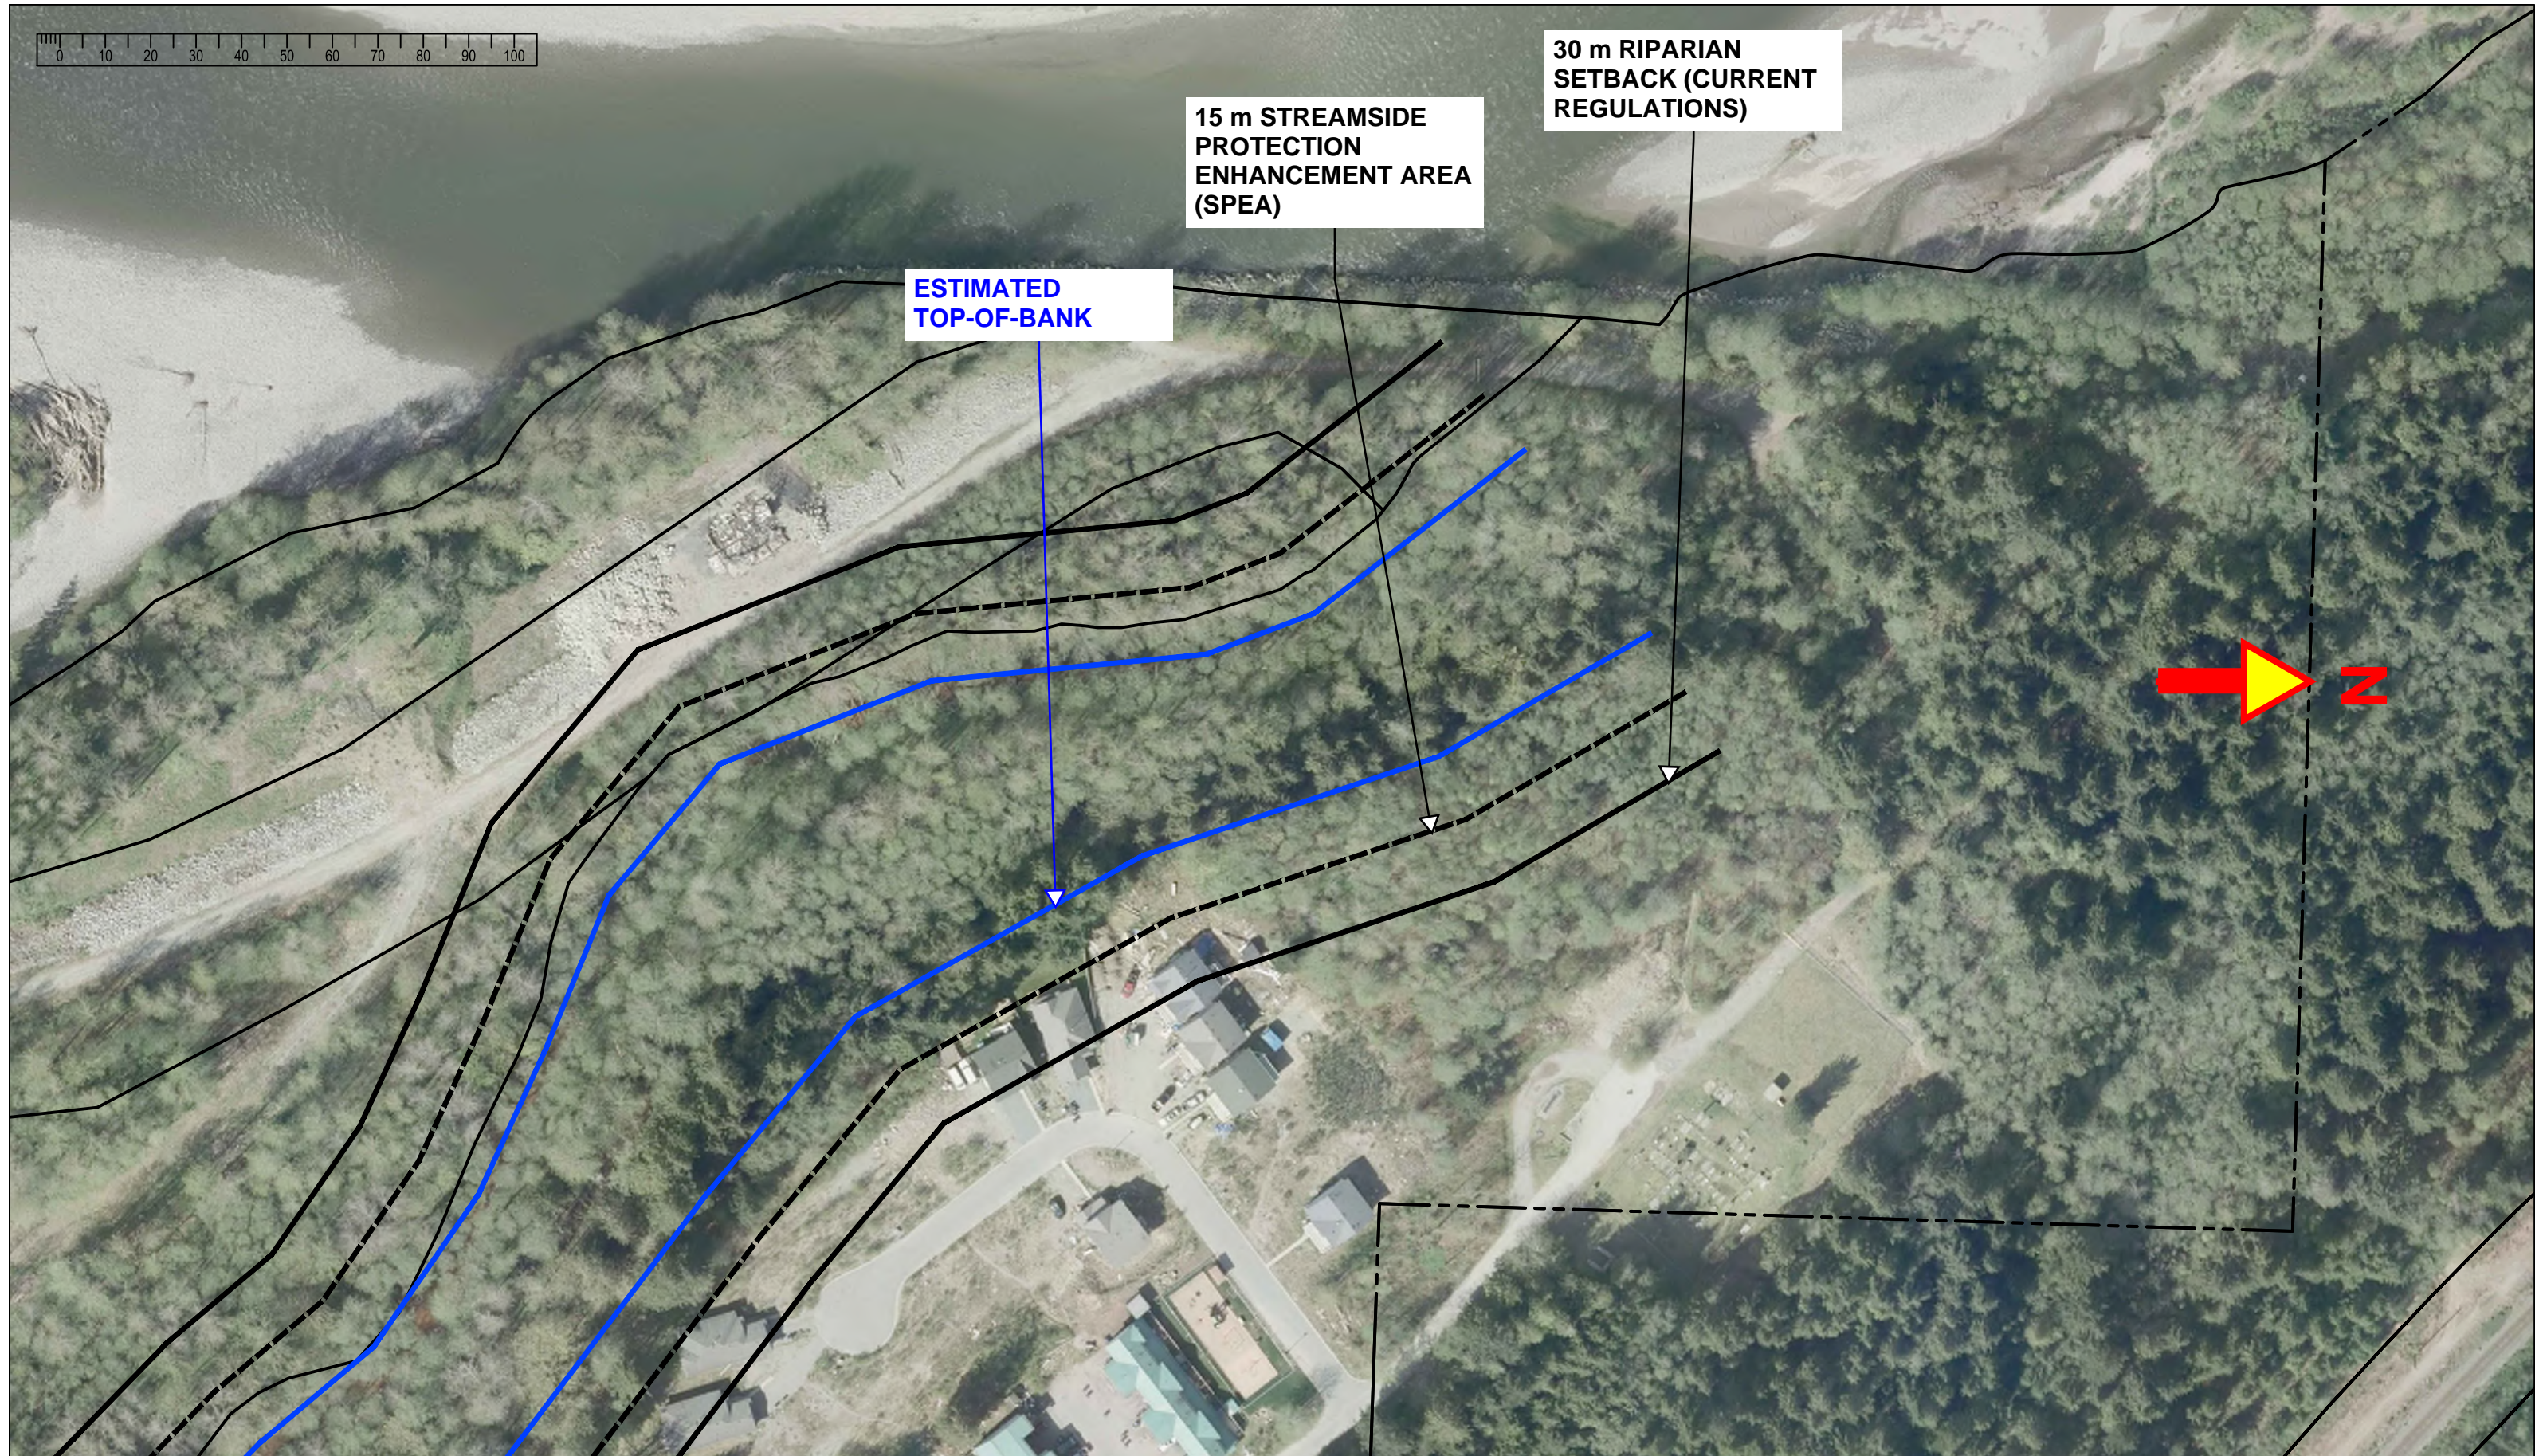
Appendix C: Judd Slough Riparian Setbacks

**30 m RIPARIAN  
SETBACK (CURRENT  
REGULATIONS)**

**ESTIMATED  
TOP-OF-BANK**

The proximity of the homes located west of the Slough makes these homes particularly prone to flooding, especially at the south end of the Slough, where the elevation of the homes appears to be less than 2 m above the top-of bank in some cases based on our site reconnaissance. Appendix 3 illustrates the historical 15-metre and current 30-metre riparian setbacks for Judd Slough.
