DISTRICT OF SQUAMISH WETLANDS INVENTORY AND MAPPING AND WATERCOURSE MAPPING

Prepared By:
EcoLogic Environmental Consulting and
Ecoscape Environmental Consultants Ltd.

Prepared For:
District of Squamish

December 2016

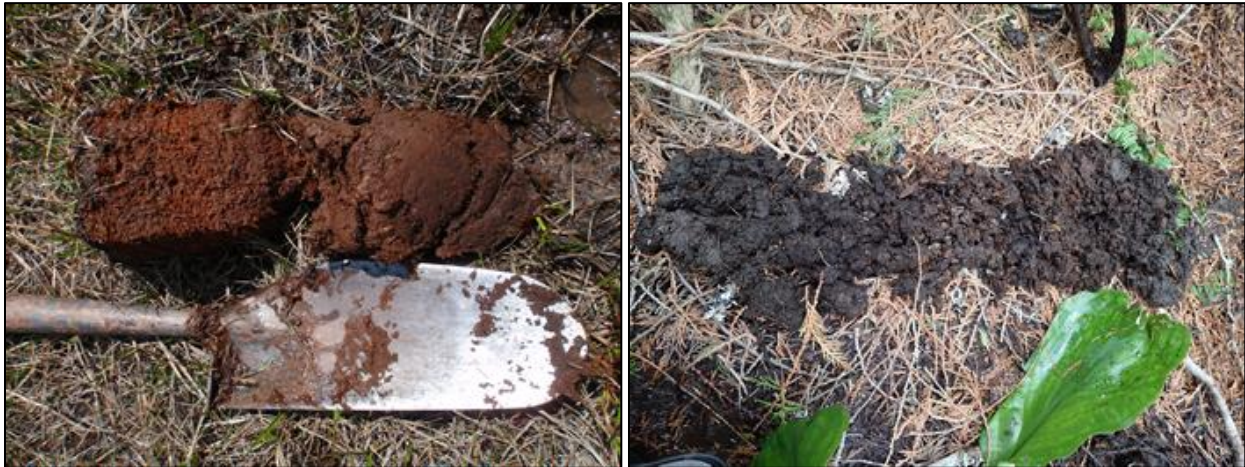
Figure 3. Example fibric peat over mesic peat in a fen (left). Figure 4. Example of a rich mineral soil from a forested swamp (right).

- Mineral wetlands are found in areas where an excess of water collects on the surface and which for geomorphic, hydrologic, biotic, edaphic (factors related to soil), or climatic reasons produce little or no organic matter or peat. Gleysolic² soils or peaty phases of these soils are characteristics of these wetlands (Fig. 4).

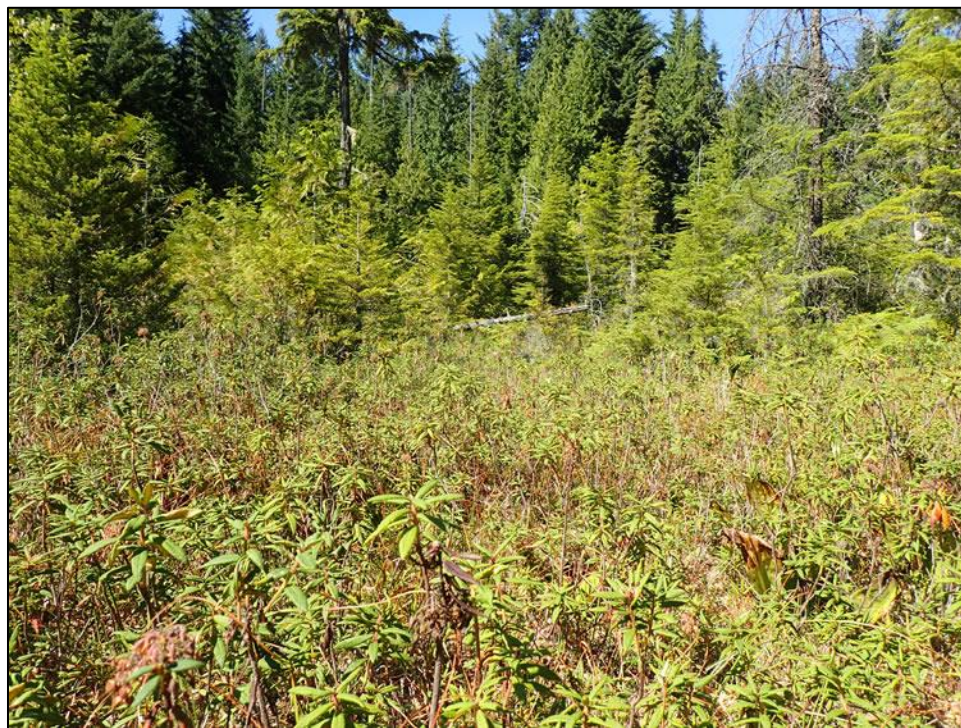
Figure 8. Unclassified Wb00 western hemlock – Labrador tea bog.

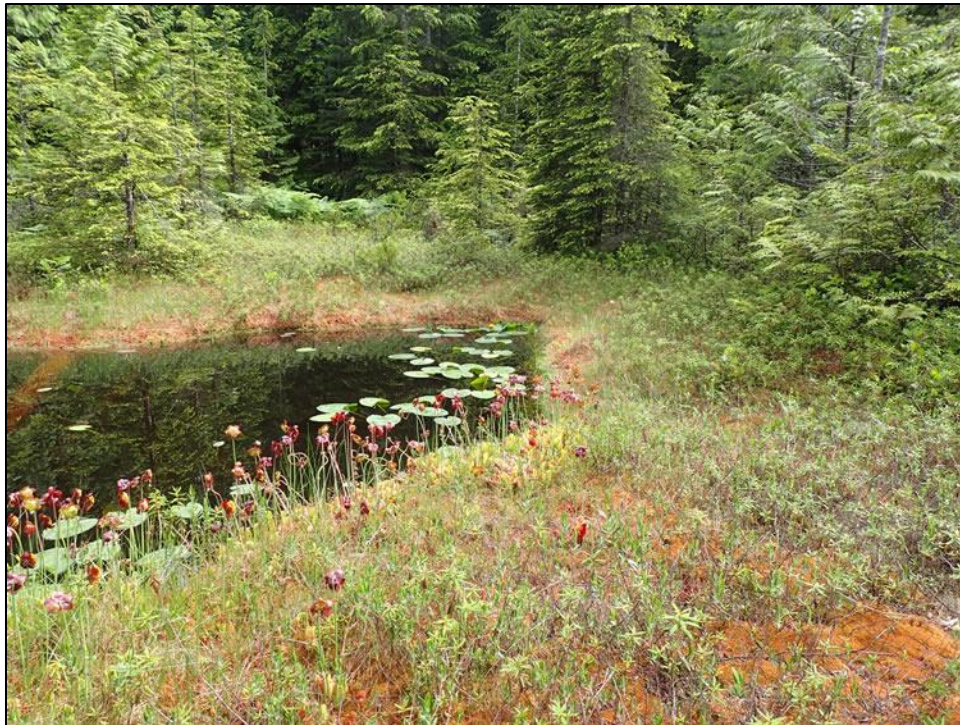
Figure 9. Wb50 Labrador tea – bog-laurel – peatmoss bog complexed with Wb00 unclassified western hemlock – Labrador tea bog in Alice Lake Provincial Park.

A third bog, also located in Alice Lake Provincial Park, was classified as a complex of two associations (Fig. 9 and 10). It contained patchy open areas of Wb50 Labrador tea – bog-laurel – peatmoss bog with small pools, complexed with a bog similar to those described above as Wb00 unclassified western hemlock – Labrador tea bog. The Wb50 is relatively widespread (with 20 occurrences mapped by the CDC from Campbell River to Richmond), but other than Burn’s Bog, generally occurs as small wetlands (MacKenzie & Moran 2004). These bogs lack tree cover, although they occasionally contain stunted lodgepole pine on slight mounds. Labrador tea forms a constant low shrub layer, while small amounts of salal and dwarf shrubs such as bog rosemary, western bog-laurel and bog cranberry are common. Herbs have a variable cover, with sundews and various sedges commonly occurring. An interesting feature of this wetland was the presence of a healthy population of purple pitcher plants, a red-listed species that is only known to occur in bogs in northeastern BC. The pitcher plant population is not considered to be a natural occurrence, and carnivorous plants in general are often planted in suitable habitat (McIntosh & Fenneman 2016). As with most bogs, deep sphagnum peatmoss forms a continuous cover. Soils were thick fibric organic material over deep (over 1.2 m) mesic organic material. The Wb50 is a blue-listed ecosystem in BC and is only known from a single location in the DoS.

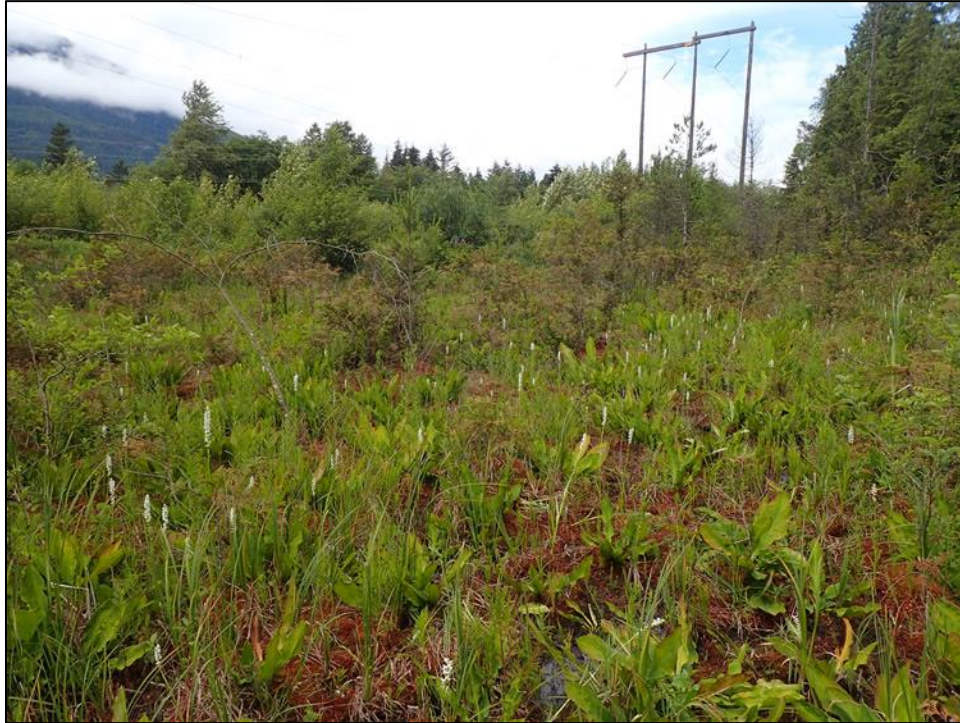
Figure 11. Modified bog-like community under a BC Hydro powerline right-of-way.

A single occurrence of a modified bog was located along a BC Hydro powerline corridor (Fig. 11). While still possessing many bog species (Labrador tea, deep sphagnum, and various dwarf shrubs) it appears to have a modified hydrological regime. Small amounts of running water was present, and there was a high cover of skunk cabbage, various sedges, bog orchid, along with western hemlock, western redcedar, lodgepole pine, and red alder. In addition to the right-of-way clearing, we suspect that the construction of the nearby highway altered local drainage patterns resulting in a modified bog-like community. While still of conservation significance due to the local rarity of bogs in the DoS, it is unlikely that this community will return to a true bog form without restoration.

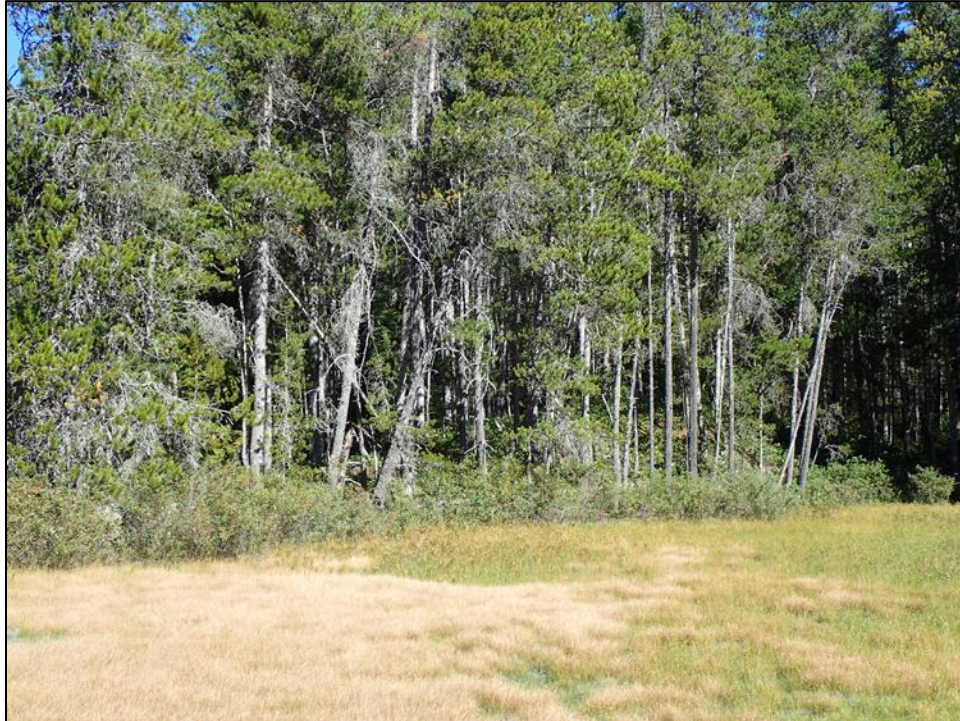
Figure 12. CWHdm/11 lodgepole pine – peatmoss bog (background) complexed with a Wf53 fen (foreground).

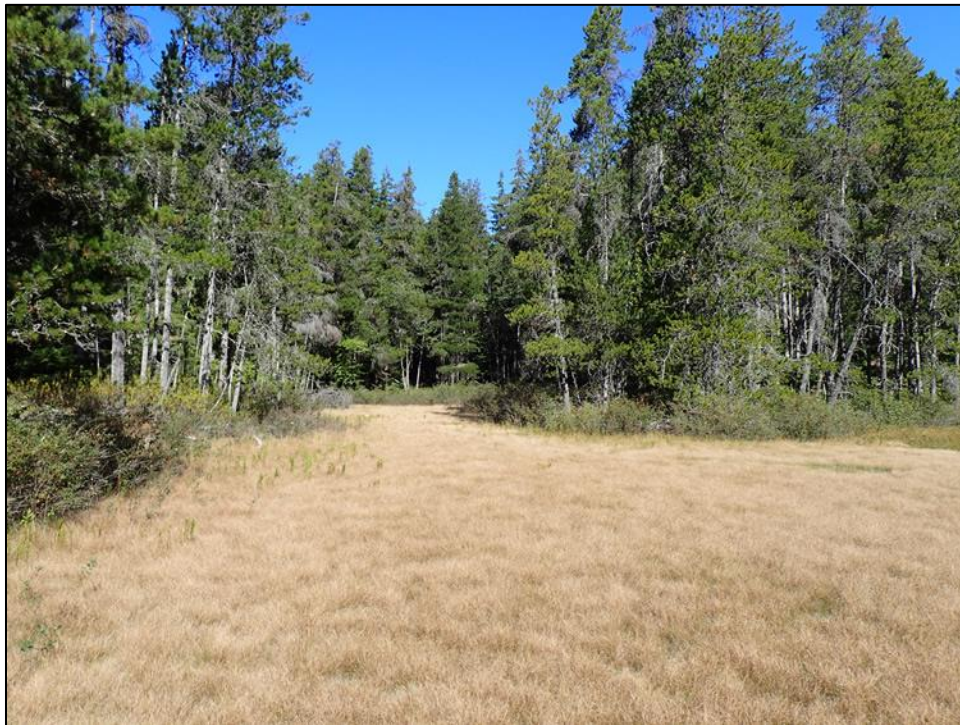
Figure 13. Wf53 slender sedge – white beak-rush fen.

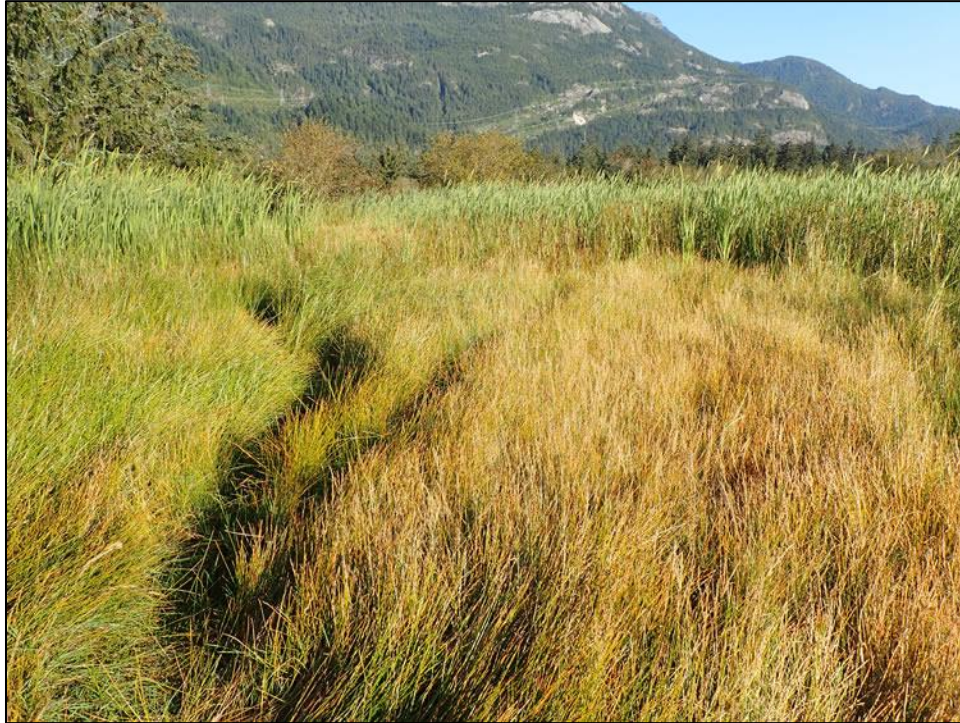
Figure 15. Wm04 Common spike-rush marsh complexed with Wm05 cattail marsh in upper portions of the Squamish Estuary.

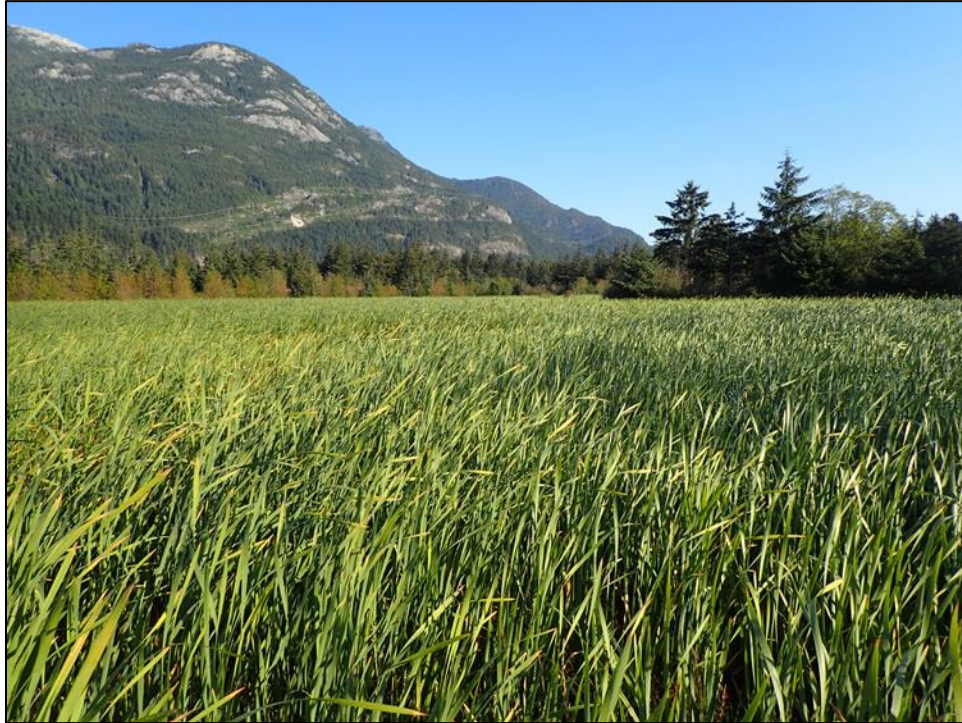
Figure 16. Thick Wm05 cattail marsh in upper portions of the Squamish Estuary.

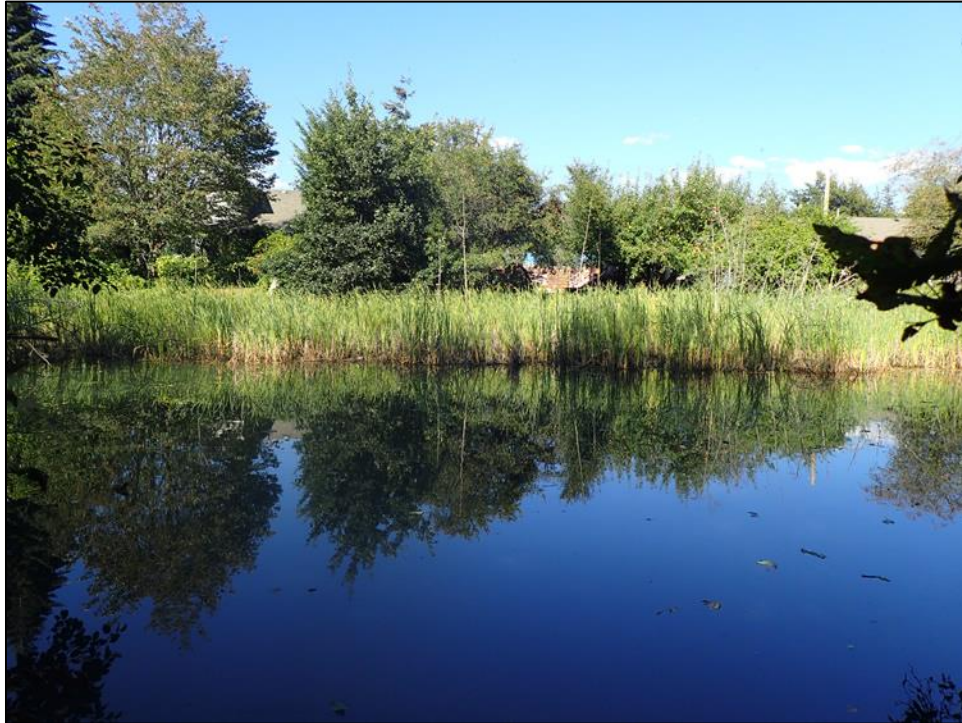
Figure 17. Narrow band of Wm05 cattail marsh on the edges of shallow open water.

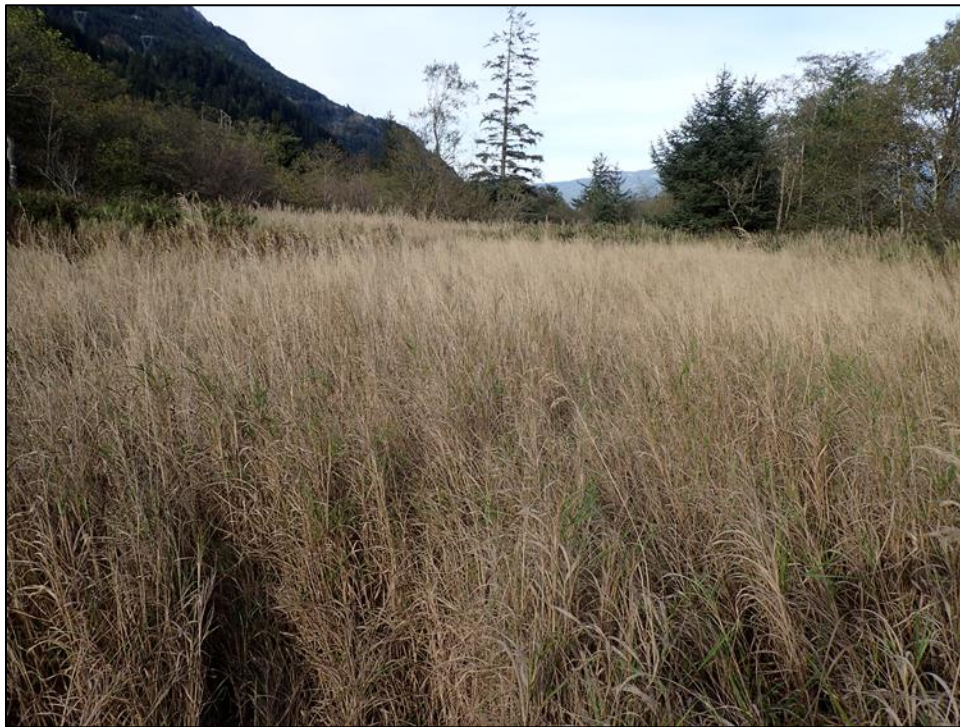
Figure 18. Marsh-like community dominated by a thick cover of orchard grass and bluejoint.

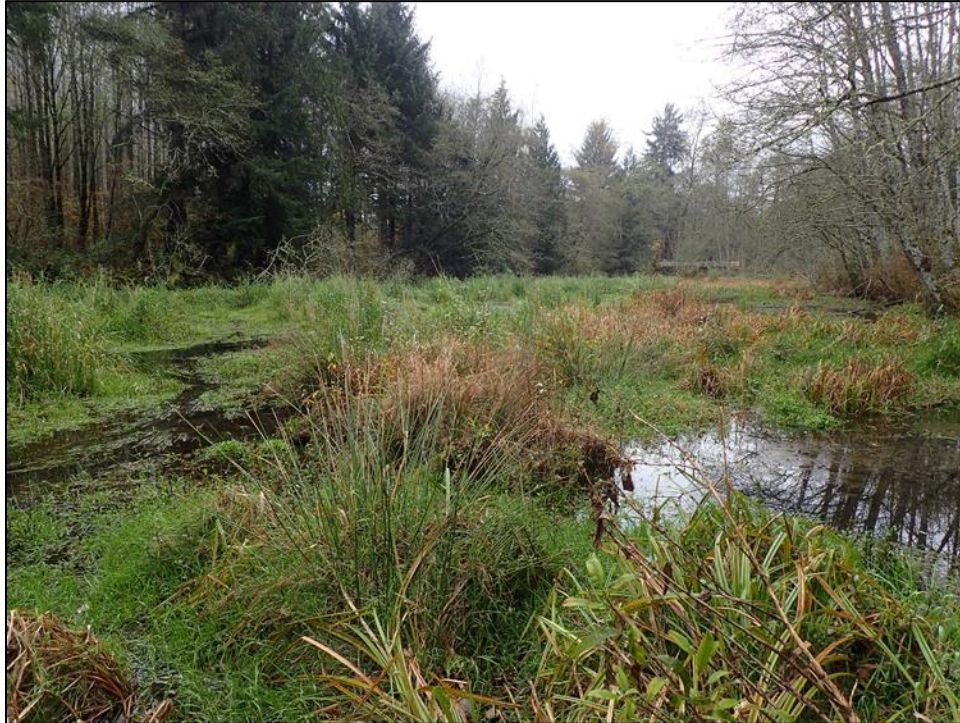
Figure 19. Slough with near stagnant water and few native species forming a marsh-like community.

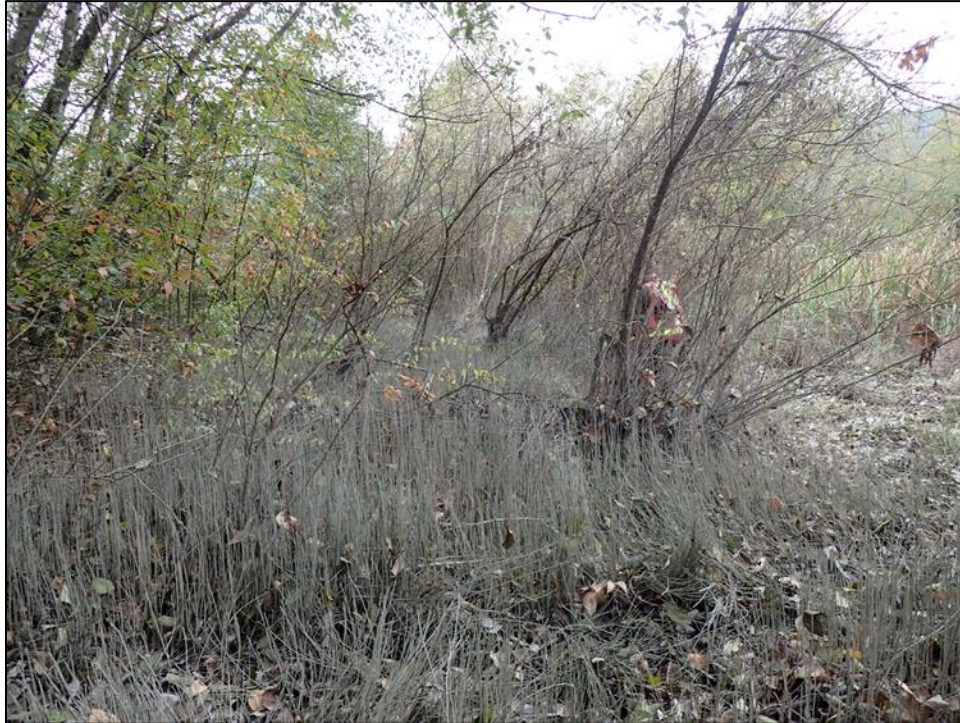
Figure 20. Ws06 Sitka willow – Sitka sedge swamp on the outer edge of a slough complex.

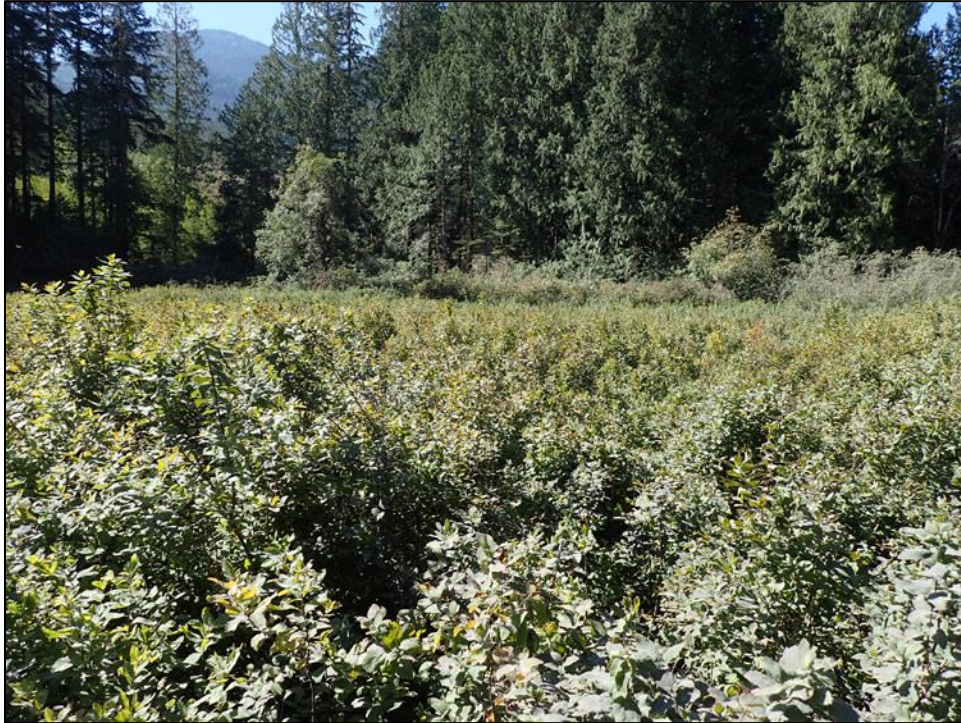
Figure 21. Ws50 pink spirea – Sirka sedge swamp forming a pue ecosystem in valley bottom depression.

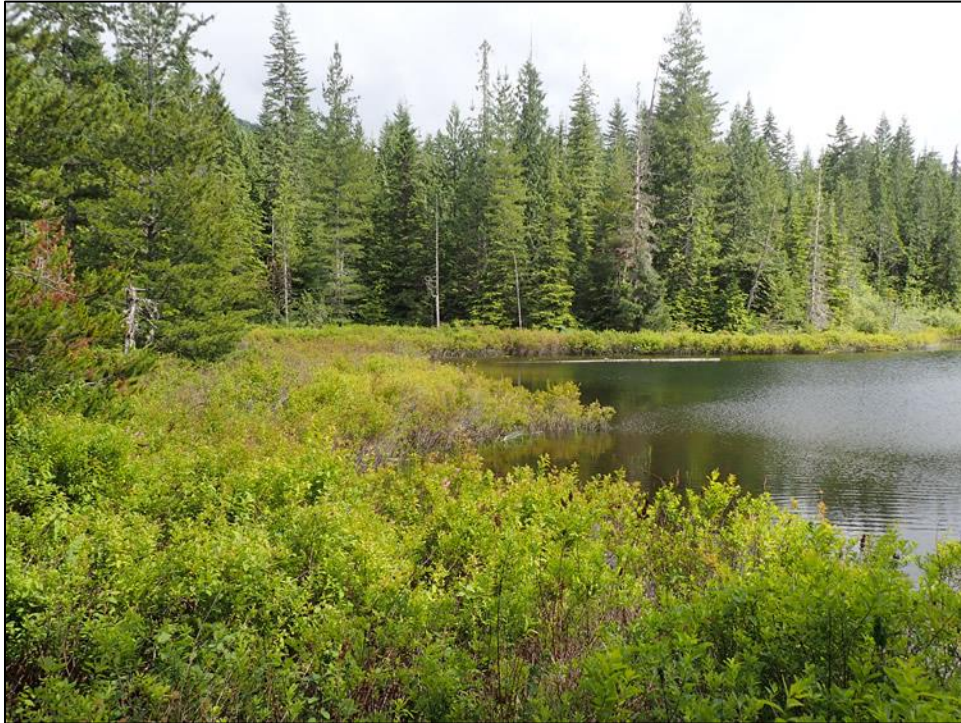
Figure 22. Ws50 pink spirea – Sirka sedge swamp forming a narrow band around a pond.

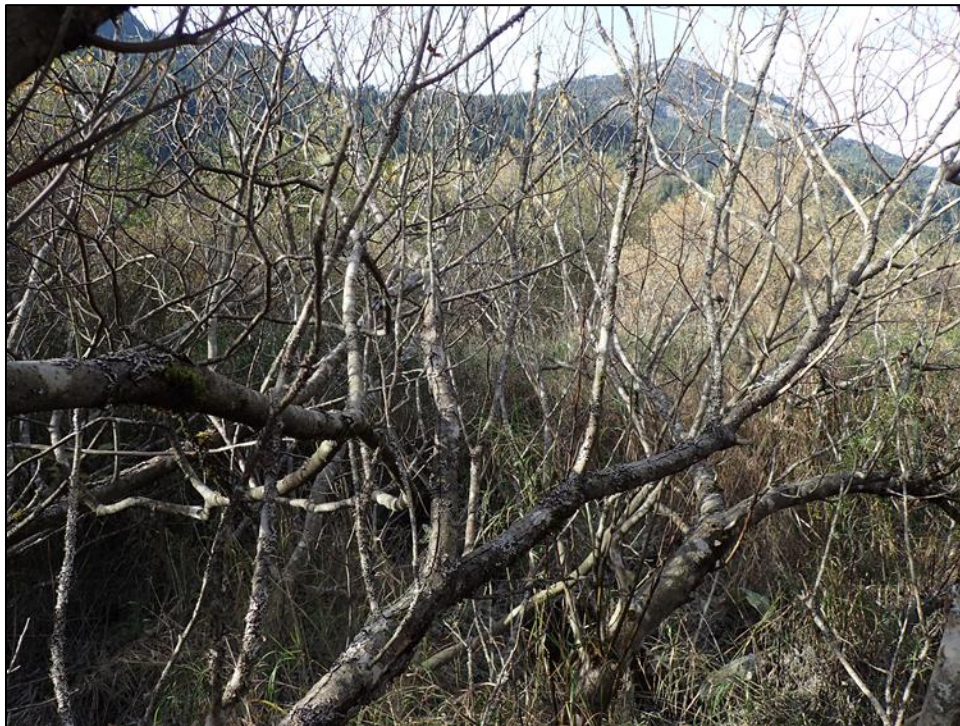
Figure 23. Dense Ws51 Sitka willow – Pacific willow – skunk cabbage swamp with thick invasive reed canarygrass.

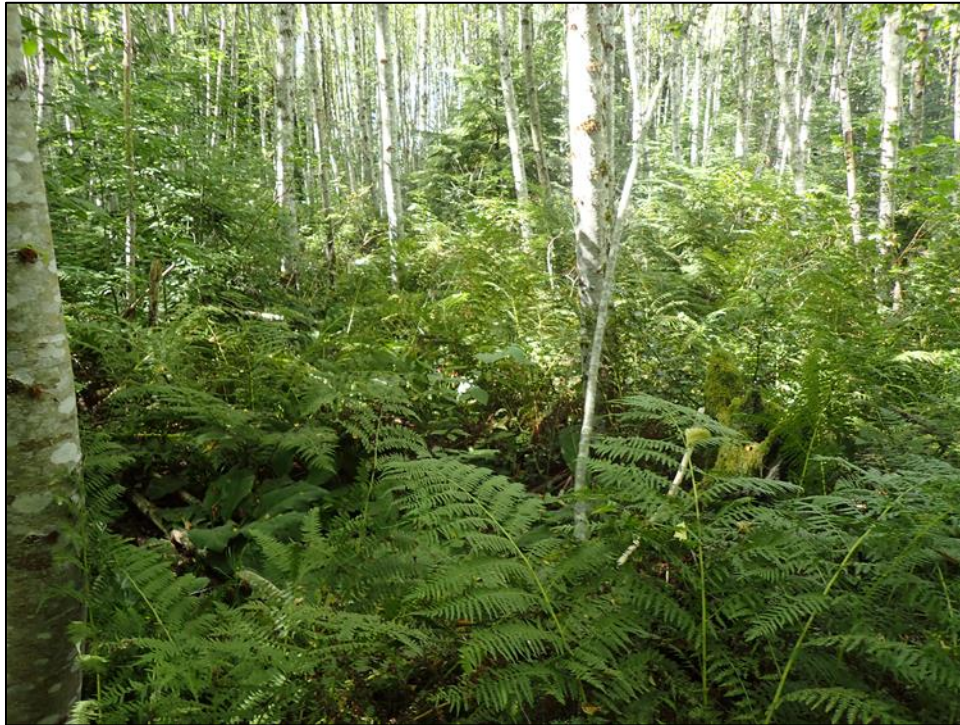
Figure 24. Ws52 red alder – skunk cabbage swamp.

herbaceous layer contains lush skunk cabbage (*Lysichiton americanus*) and lady fern (*Athyrium felix-femina*), along with a diverse assortment of other species (Fig. 24). The moss layer is typically sparse, but often contains a variety of leafy mosses. The Ws52 can be difficult to differentiate from young Ws53 swamps as red alder is an early successional species that quickly establishes after disturbance. A limited amount of western redcedar regeneration and a lack of distinctly mounds (mineral soils) with either regenerating conifers or old conifer stumps, is one way to tell them apart.

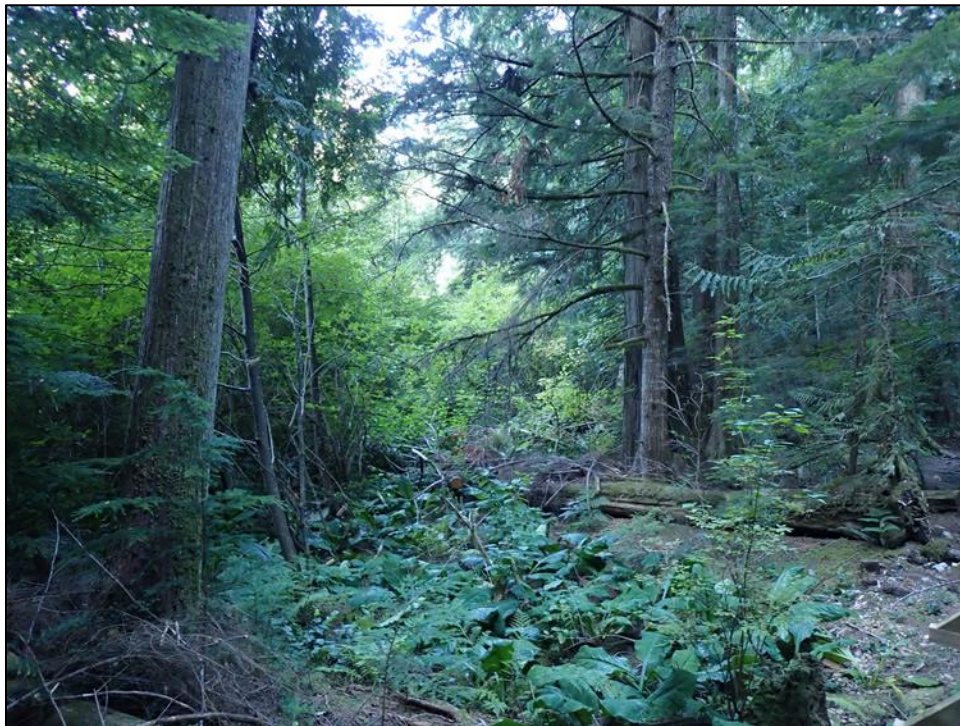
Figure 25. Typical Ws53 western redcedar – sword fern – skunk cabbage swamp with maturing conifer tree canopy.

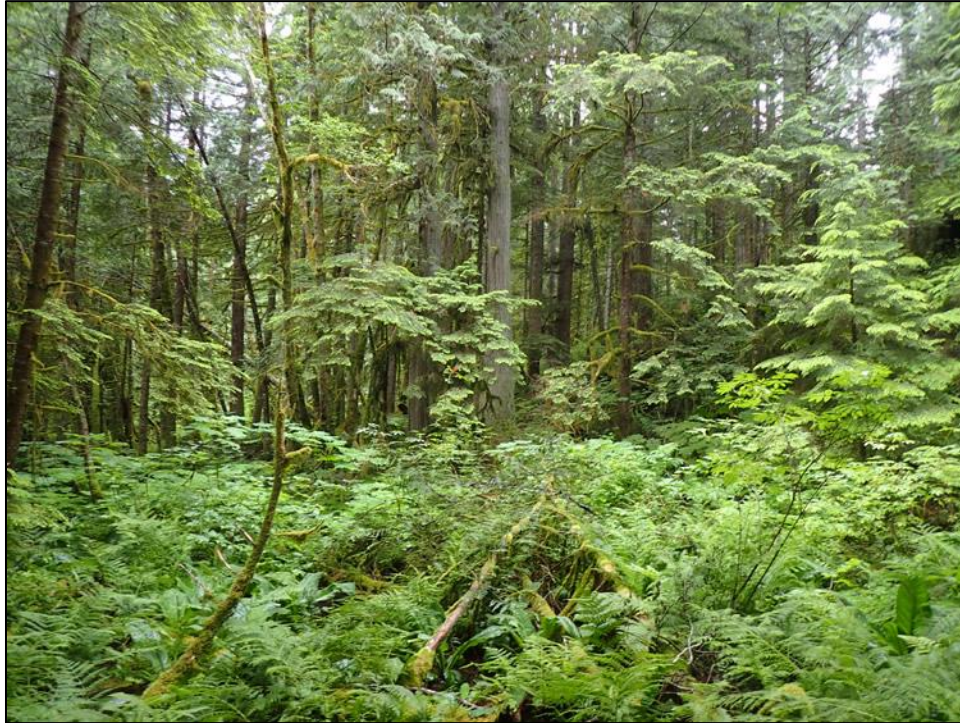
Figure 26. Younger Ws53 western redcedar – sword fern – skunk cabbage swamp with a mixed stand of western redcedar, western hemlock and bigleaf maple.

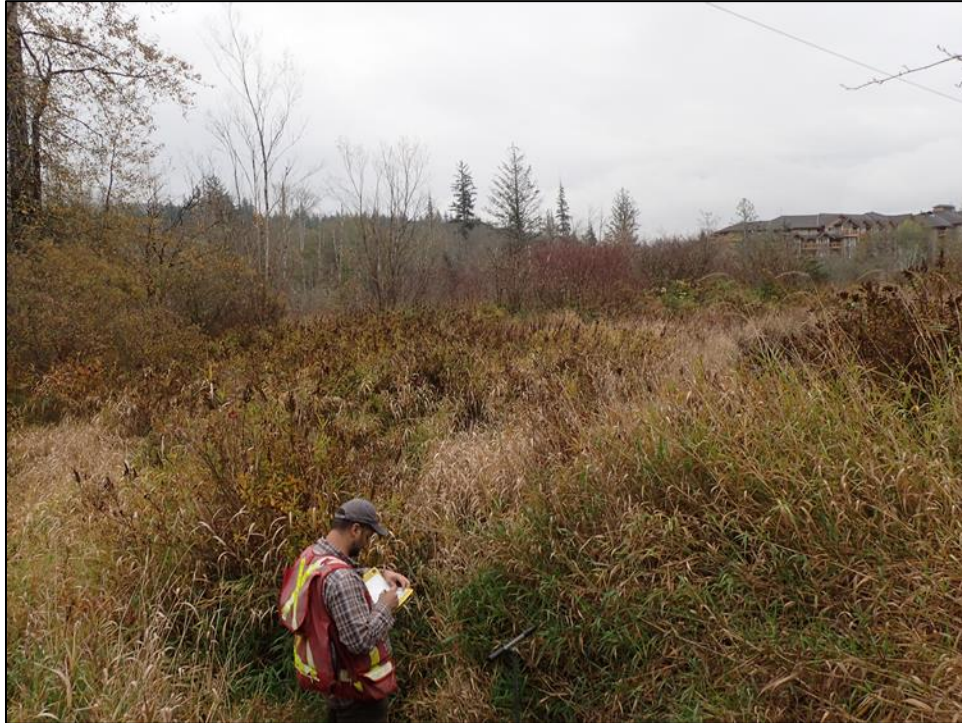
Figure 27. Hardhack swamp with thick invasive reed canarygrass.

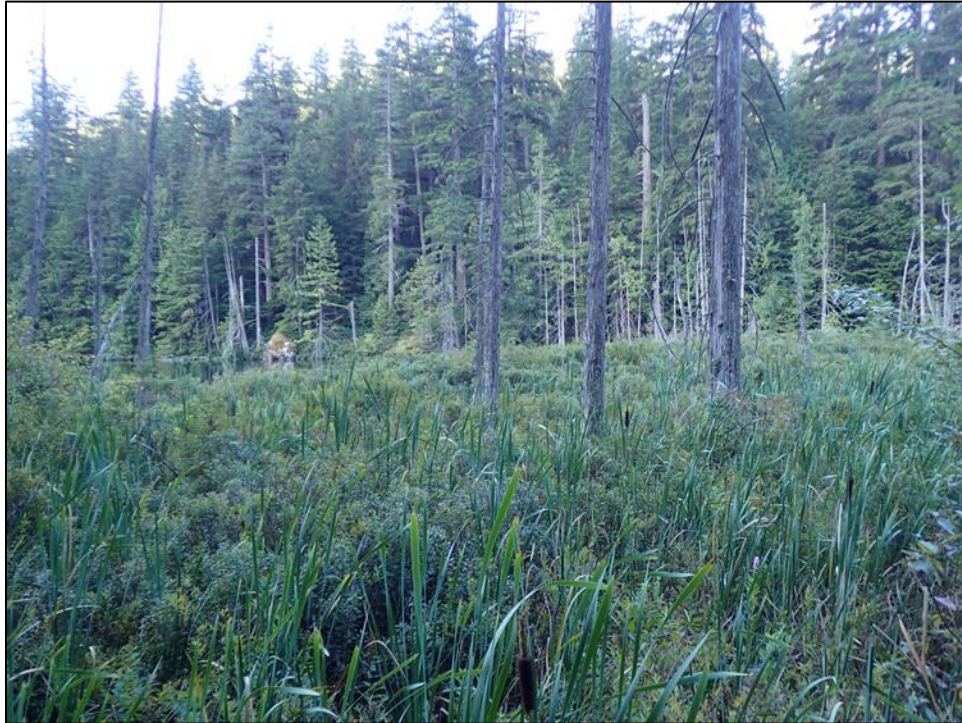
Figure 28. Swamp at the north end of Brome Lake that could not be classified partially due to historic disturbances.

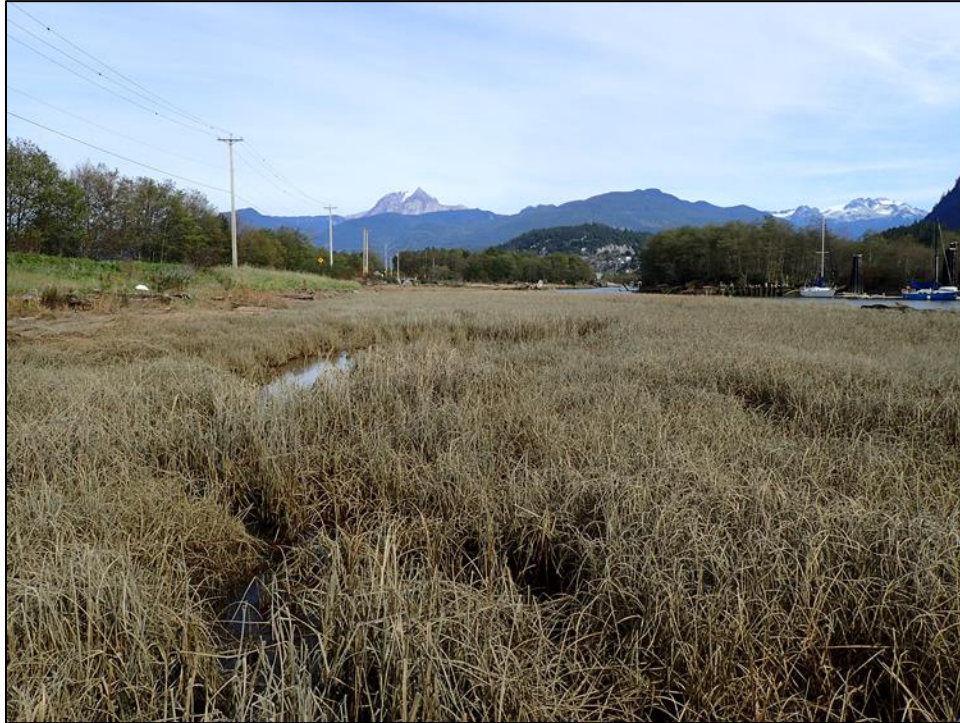
Figure 30. Em05 Lyngbye's sedge estuarine marsh occurring between flooded intertidal mudflats and an elevated road.

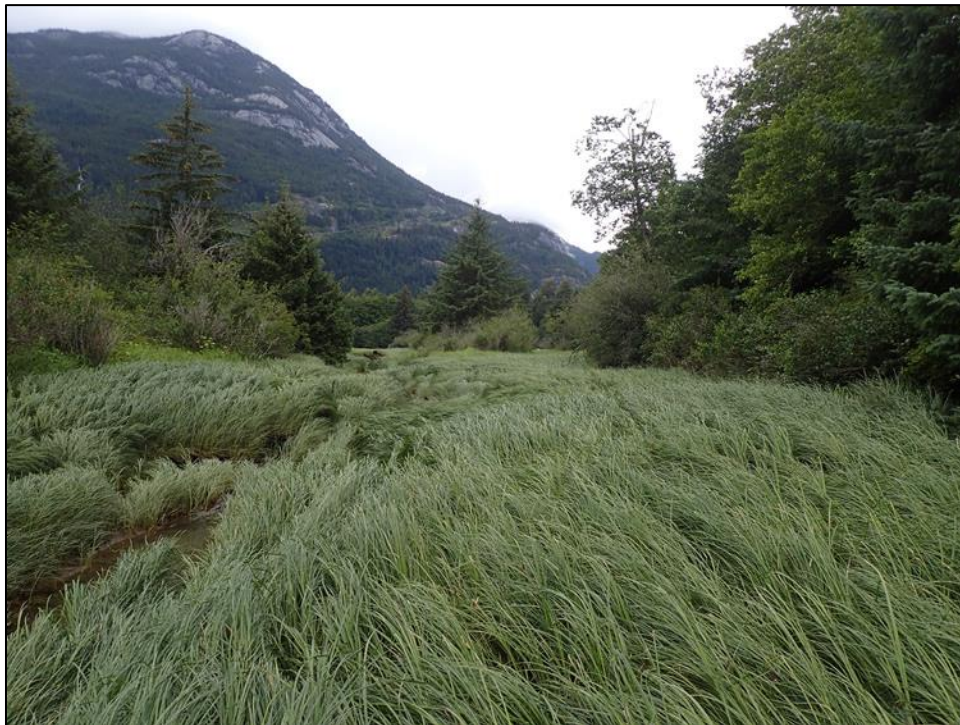
Figure 31. Em05 Lyngbye's sedge estuarine marsh in a flood channel through a forested portion of the upper estuary.

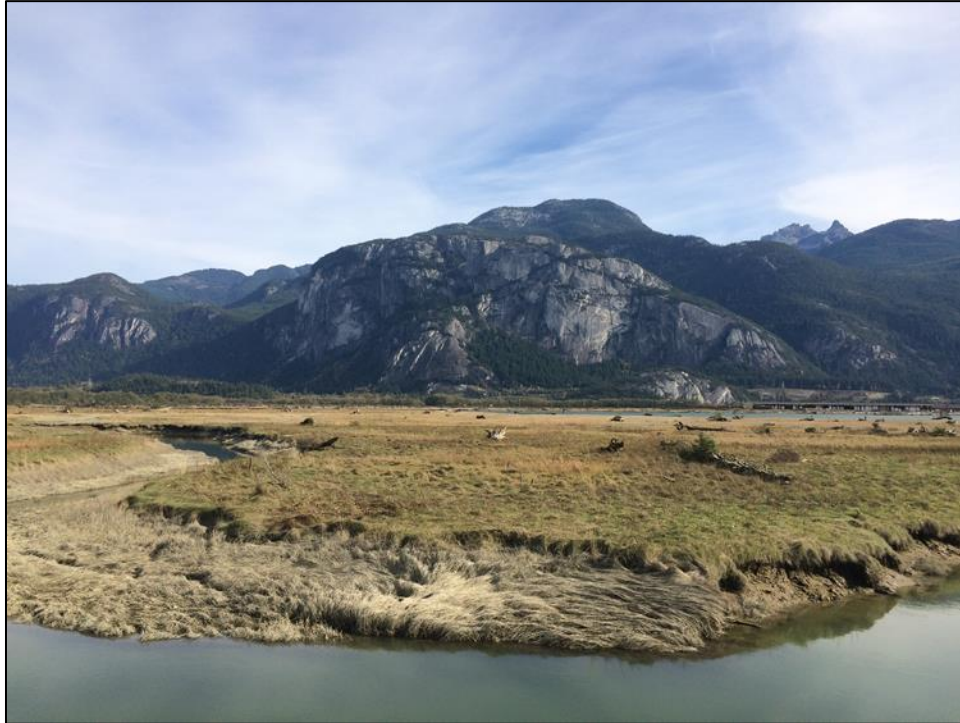
Figure 32. Ed01 tufted hairgrass – meadow barley estuarine meadow on the raised areas with Lyngbye’s sedge estuarine marsh in the foreground.

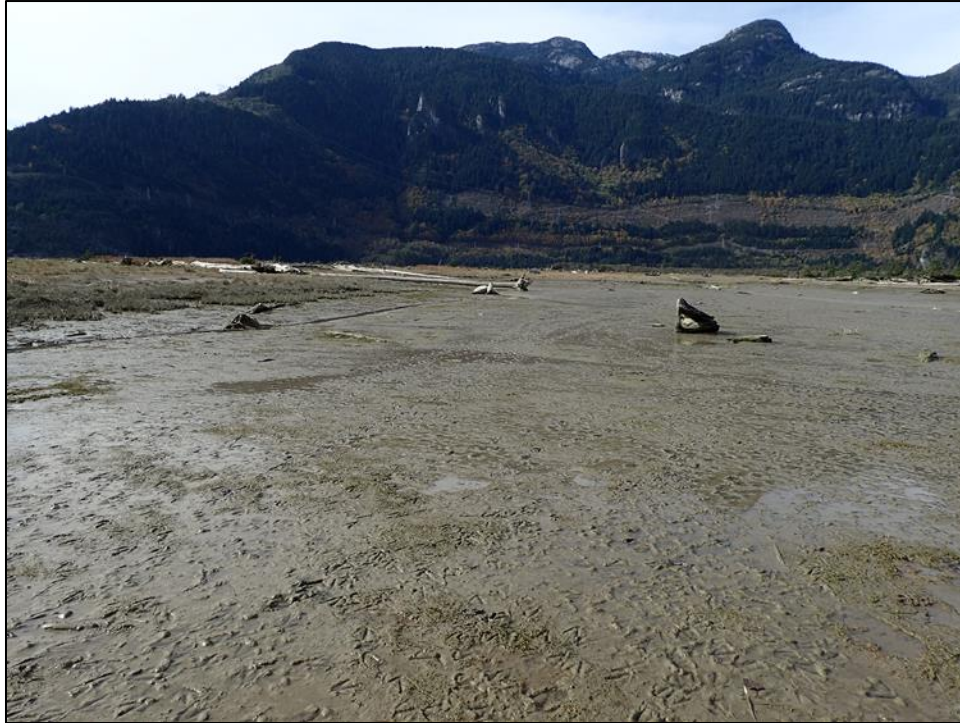
Figure 36. Intertidal mudflat at low tide.

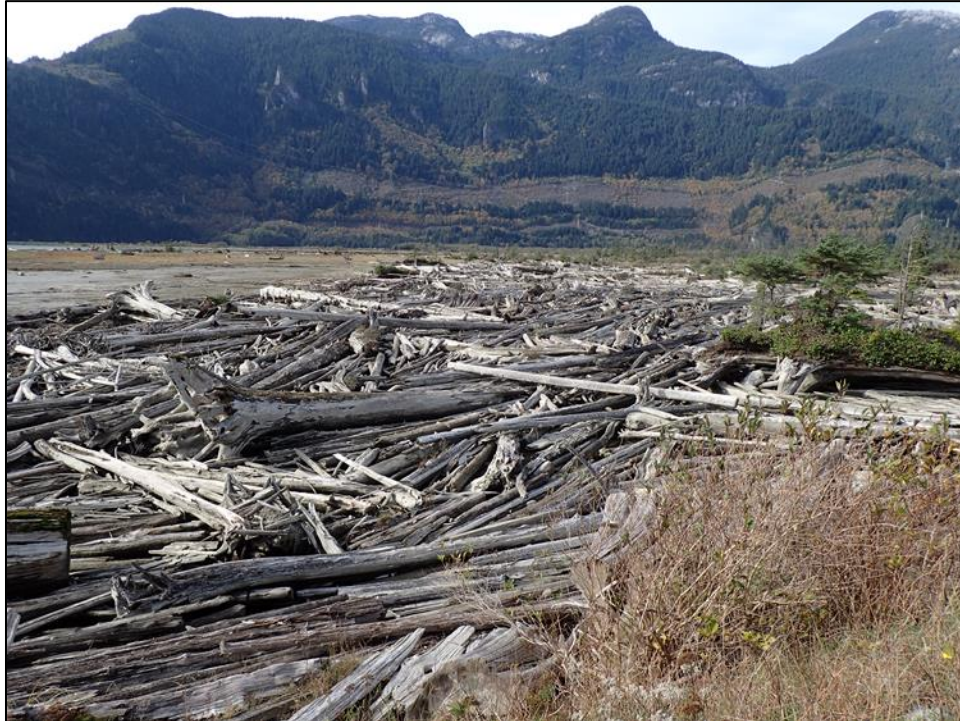
Figure 37. Beach with accumulations of logs and woody debris.

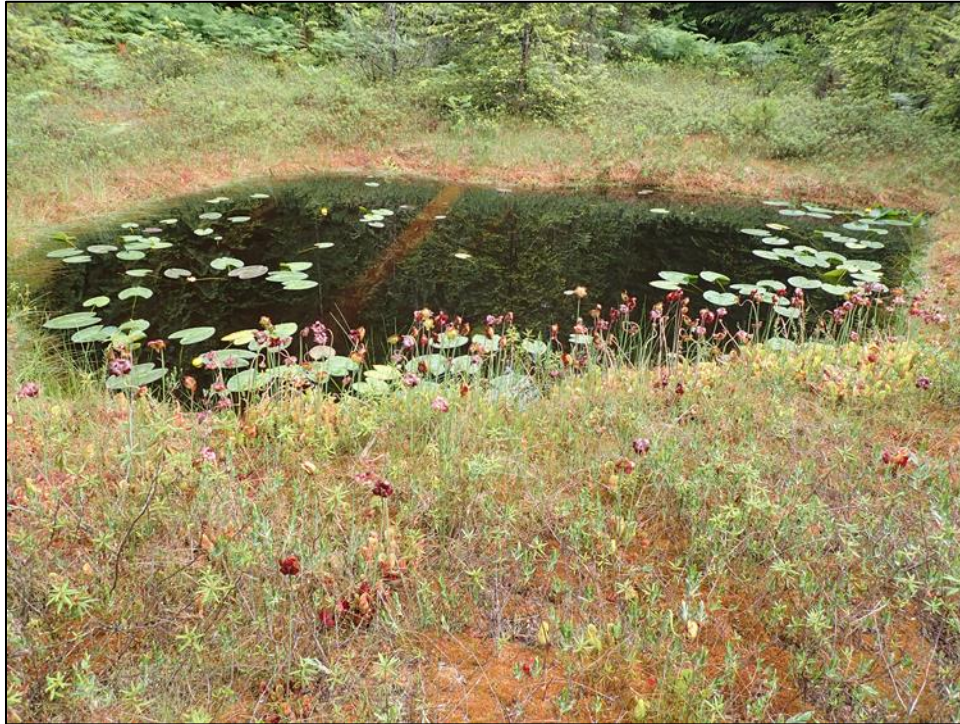
Figure 38. Small shallow open water with yellow pond lily (*Nuphar lutea*) in a Wb50 bog complex.

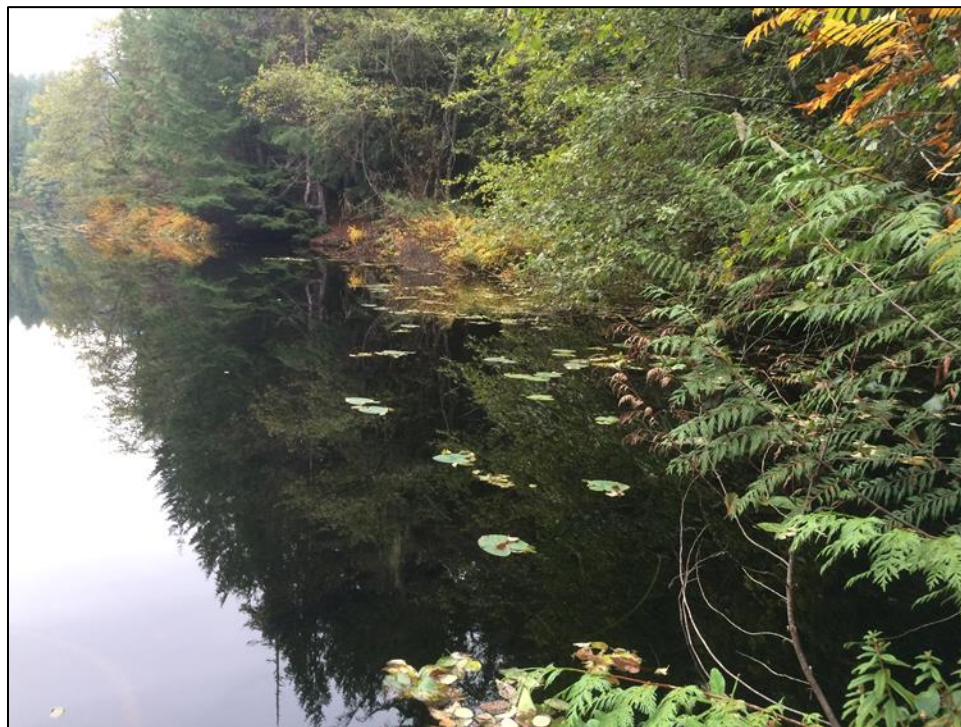
Figure 39. Fringe of shallow open water with yellow pond lily (*Nuphar lutea*) on the edge of Stump Lake.

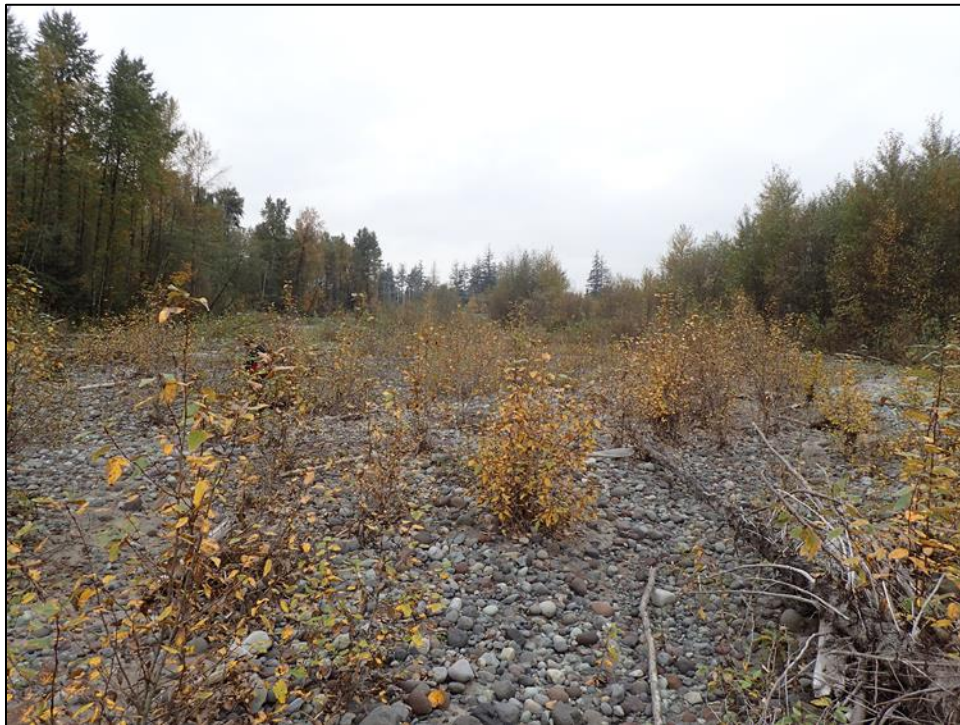
Figure 40. Unclassified low-bench Floodplain with a sparse cover of low cottonwood shrubs.

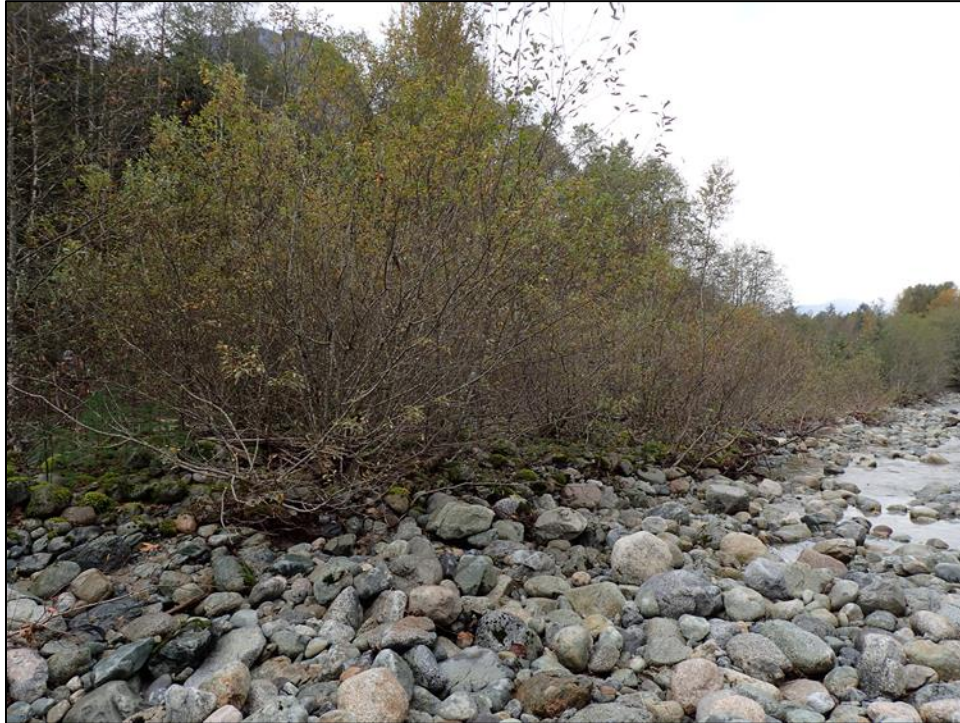
Figure 41. Unclassified low-bench Floodplain with dense cover of tall willow shrubs.

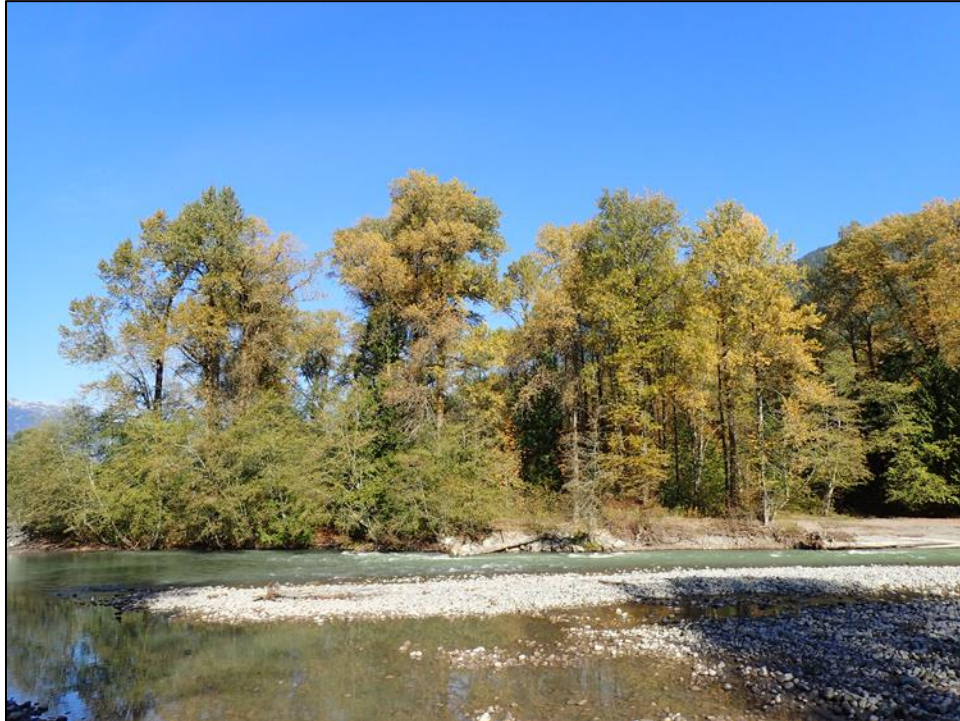
Figure 42. Mature Fm50 Cottonwood - red alder - salmon berry mid bench floodplain forest with a cottonwood dominated stand.

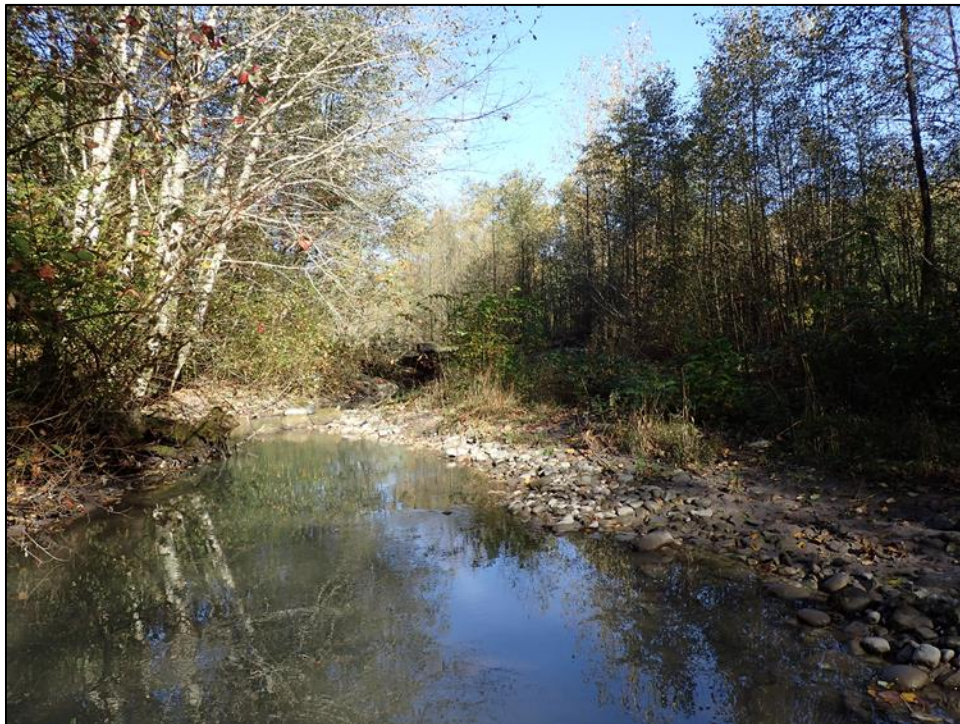
Figure 43. Young Fm50 Cottonwood - red alder - salmon berry mid bench floodplain forest with a cottonwood and red alder dominated stand along a constructed fish channel.
