DISTRICT OF SQUAMISH WETLANDS INVENTORY AND MAPPING AND WATERCOURSE MAPPING

Prepared By:
EcoLogic Environmental Consulting and
Ecoscape Environmental Consultants Ltd.

Prepared For:
District of Squamish

December 2016

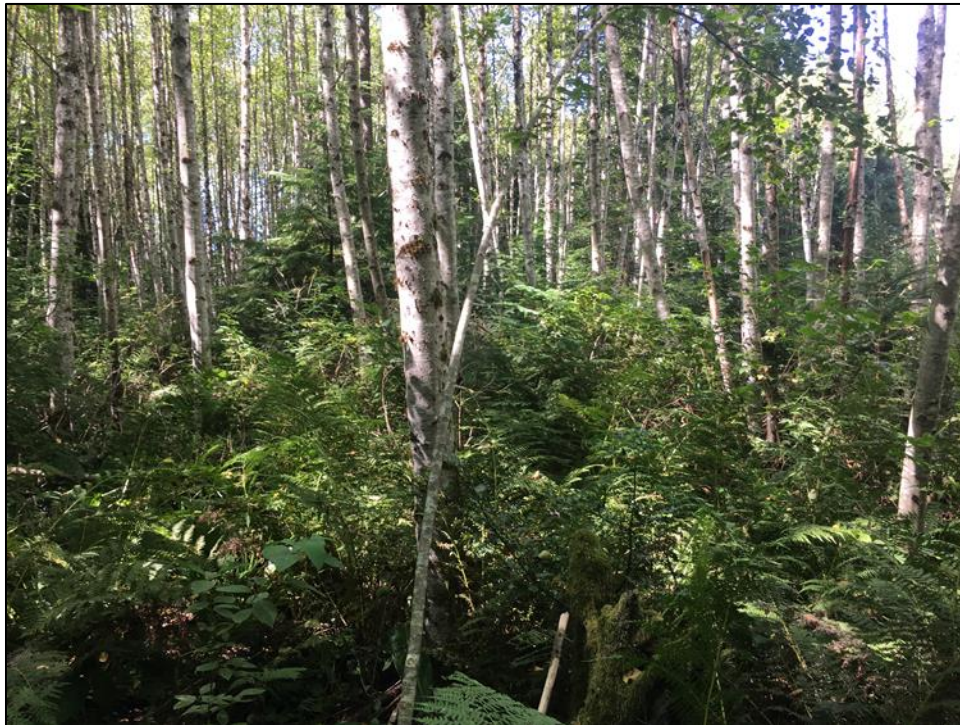
Figure 44. Sitka spruce – salmonberry high bench floodplain forest dominated by young red alder with a lush understory including conifer saplings.

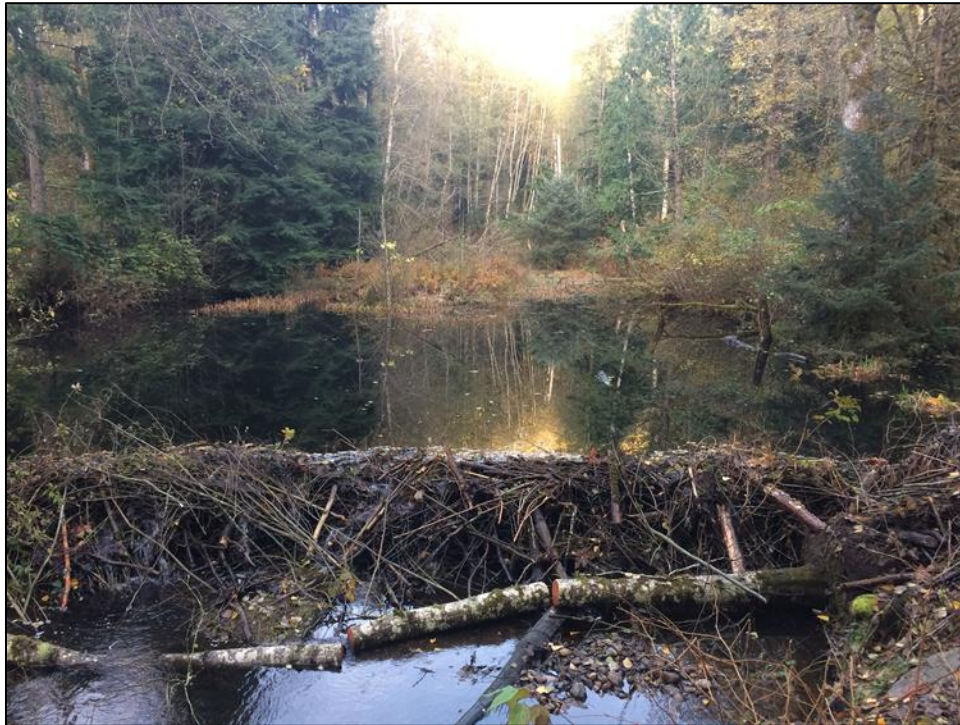
Figure 45. Small beaver pond with a swamp fringe.

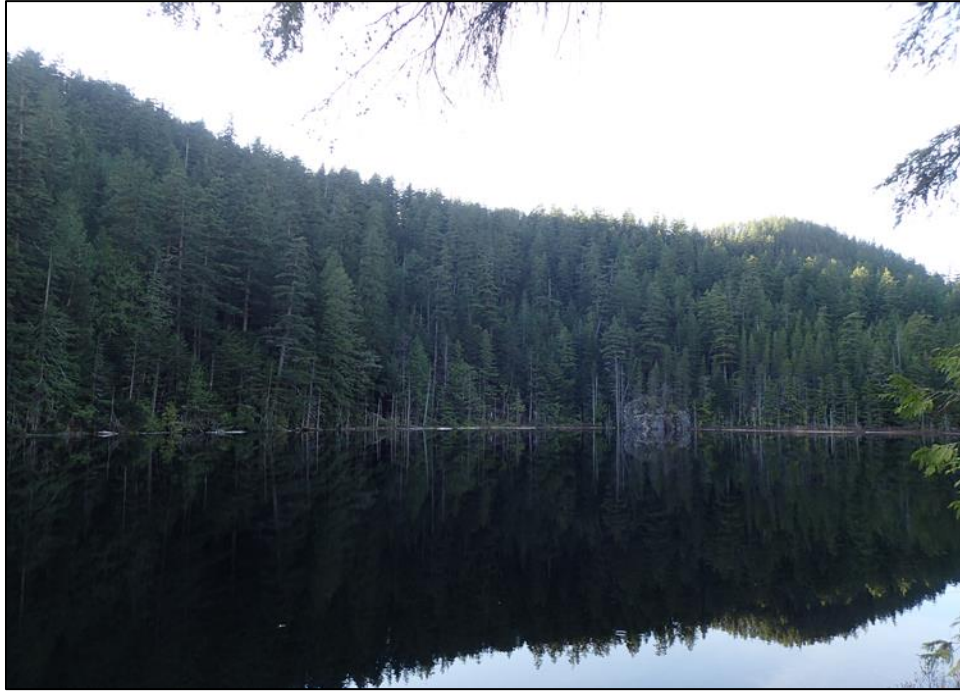
Figure 46. Large pond (Brome Lake) with a rocky, forested shoreline.
