INTEGRATED FLOOD HAZARD MANAGEMENT PLAN

Background Report

Final Report
September 2017

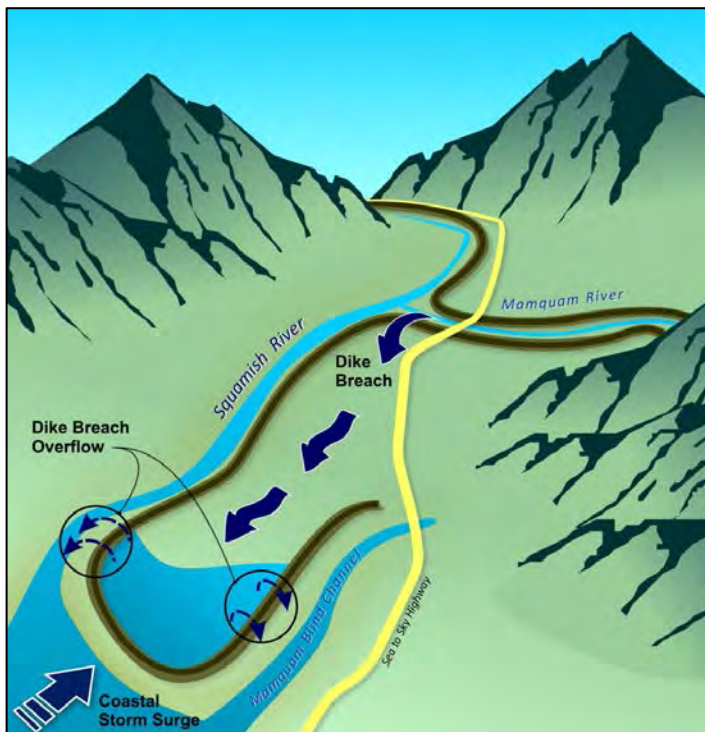
Figure 4-1: Conceptual Illustration of Coastal/Dike Breach Flood Protection Conflicts

While continuous protection works would mitigate coastal flood hazards, the 1994 FHMP also points out that introducing a continuous perimeter of coastal flood protection works could create a "bathtub" effect during an upstream dike breach (Figure 4-1). This possibility led the 1994 FHMP to propose downtown FCLs 0.3 m above the proposed coastal flood protection perimeter.

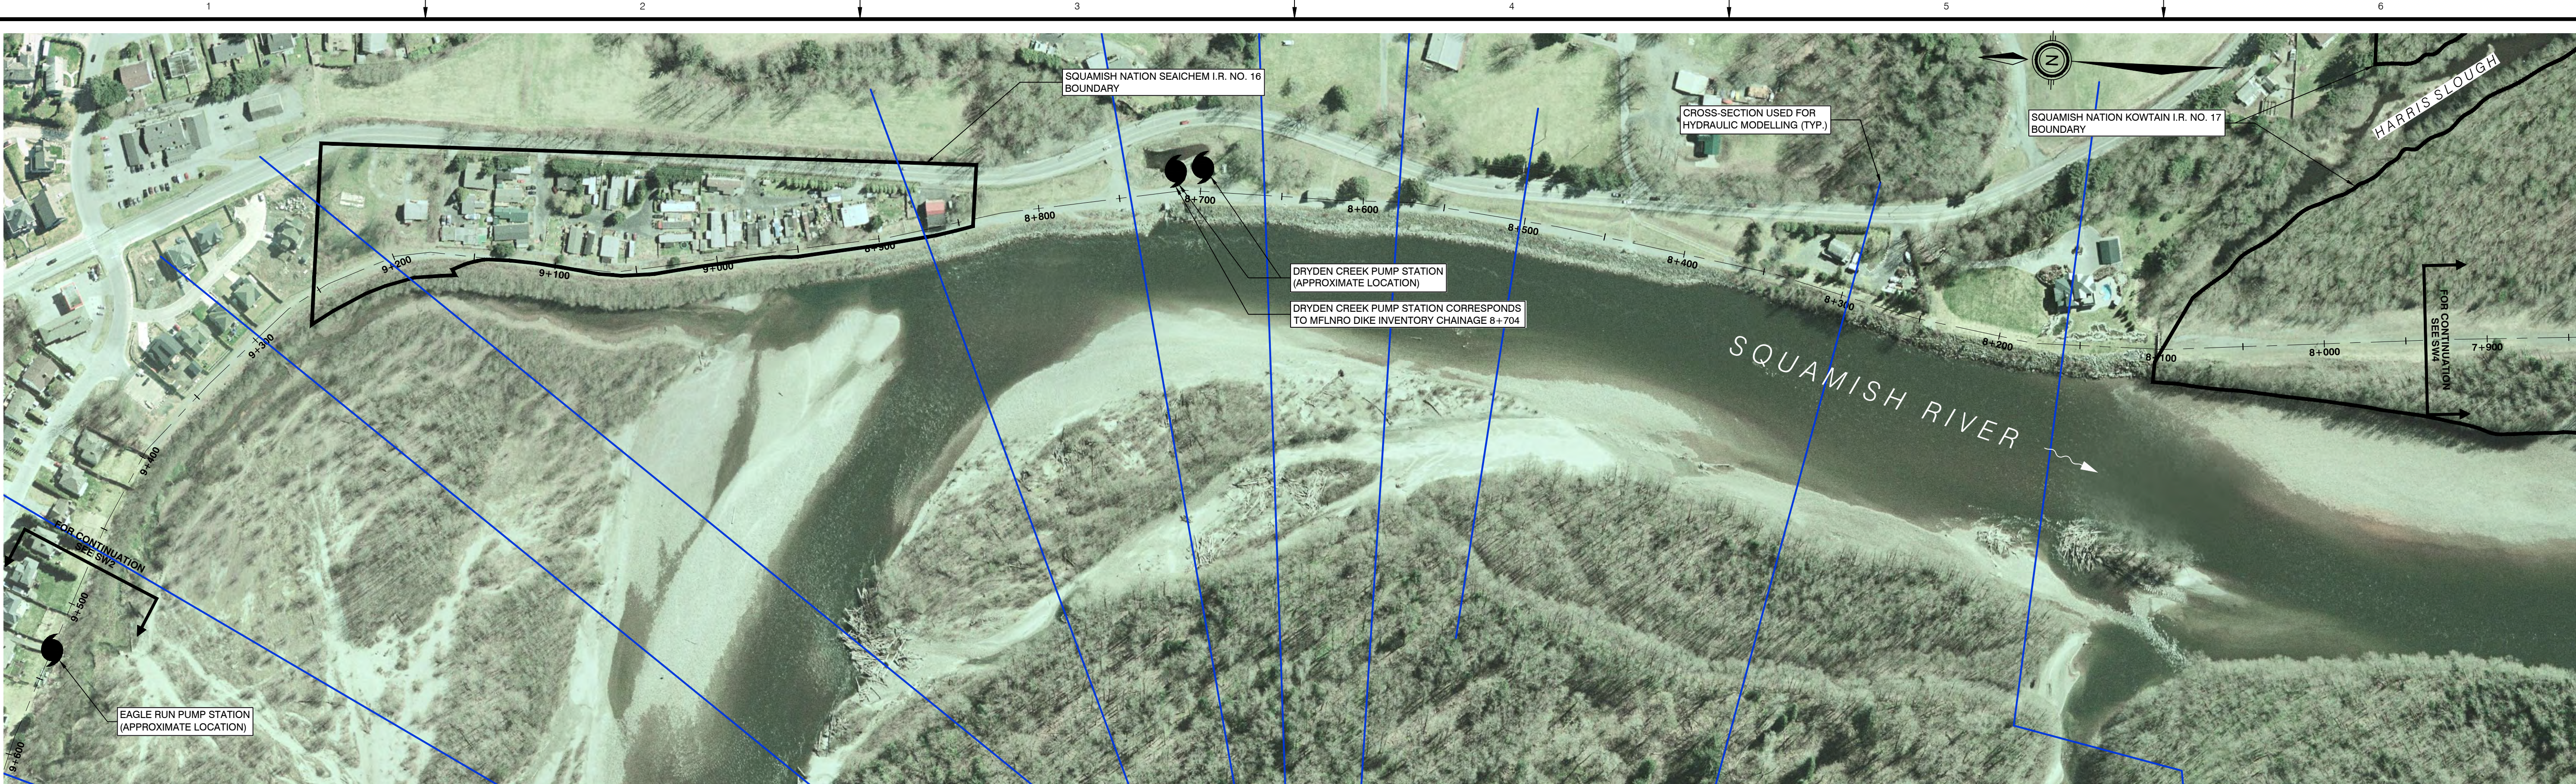
PLAN
Scale: 1:2000

DISTRICT OF SQUAMISH INTEGRATED FLOOD HAZARD MGMT PLAN DIKE CREST & WATER SURFACE PROFILES YEAR 2100 Q200 & Q1000 BRACKENDALE STA. 9+500 TO 11+000				
Project No.	463-278	Drawing No.		
Group	SITE WORKS		SW2	4

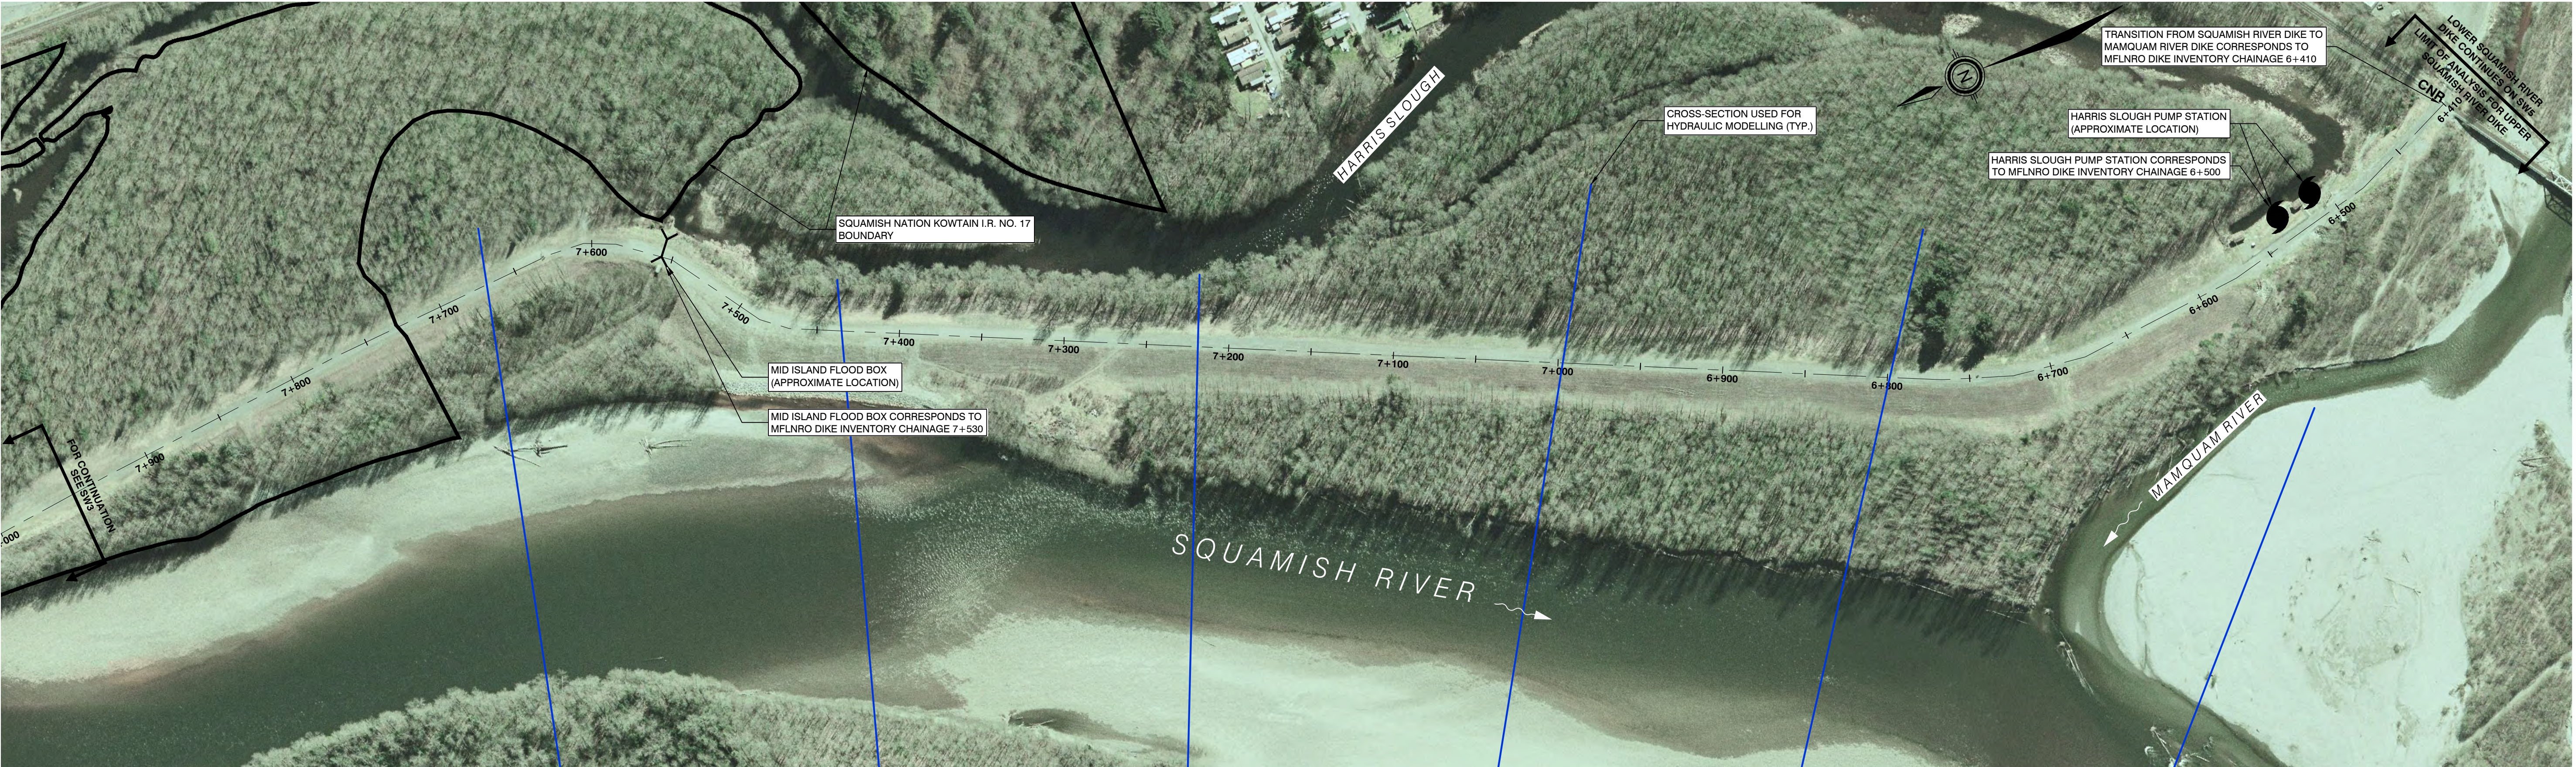
DISTRICT OF SQUAMISH INTEGRATED FLOOD HAZARD MGMT PLAN			
DIKE CREST & WATER SURFACE PROFILES YEAR 2100 Q200 & Q1000 EAGLE RUN STA. 8+000 TO 9+500			
Project No.	463-278	Drawing No.	
Group	SITE WORKS		
Rev.			
	SW3		4

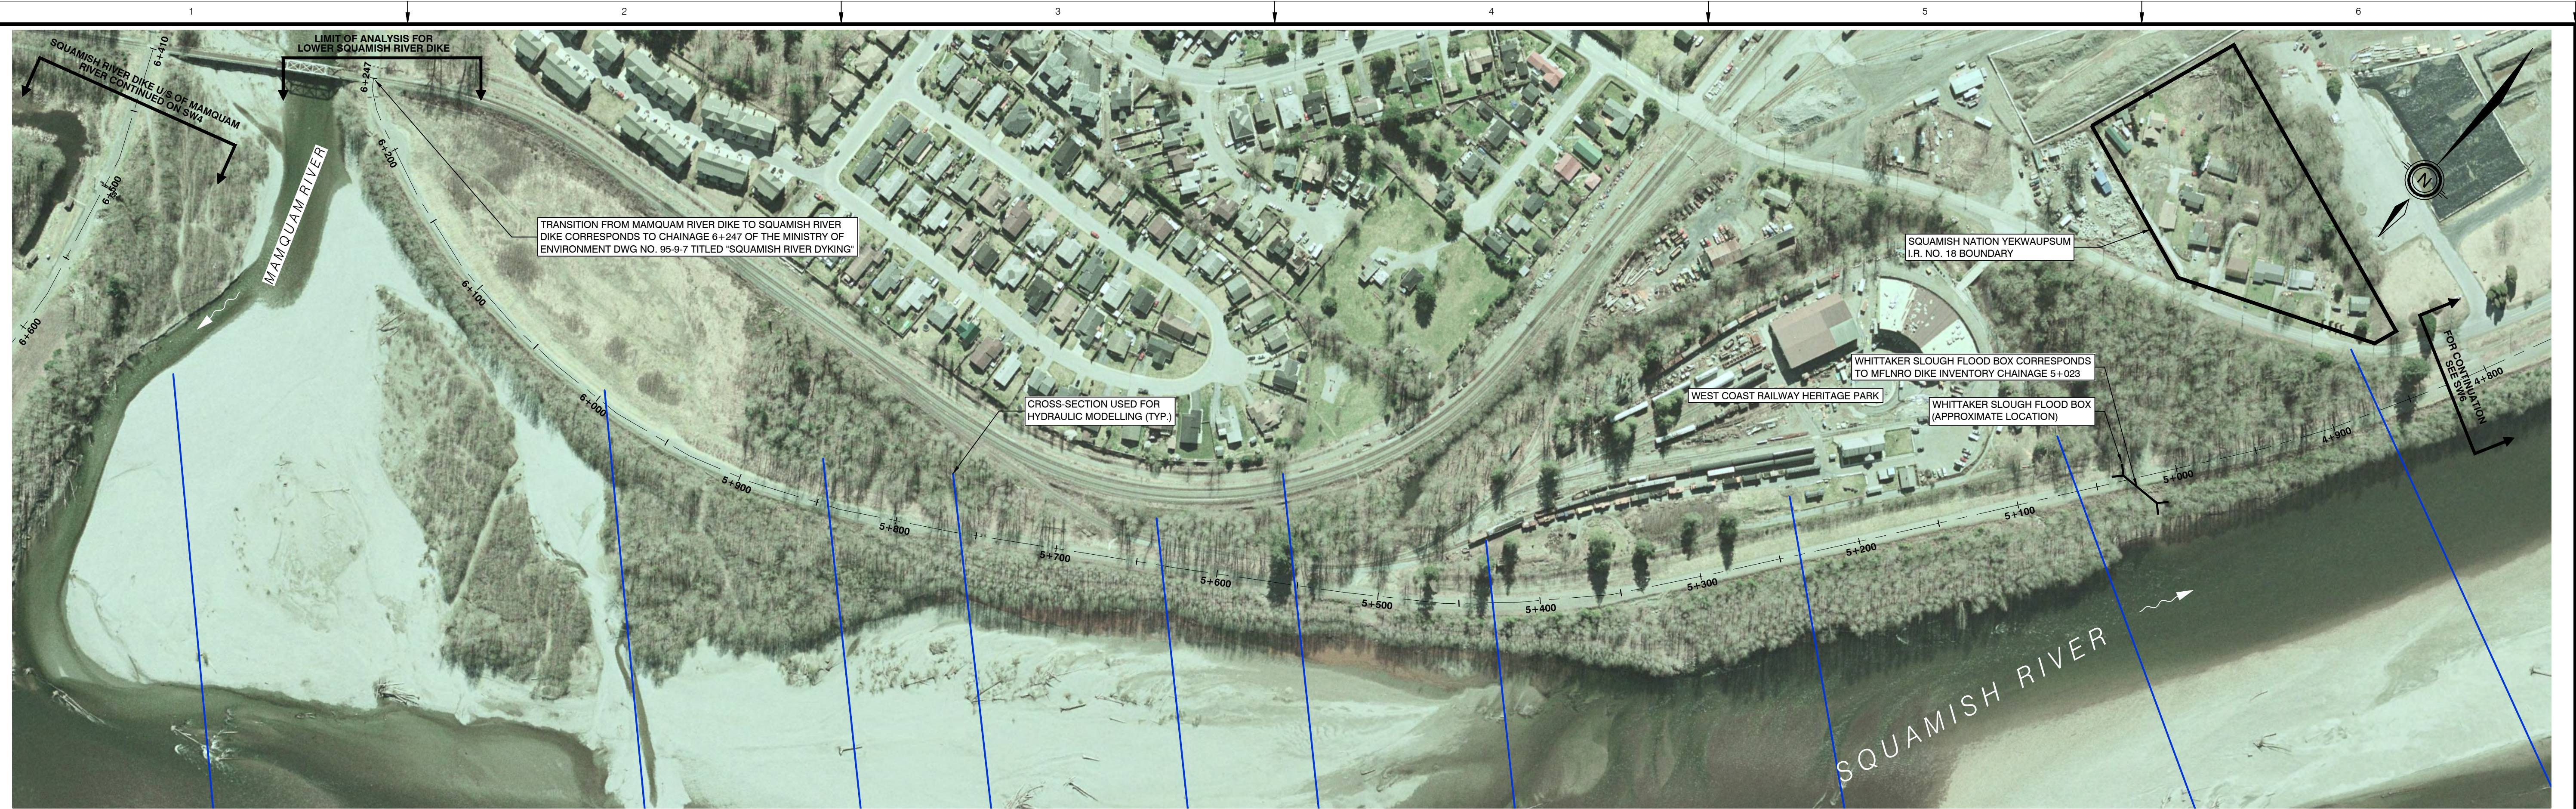
PLAN
Scale: 1:2000

SW4

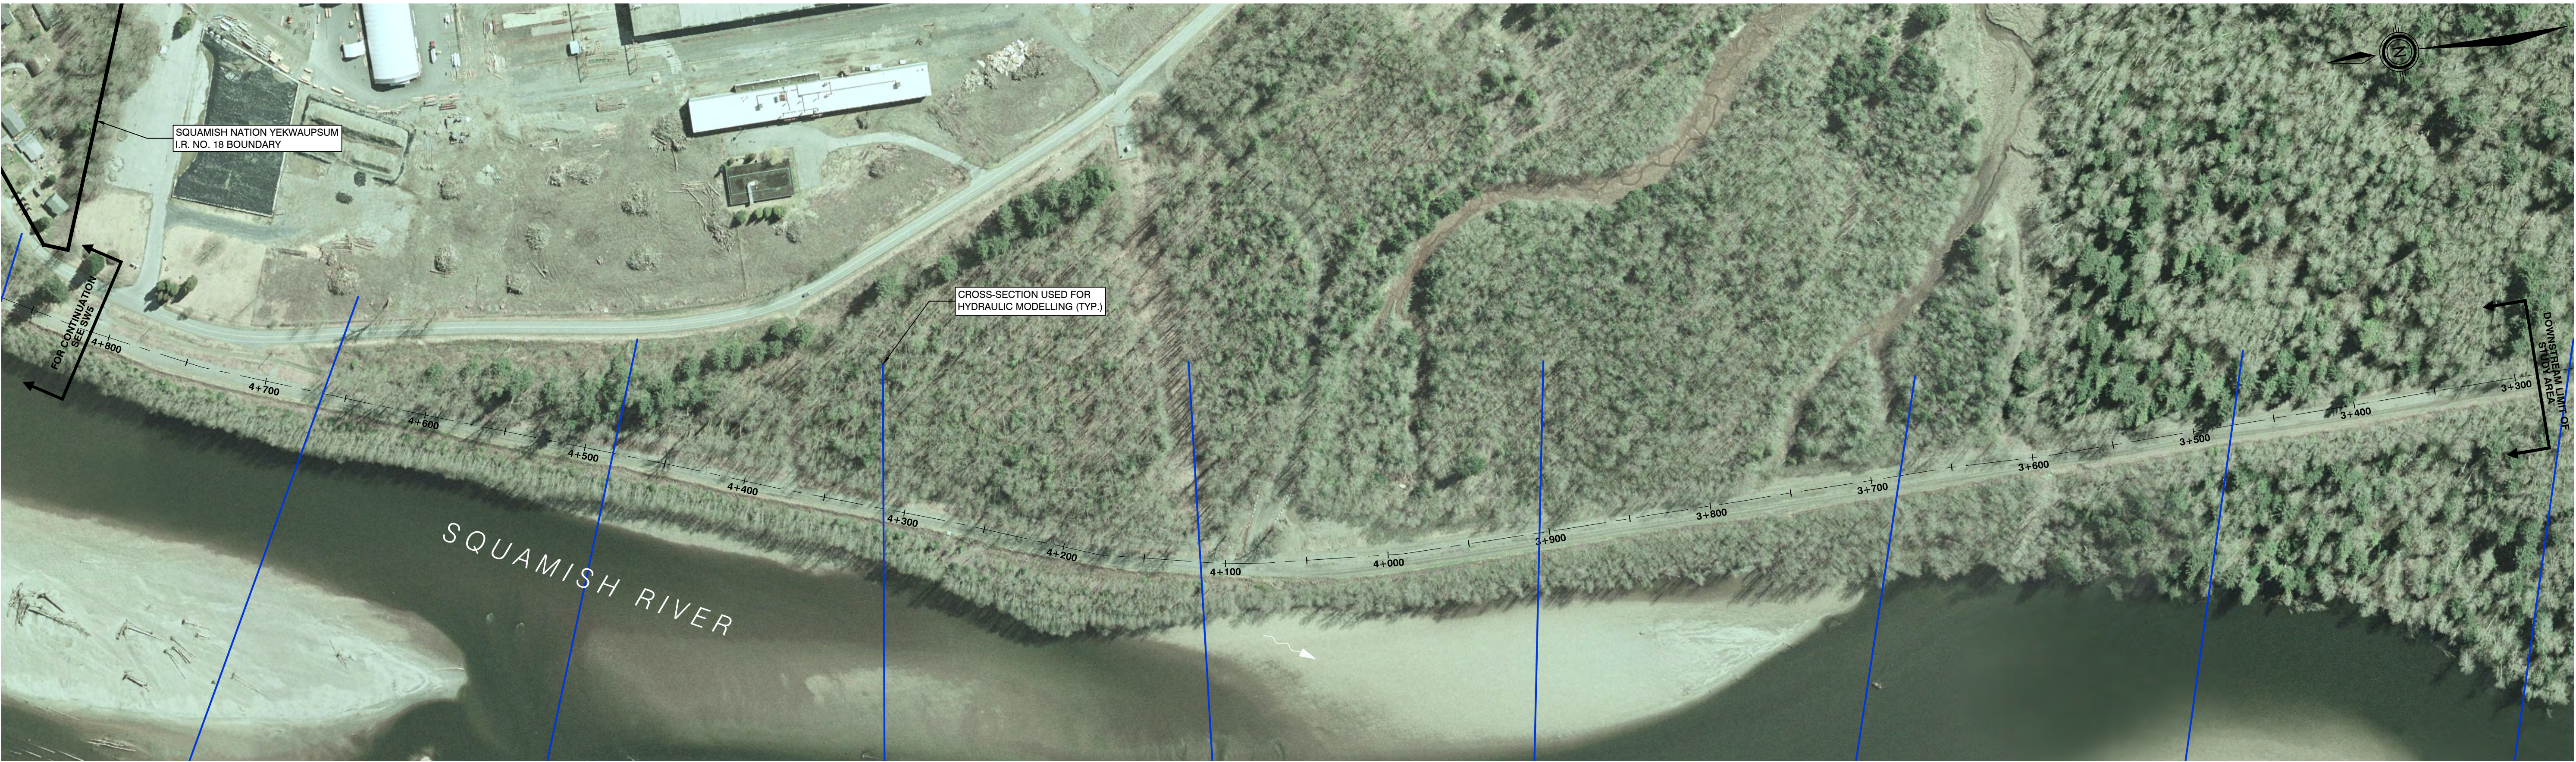
PLAN
Scale: 1:2000

<p align="center">DISTRICT OF SQUAMISH INTEGRATED FLOOD HAZARD MGMT PLAN DIKE CREST & WATER SURFACE PROFILES YEAR 2100 Q200 & Q1000 MAMQUAM CONFLUENCE STA. 4+800 TO 6+300</p>			
Project No. 463-278		Drawing No.	
Group SITE WORKS		SW5	
		Rev. 4

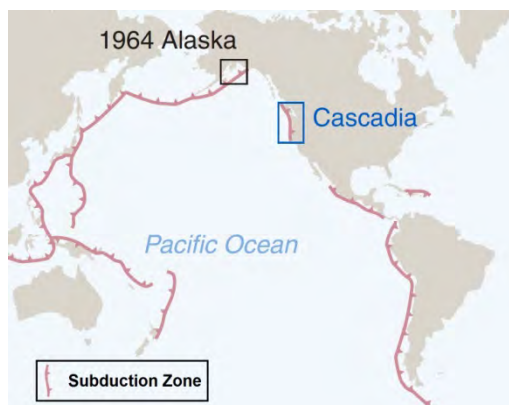
Figure 2: Subduction Zones in the Pacific Ocean Basin
(adapted from [1])

As tsunami waves can travel great distances from their generating source, any tsunamigenic earthquake along the subduction zones surrounding the Pacific Ocean, Figure 2, can potentially affect the west coast of Canada. However, the height of the tsunami waves reaching the coast will depend on the orientation of the fault line, which governs the predominant direction of wave propagation.
