# Garibaldi Springs Lands, Squamish, BC Bio-Inventory Assessment

**Project No.: 725-01-02**

**Version: 5.0**

**Date: June 15, 2018**

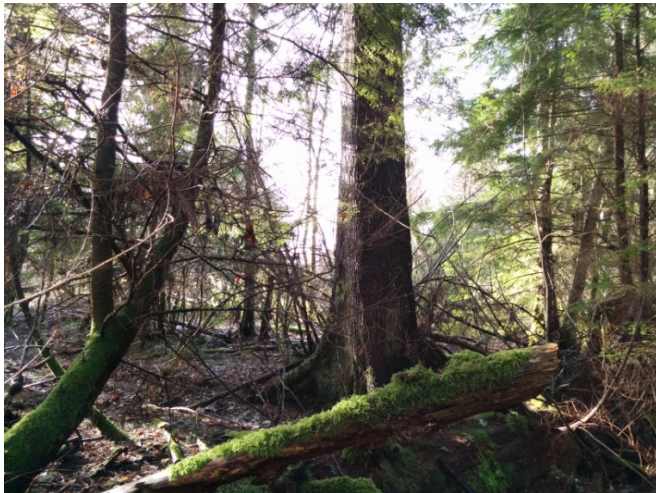
TEM Polygon 1 is located in on the southern border of the property, making up 0.3 hectares and 1 % of the site. Upon field verification, Polygon 1 was assigned TEM code 10RF5M. This TEM code is slightly dryer than swamp wetland classes, Ws52 (Red alder – Skunk cabbage) and Ws54 (Western hemlock – Skunk cabbage), assigned by others (Ecoscape, 2016a). This polygon is characterised by young forest with a mix of coniferous and deciduous trees. A previous study conducted in the forest immediately south of Polygon 1 concluded that the forest is dominated by western hemlock and western redcedar, with a few remaining mature Sitka spruce and lesser extents of red alder, vine maple, bigleaf maple and black cottonwood, and a herb layer of salal, red huckleberry and sword fern (Cascade, 2015). A representative photo is provided below (Photo 2).

Photo 2: Young forest representative of Polygon 1. January 26, 2016.

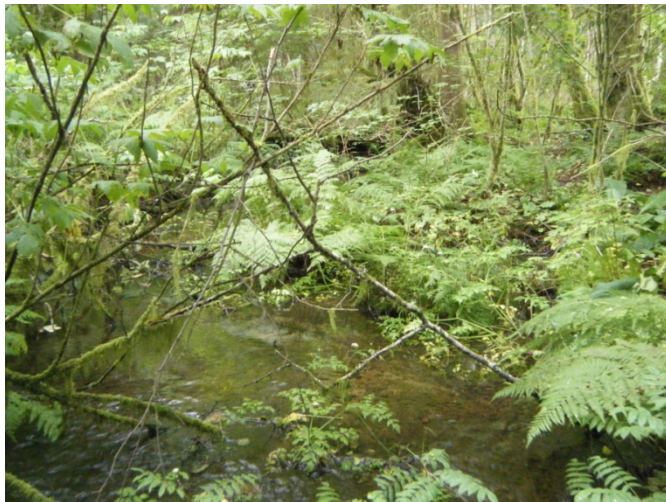
Photo 3: Meighan Creek meandering through Polygon 2. July 14, 2016.

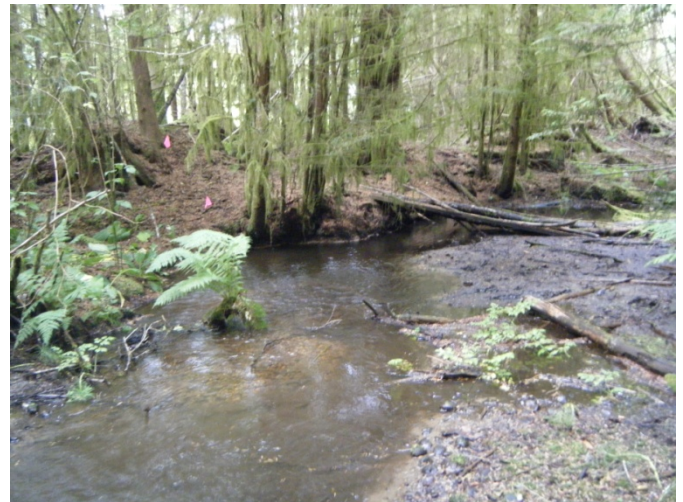
Polygon 2 is 2.0 hectares in size and is located in the southeast corner of the subject site on flat, moist land at the toe of an escarpment. This polygon is a mix of site series 07 (60%) and site series 12 (40%); Meighan Creek and tributaries meander throughout and the polygon contains wetland features. Coho Park Trail also traverses this polygon. A previous study found that the stands are characterised by young forest dominated by western hemlock and western redcedar, with lesser extents of red alder, vine maple, bigleaf maple, paper birch and black cottonwood, and a herb layer dominated by salal, red huckleberry and sword fern (Cascade, 2015). Reprehensive photos are provided below (Photo 3 and Photo 4).

Photo 4: Meighan Creek and young forest in Polygon 2. July 14, 2016.

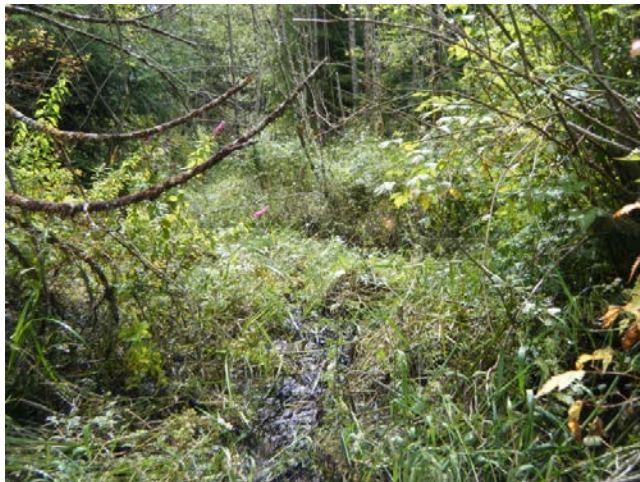
Polygon 3 is 1.3 hectares in size and occupies 3% of the subject property. Polygon 3 is located adjacent to Polygon 2, and Meighan Creek continues to meander through this portion; however, this land is characterised by swamp wetland maintained in a tall shrub structural stage, possibly due to the beaver activity observed in this area. Photos are provided below (Photo 5 to Photo 7).

Photo 5: Wetland associated with Meighan Creek in Polygon 3. July 14, 2016.

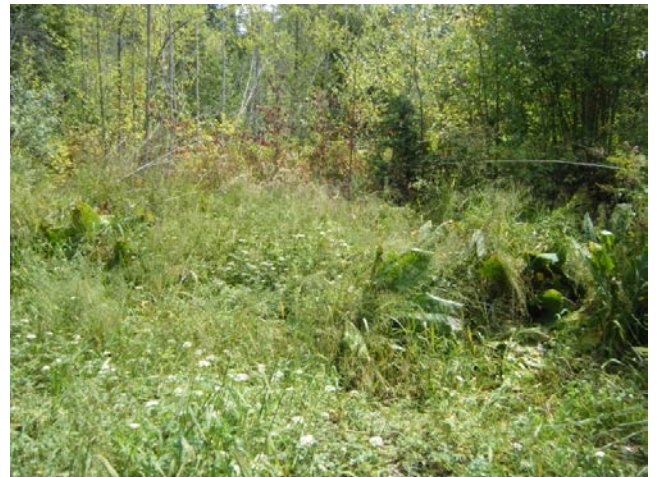
Photo 6: Wetland characteristic of Polygon 3. July 14, 2016.

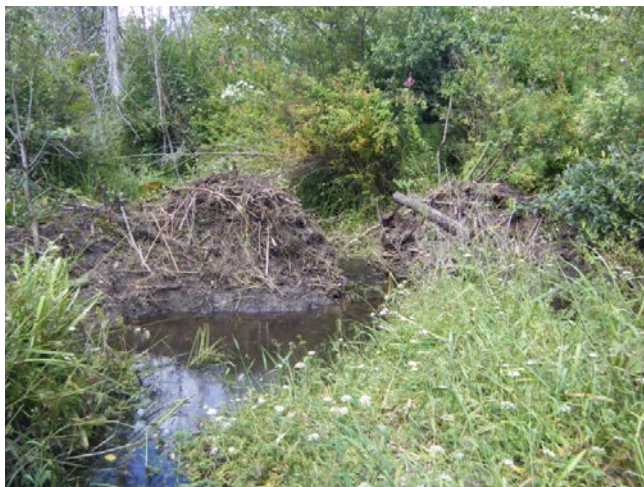
Photo 7: Beaver dam on Meighan Creek in Polygon 3. July 14, 2016.

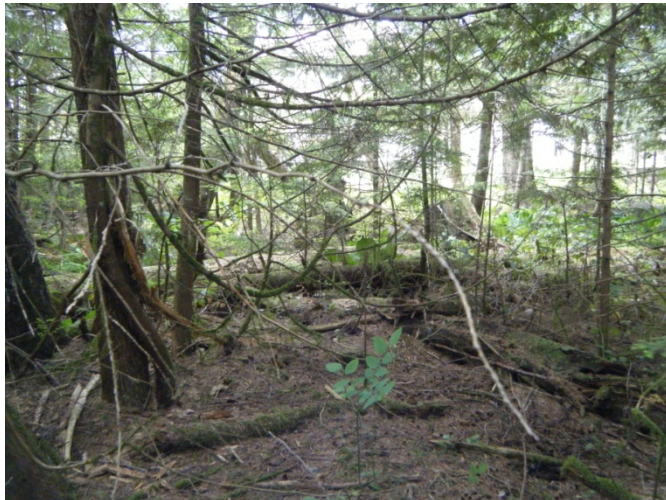
TEM Polygon 4, located on the western portion of the property, is 4.9 hectares and makes up approximately 10% of the subject site. This polygon contains young forest estimated to be approximately 40 years old. Dominant tree species present include western hemlock, western redcedar and Sitka spruce. Soils are rich, moist to wet, silt of medium coarseness. Representative photos of the polygon are provided below (Photo 8 and Photo 9).

Photo 8: Young coniferous forest in Polygon 4. June 30, 2016.

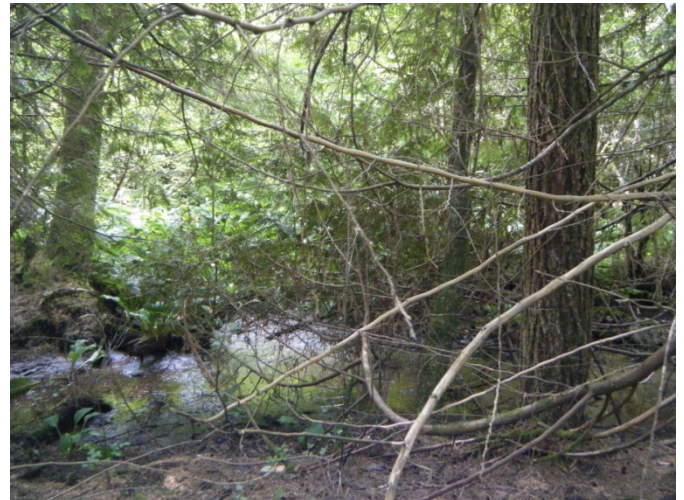
Photo 9: Drainage / tributary to Meighan Creek in Polygon 4. June 30, 2016.

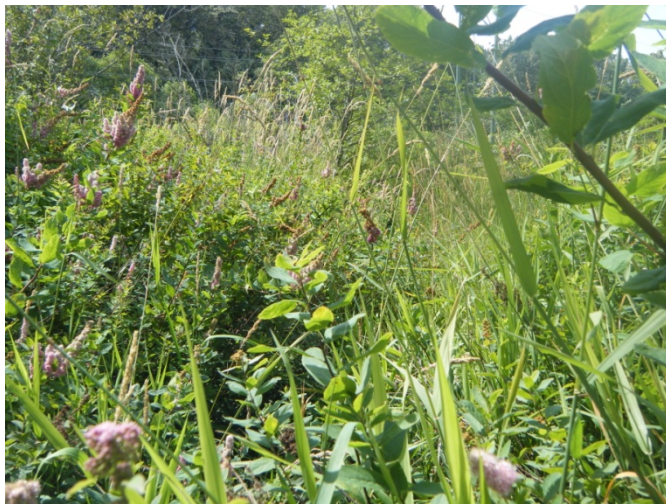
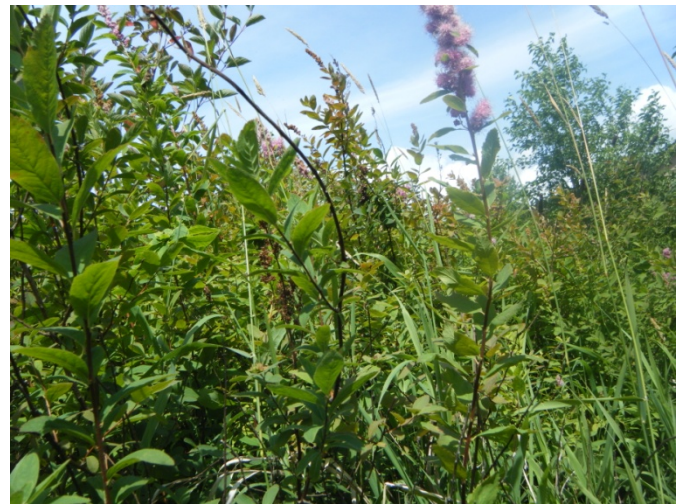
Field verification of Polygon 8 was in keeping with the assignment of swamp wetland class Ws50 (Pink spirea – Sitka sedge) by others (Ecoscape, 2016a) and overlaps with the structural stage, soil nutrient and soil moisture regimes of the other wetland classifications assigned by others including 7Ws3b 3Ws546oM and 6Ws503a 2OW 2Ws.

Photo 10: Pink spirea - Sitka sedge wetland in Polygon 8. June 30, 2016.

Photo 11: Pink spirea - Sitka sedge wetland in Polygon 8. June 30, 2016.

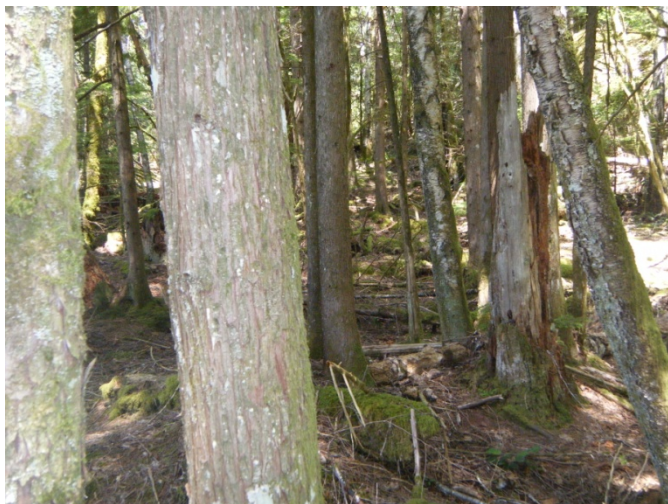
Polygon 6 is located northeast of Polygons 2 and 3, on a steep slope of 35%, occupying 1.1 ha, or 2% of the site. This polygon is drier than its neighbouring polygons to the south due to its slope position, and is dominated by western redcedar, with lesser extents of paper birch, Douglas-fir and western hemlock. The shrub layer contains salal, dull Oregon grape, red huckleberry and vine maple. The Coho Park trail continues into Polygon 6 from Polygon 2. Photos representative of Polygon 6 are presented below.

Photo 12: Young forest in Polygon 6. June 30, 2016.

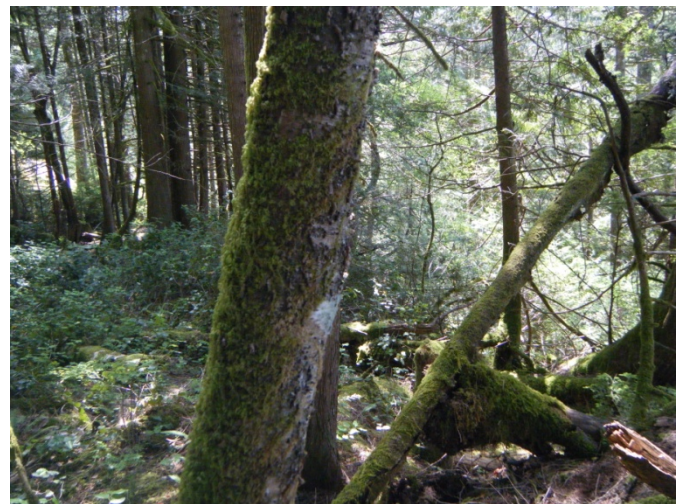
Photo 13: Young forest in Polygon 6. June 30, 2016.

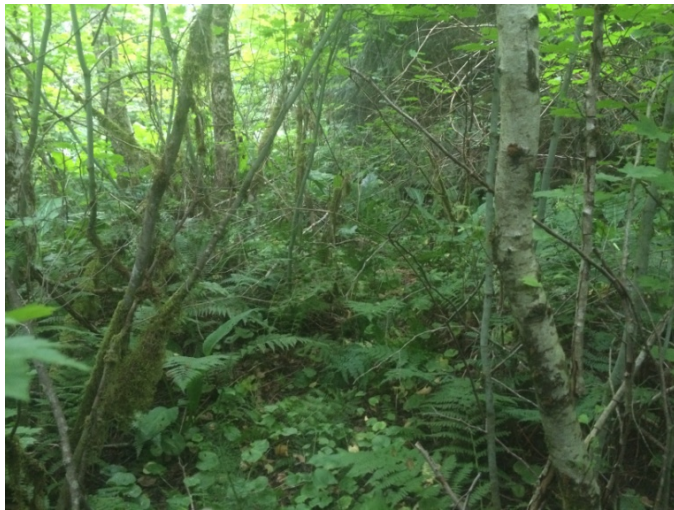
This polygon is located at the middle of the subject property between No Name Creek and Thunderbird Creek, making up 6.7 hectares and 14% of the subject property. This polygon has a mix of maturing seral and young climax forest and is exposed to frequent disturbance, being within the active floodplain of No Name Creek and Thunderbird Creek. Vegetation cover is dominated by red alder with a relatively dense understory of shrubs. Representative photos of the polygon are provided below (Photo 14 to Photo 17).

Photo 14: View of the vegetation along Thunderbird Creek in TEM Polygon 7. July 6, 2016.

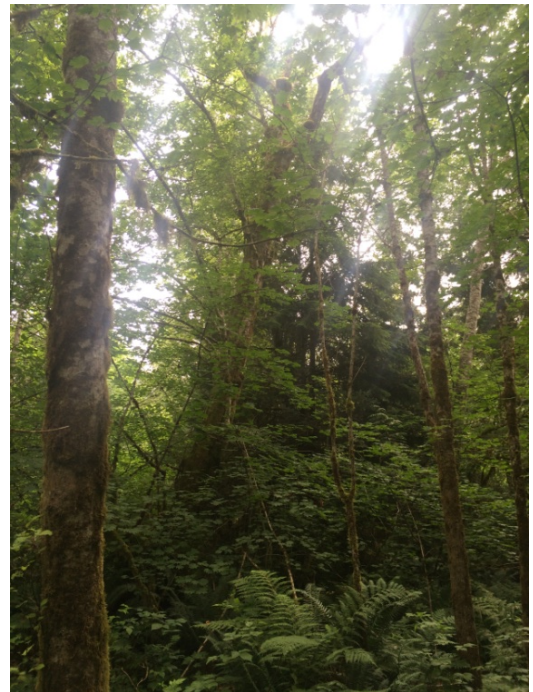
Photo 15: View of the vegetation along Thunderbird Creek in TEM Polygon 7. July 6, 2016.

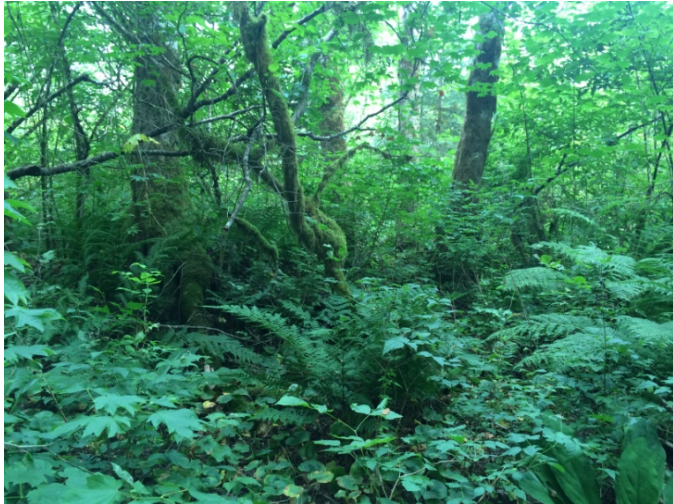
Photo 16: View of the vegetation at the center of the TEM Polygon 7 .July 6, 2016.

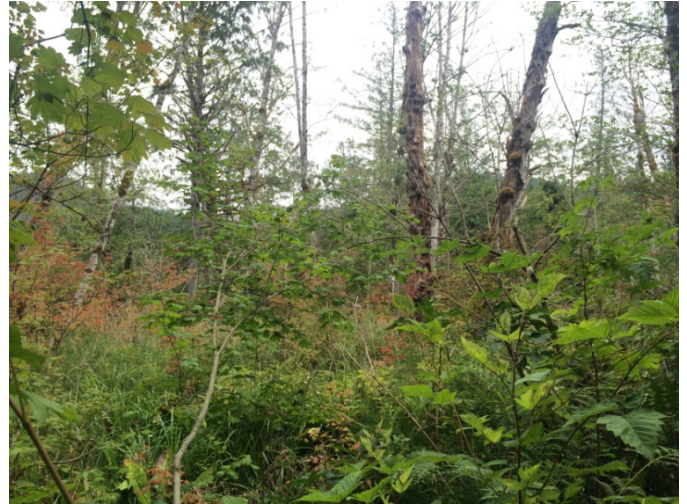
Photo 17: View of the vegetation at the center of the TEM Polygon 7 .July 6, 2016.

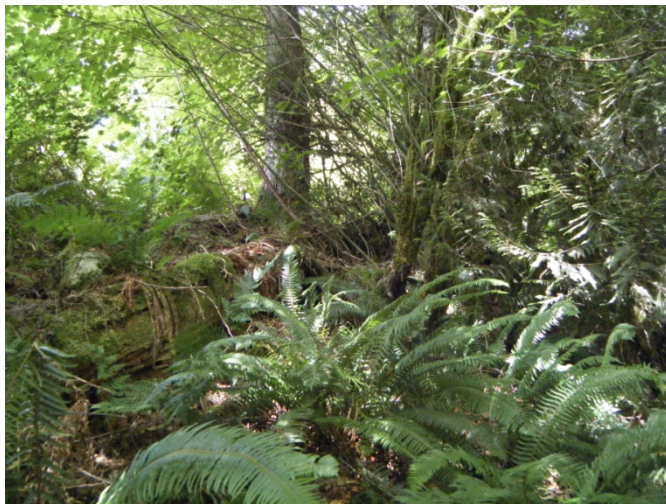
Polygon 9 is located along the east side of the property making up 0.7 hectares and 1% of the subject property. No Name Creek bisects the polygon. The terrain is characterized by a steep gradient of approximately 50% and the vegetation is characterized by a mature forest dominated by western redcedar, western hemlock with some red alder. The stand age was estimated at 80 years old. Representative photos of the polygon are provided below (Photo 18 and Photo 19).

Photo 18: View of the vegetation in TEM polygon 9. July 6, 2016

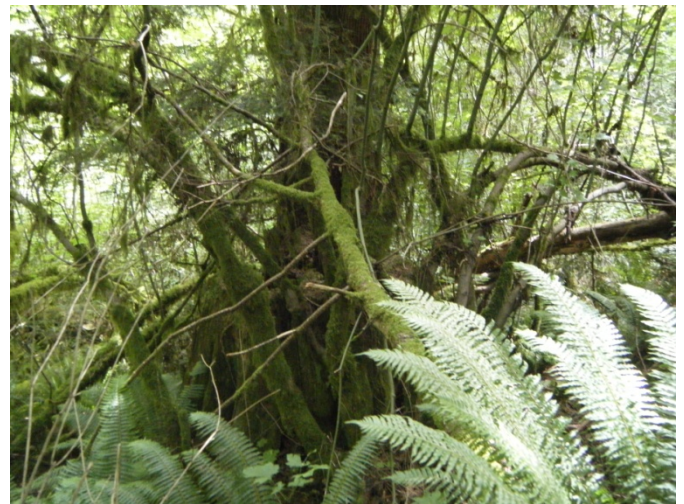
Photo 19: View of the vegetation in TEM polygon 9. July 6, 2016.

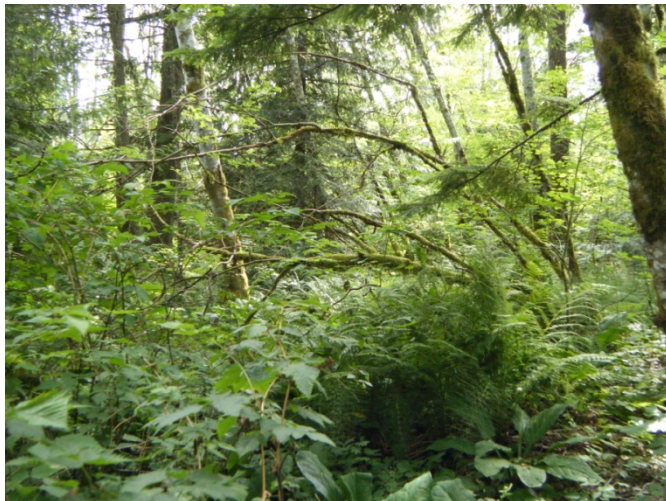
This polygon is located along Newport Creek and its associated wetlands, making up 1.7 hectares and 4% of the subject property. This polygon is characterized by a mature climax forest and is exposed to frequent disturbance, being within the active floodplain of Newport Creek. Vegetation is composed of mix of deciduous and coniferous tree and is dominated by red alder with a relatively dense understorey dominated by salmonberry. Stand age was estimated to be between 50 and 80 years old. The water table was present 25 cm below the soil surface. Representative photos of the polygon are provided below (Photo 20 and Photo 21).

Photo 20: View of the vegetation in TEM polygon 10. July 6, 2016.

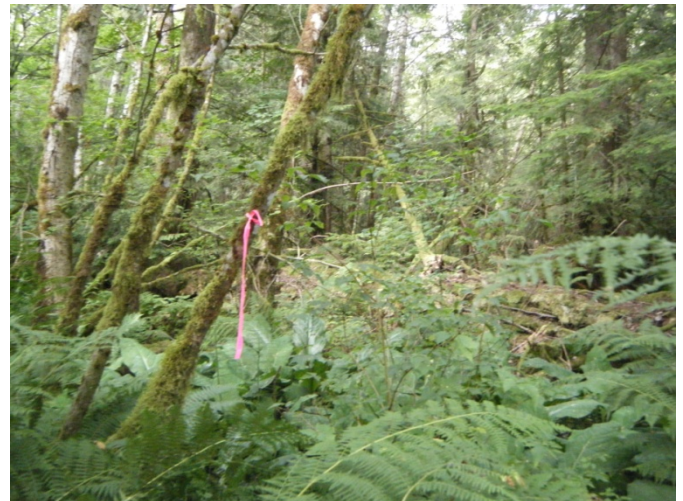
Photo 21: View of the vegetation in TEM polygon 10. July 6, 2016.

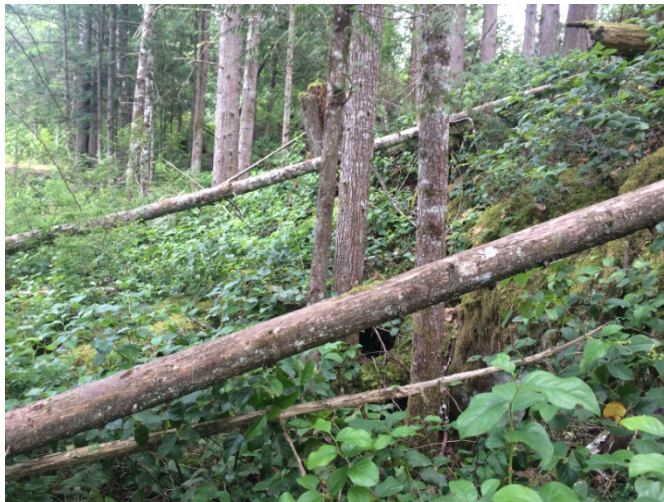
Polygon 11 is located near the upper reach of Newport Creek on the East side of the property. This polygon makes up 1.5 hectares and 3% of the subject property. The terrain presents a gentle slope of approximately 21%. The forest is characterized by a mature structural stage. Vegetation cover is dominated by western redcedar with a shrub layer dominated by salal. Stand age was estimated to be approximately 80 years old. An abundance of sapsucker wells were observed on trees in this polygon. Representative photos of the polygon are provided below (Photo 22 and Photo 23).

Photo 22: View of the vegetation in TEM polygon 11. July 6, 2016

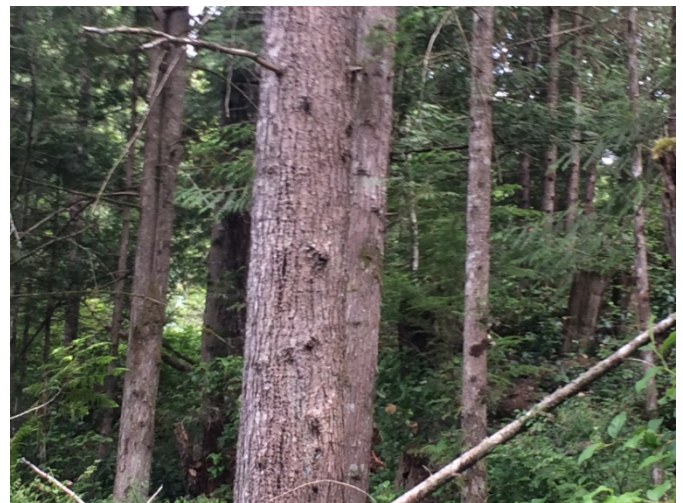
Photo 23: View of the sapsucker wells on a tree in TEM polygon 11. July 6, 2016.

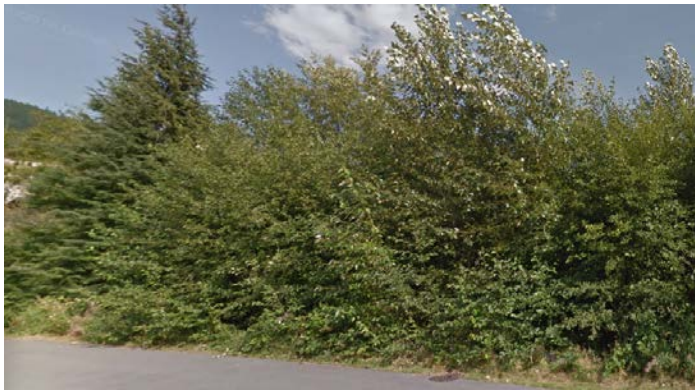
This polygon is composed of dense stand of red alder, with occasional western redcedar and western hemlock. This polygon makes up 0.5 hectares, approximately 1% of the subject property. The predominantly deciduous polygon has a pole/sampling structural stage, while the occasional coniferous trees present are slightly older, with a young structural stage (Photo 24).

Photo 24: View of Polygon 12 from Dowad Drive (Google Street View, August 2014)

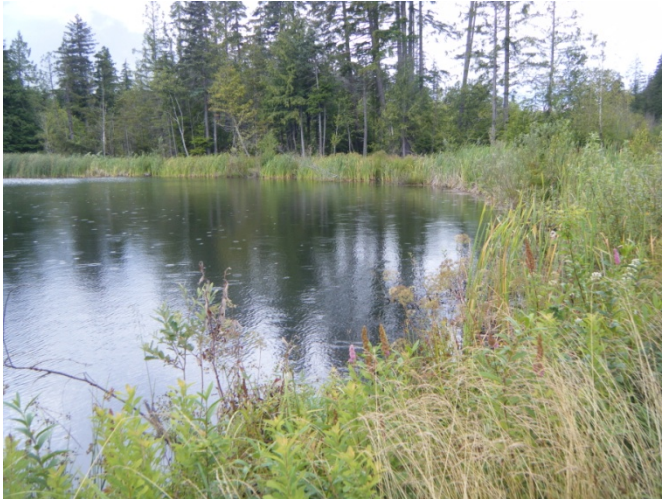
This polygon is composed of the various ponds present on the subject property. A total of eight ponds are present on site. Each pond is given a number from 1 to 8. A representative photo of the polygon is provided below (Photo 25)

Photo 25: View of Pond 5. July 14, 2016

Coarse woody debris on the forest floor is an indicator of potential species richness for forested areas. Micro habitats, decay, and nutrient cycling provide a range of life cycle opportunities for wildlife and vegetation. Coarse woody debris of varying diameters, lengths, and levels of decay (Photo 25), in addition to rotting stumps, are abundant on the forest floor in all TEM Polygon within the exception of the golf course polygon.

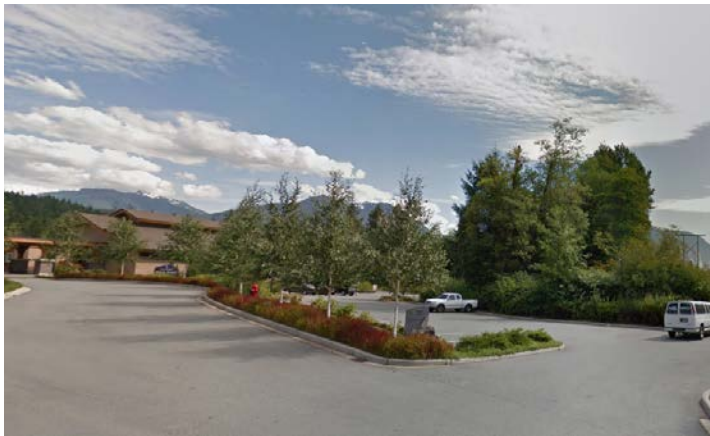
This polygon is composed of the golf course clubhouse and associated parking lot, with vegetation limited to ornamental planting. It has an area of 0.3 ha and makes up less than 1% of the site. A representative photo of the polygon are provided below (Photo 26)

Photo 26: View of Polygon 14, showing driveway, parking lot and club house in background (Google Street View, August 2011)

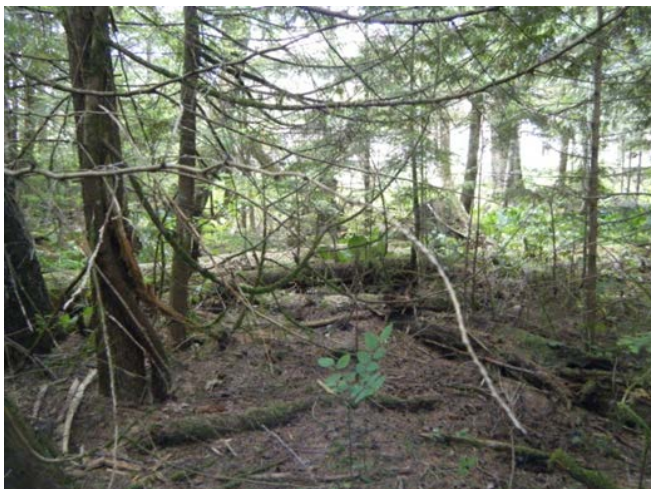
Photo 27: Abundance of Coarse woody debris in Polygon 4. June 30, 2016.

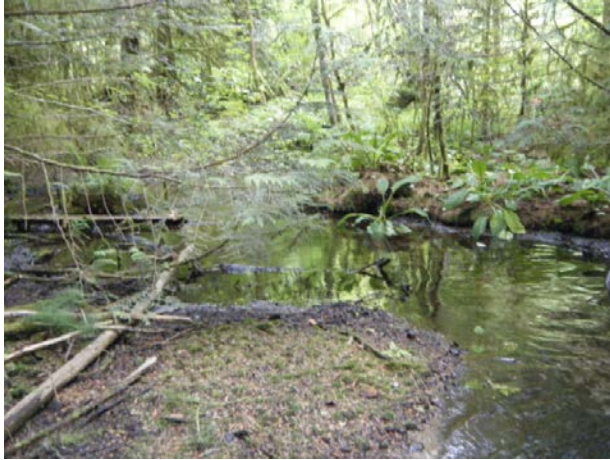
Photo 28: Meighan Creek upstream portion. July 14, 2016.

Meighan Creek enters the subject property from the south, where it flows at a gradient of approximately 0.5 % through mature forest composed of Sitka spruce, western hemlock and western redcedar. Stream widths in this area are approximately 6 m, and multiple tributaries and drainages flow into this section of Meighan Creek (Photos 26 to 29). Meighan Creek then continues through a wetland area on the subject site, and joins a connector watercourse to Pond 5. Multiple beaver dams and access channels were observed in this wetland area. From here, Meighan Creek flows west to the constructed wetland complex on the western border of the property, where it flows into culverts under Tantalus Road and Highway 99.

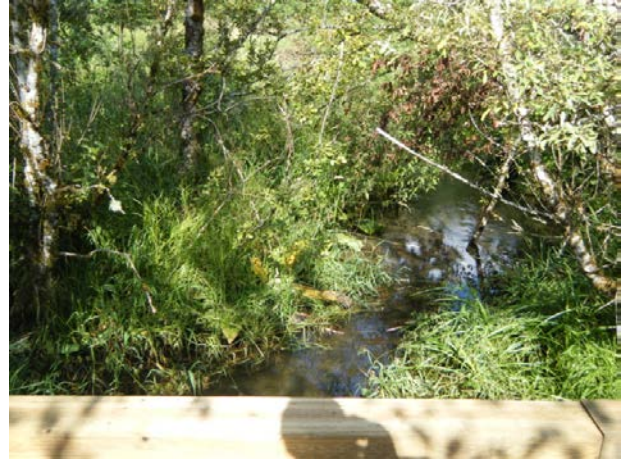
Photo 29: View of Meighan Creek and associated wetland area. July 14, 2016.

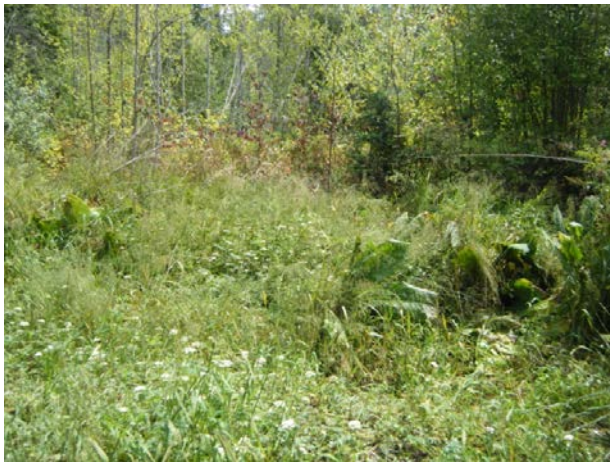
Photo 30: Meighan Creek wetland area. July 14, 2016.

Thunderbird Creek flows through Sitka spruce / red alder forest from the eastern border of the property at a gradient of approximately 2%; upstream of the eastern property border an escarpment and 15 m waterfall pose a barrier to fish (Photo 30). Thunderbird Creek flows through the centre of the subject site at a gradient of 0 to 0.5 % and into a wetland complex where it joins No Name Creek and Newport Creek.

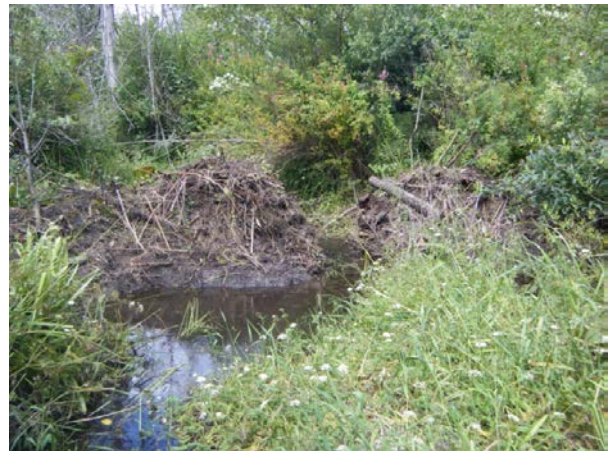
Photo 31: Beaver dam on Meighan Creek. July 14, 2016.

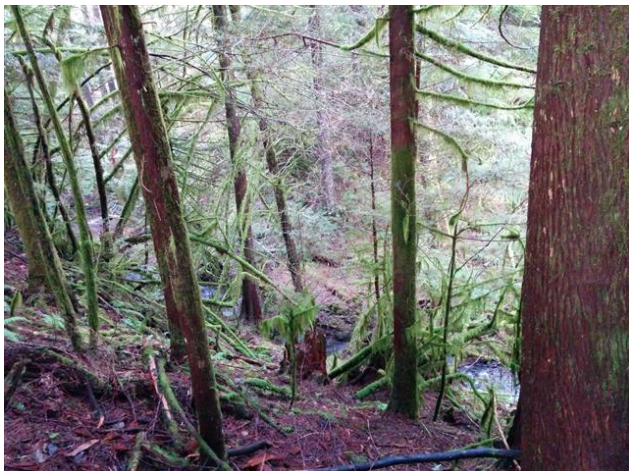
Photo 32: View of Thunderbird Creek upstream section. November 2, 2015.

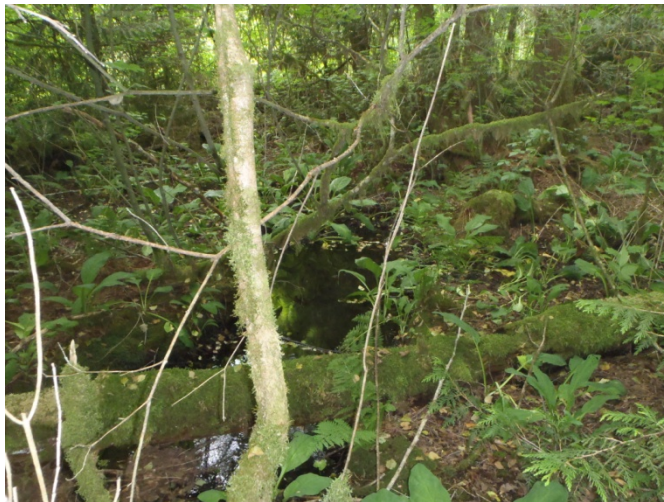
Photo 33: Upstream section of No Name Creek. July 25, 2016.

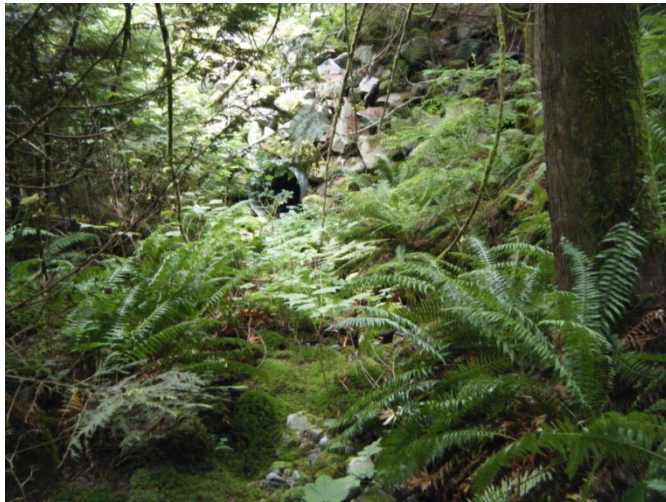
Photo 34: Upstream portion of Newport Creek. July 20, 2016.

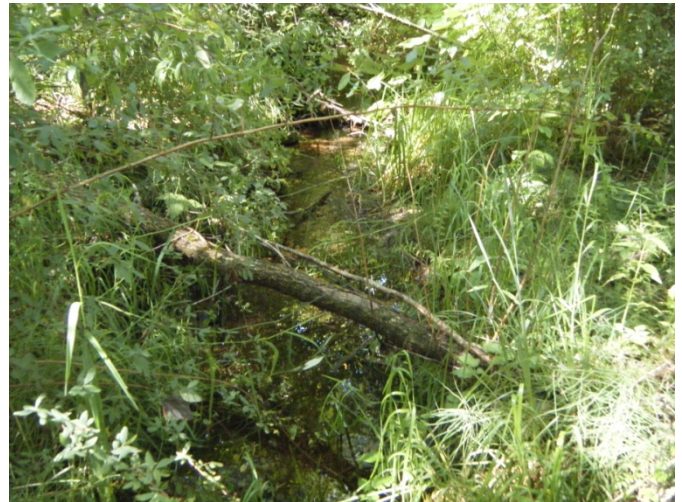
Photo 35: Newport Creek upstream of wetland/stream complex. July 21, 2016.

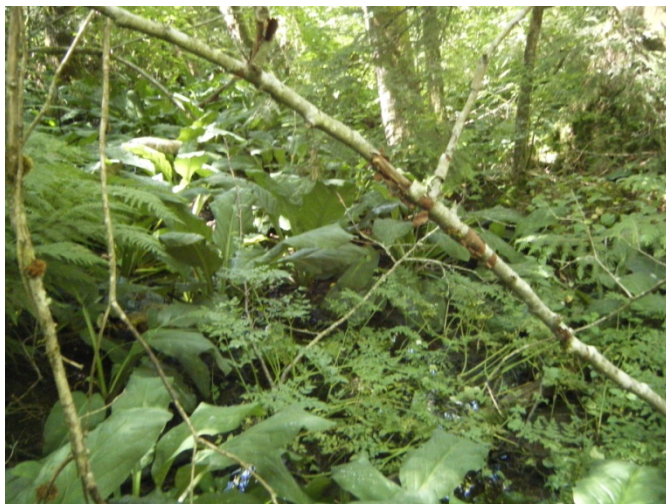
Photo 36: Newport Creek stream/wetland complex. July 21, 2016.

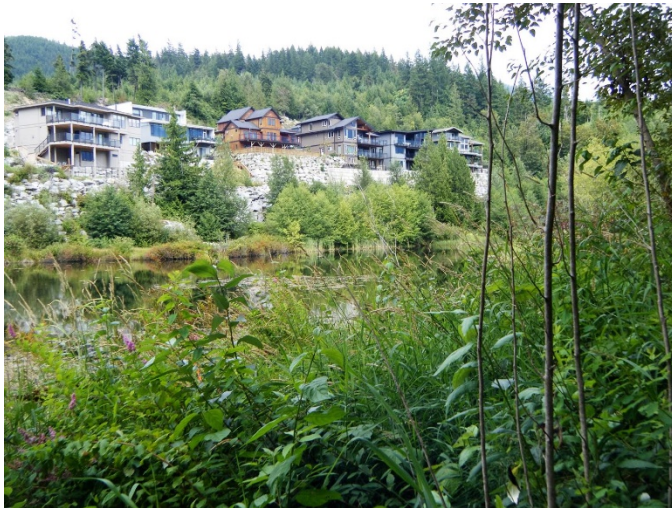
Photo 38: View of Pond 1. July 20, 2016.

It is fed from the southeast by Newport Creek and drains into a constructed channel at its northwest end, eventually flowing into Thunderbird Creek via another constructed compensation channel which was referred to as New 5 during golf course construction. Both the inlet and outlet channels were also constructed as compensation channels and were intended to be fish passable. The inlet was designed to be 1-1.5 m wide and 90 m long, and was constructed to direct overland flows and intermittent flows from Newport Creek to Pond 1. The outlet channel was constructed to be 2 m wide and 35 m long and was designed to provide a permanent secure source of water to the compensation channel New 5 located adjacent to Tantalus Road. In September 2006, no connection was observed at the outlet to Newport Creek and recommendations were made to improve this connection and thereby improve water quality (low dissolved oxygen and high temperatures) and coho numbers (Cascade, 2006a). The degree of connectivity is unknown at this time; however, fish presence has been established. A connectivity and water quality survey and, possibly fish sampling, should be conducted and restoration works, if required, could be offered as compensation for the proposed development.

Original riparian setbacks on Pond 1 included both in-play and out-of-play areas. The southeast end of the pond was in-play and was therefore planted with a variable 0-5 m setback with low shrub (hardhack, salmonberry, and rose) in 2002. The trees along the east edge of the pond were also in-play and were planted in low shrub (primarily snowberry). All other areas along the perimeter of the pond were considered out-of-play and riparian vegetation was retained or planted appropriately.

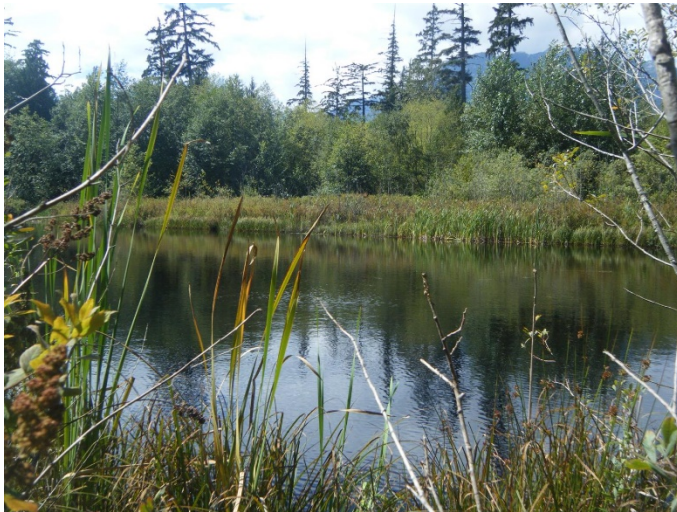
Photo 39: View of Pond 2. August 4, 2016.

Pond 2 was also constructed in 2002 and is located in the eastern portion of the golf course lands, between Thunderbird and No Name Creeks (Photo 39). The pond has an open area of approximately 1,769 m<sup>2</sup> as measured from 2013 ortho aerial photographs (DOS, 2016) and has a wetland shelf mainly along its west and southwest shores.

The majority of riparian areas around Pond 2 were in-play. Western redcedar, western hemlock, black cottonwood, Pacific crab apple, black hawthorn, Pacific ninebark, red-osier dogwood, vine maple and short shrub, including hardhack, thimbleberry and salmonberry, with a fringe of sedges and rushes near the pond were planted during construction. Red alder has also regenerated. (Cascade, 2004).
