# DISTRICT OF SQUAMISH

## HYDROGEOMORPHIC ASSESSMENT OF SQUAMISH RIVER NEAR THE WASTEWATER TREATMENT PLANT OUTFALL

Polar File No. 910201  
FINAL REPORT  
September 2020

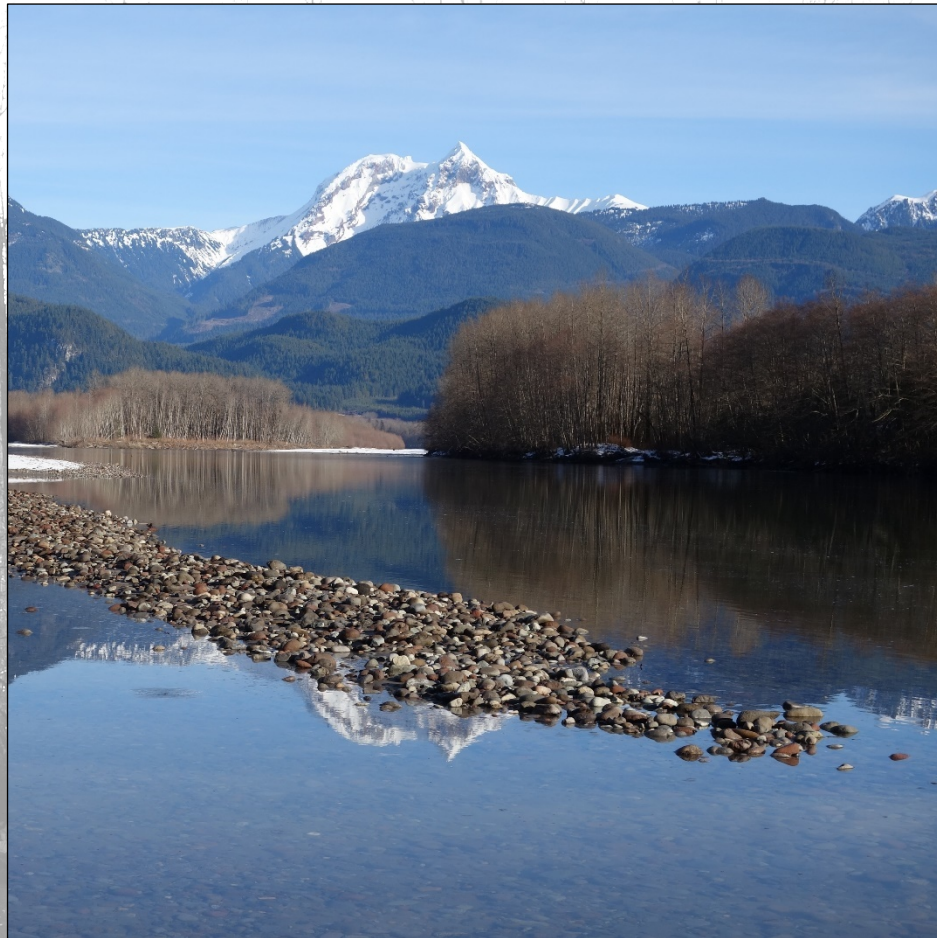
#### *COVER PHOTO*

View upstream of Squamish River across from the wastewater treatment plant outfall during low flow conditions on January 14, 2015 [69.1 m<sup>3</sup>/s discharge for Squamish River near Brackendale (08GA022)].

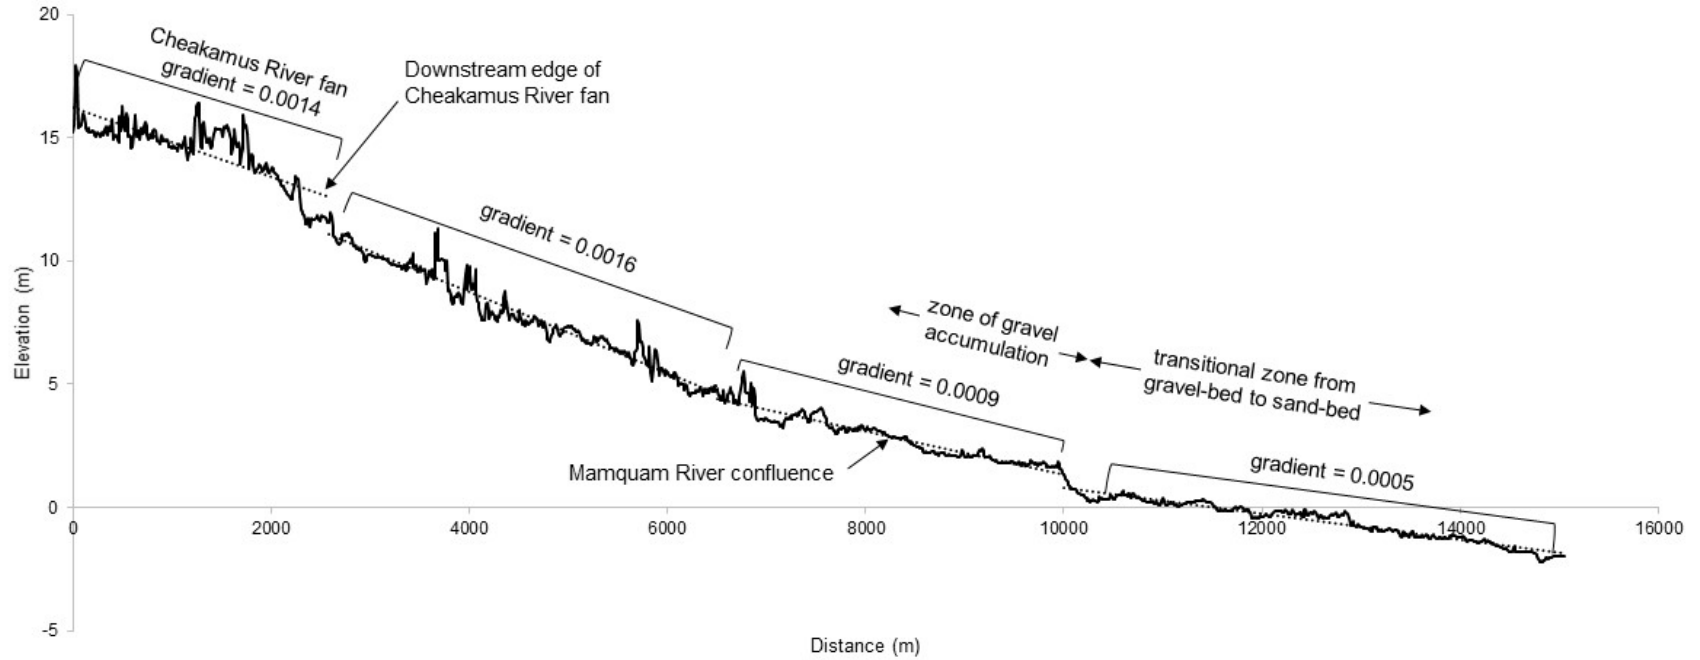
FIGURE 3.1 Longitudinal profile showing assumed water surface elevations of the Squamish River centreline along 10 m intervals. Note the changes in gradient as the river approaches Howe Sound. Digital Elevation Model (dated 2016) obtained from the District of Squamish.

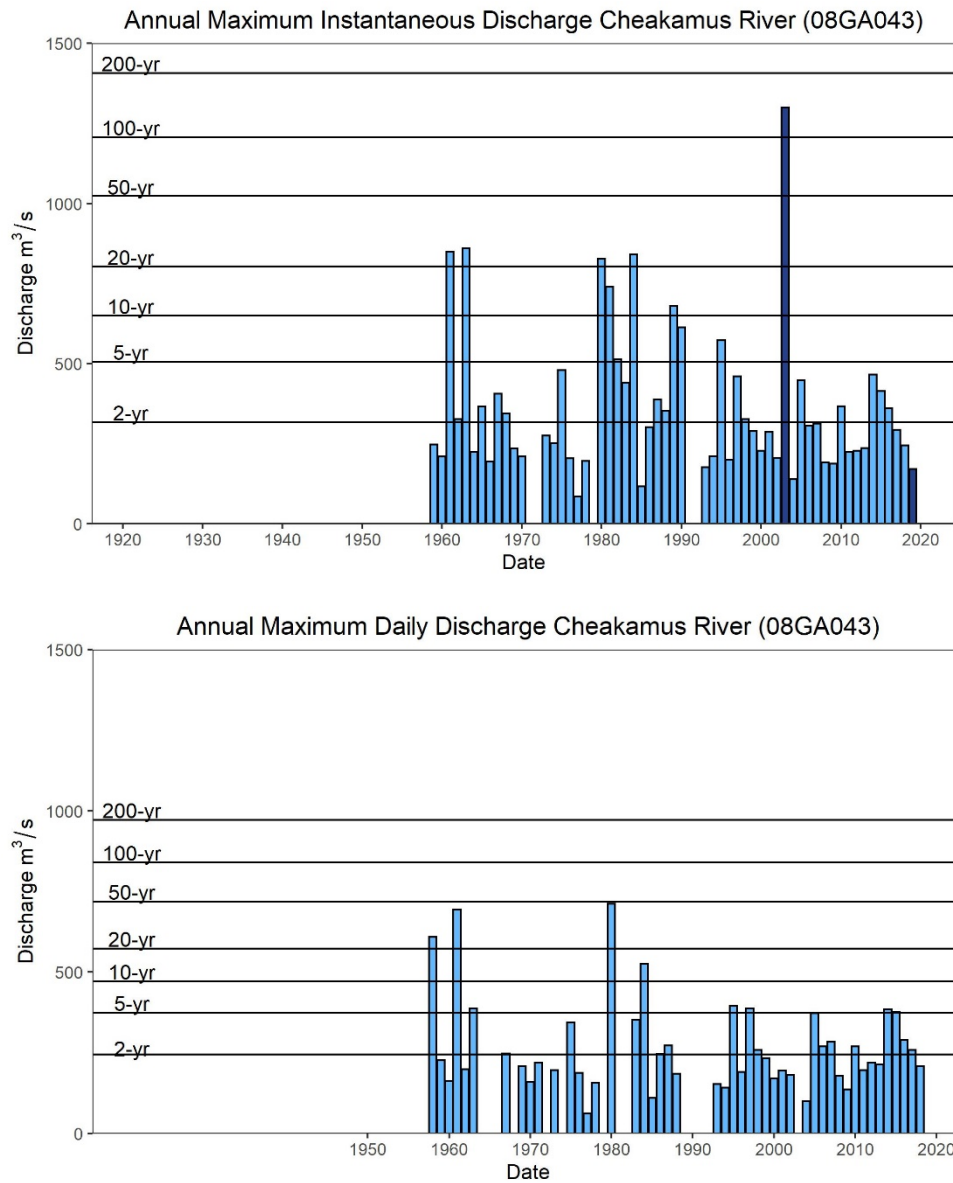
FIGURE 4.2 Annual maximum instantaneous flows and maximum daily flows for the Cheakamus River near Brackendale (08GA043). Provisional data is shown in dark blue. The instantaneous peak flow in 2003 was estimated by KWL (2011). Horizontal lines shown on both plots represents average return period results for instantaneous and daily flows calculated by KWL (2011).

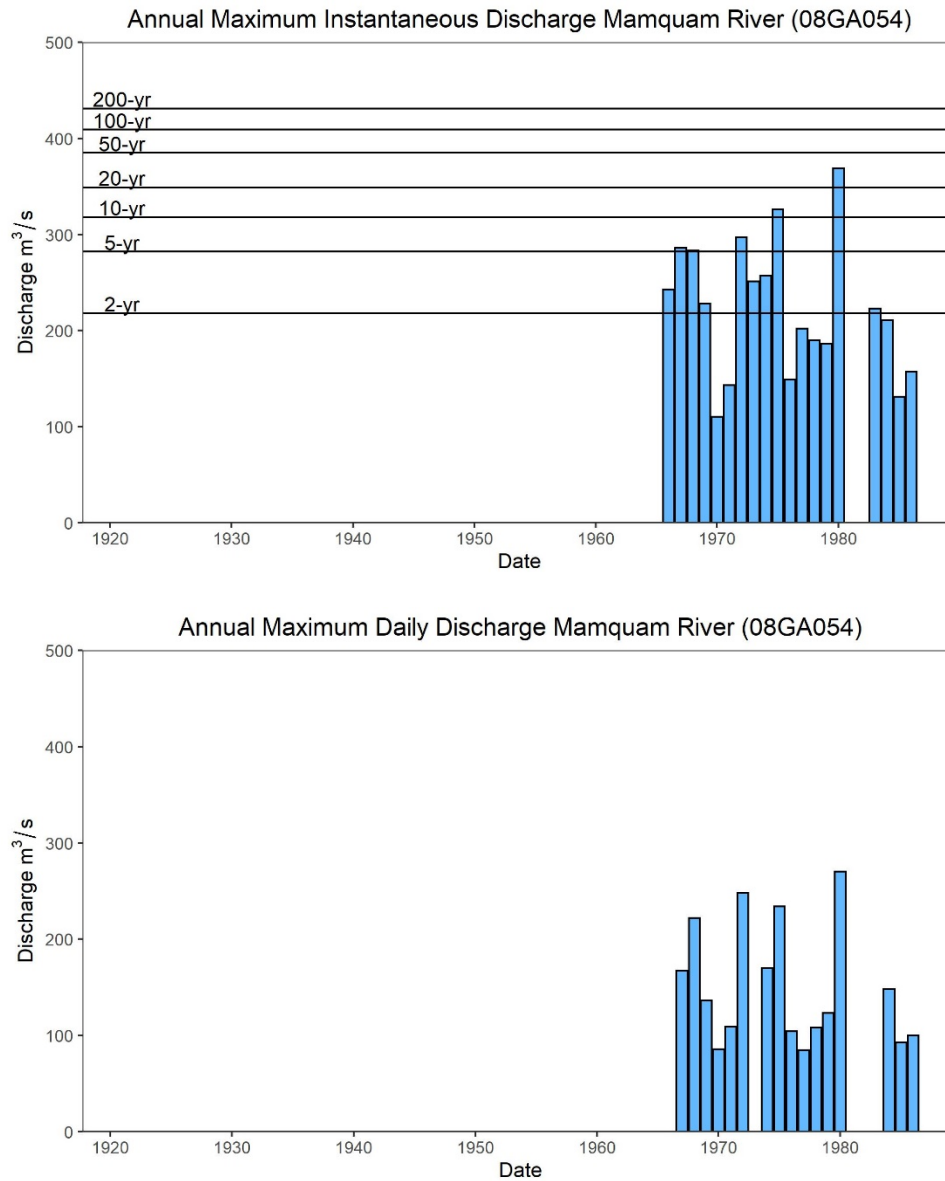
FIGURE 4.3 Annual maximum instantaneous flows and maximum daily flows for the Mamquam River above Mashiter Creek (08GA054). Horizontal lines shown on the instantaneous plot represents average return period results for instantaneous peak flows calculated by KWL (2011). An average return period result was not calculated for the daily flows due to discrepancies observed between flood frequency distributions (KWL, 2011).

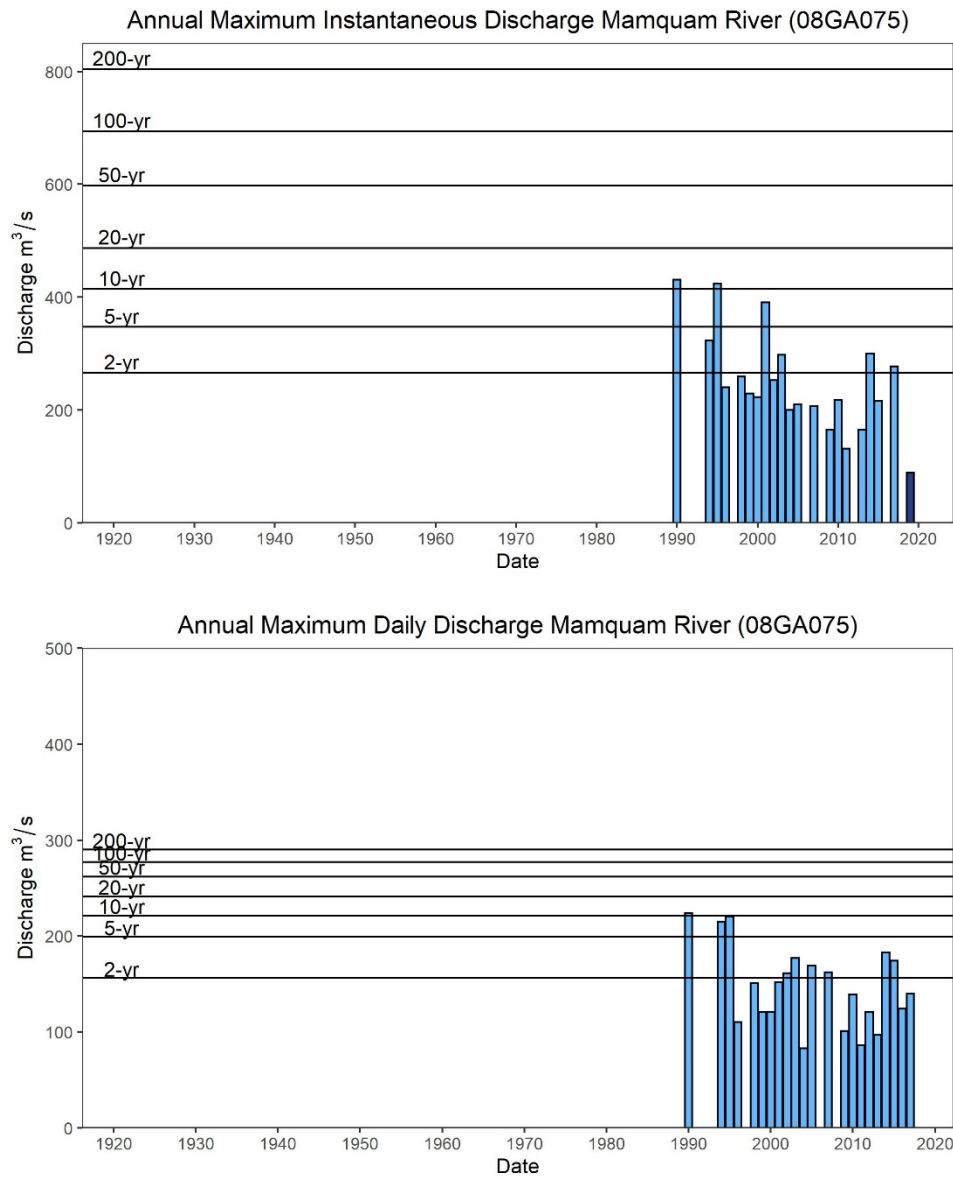
FIGURE 4.4 Annual maximum instantaneous flows and maximum daily flows for the Mamquam River above Ring Creek (08GA075). Provisional data is shown in dark blue. Horizontal lines shown on both plots represents return periods for instantaneous and daily flows calculated by KWL (2011). Given the relatively short period of record (12 years), these results have relatively high uncertainty.

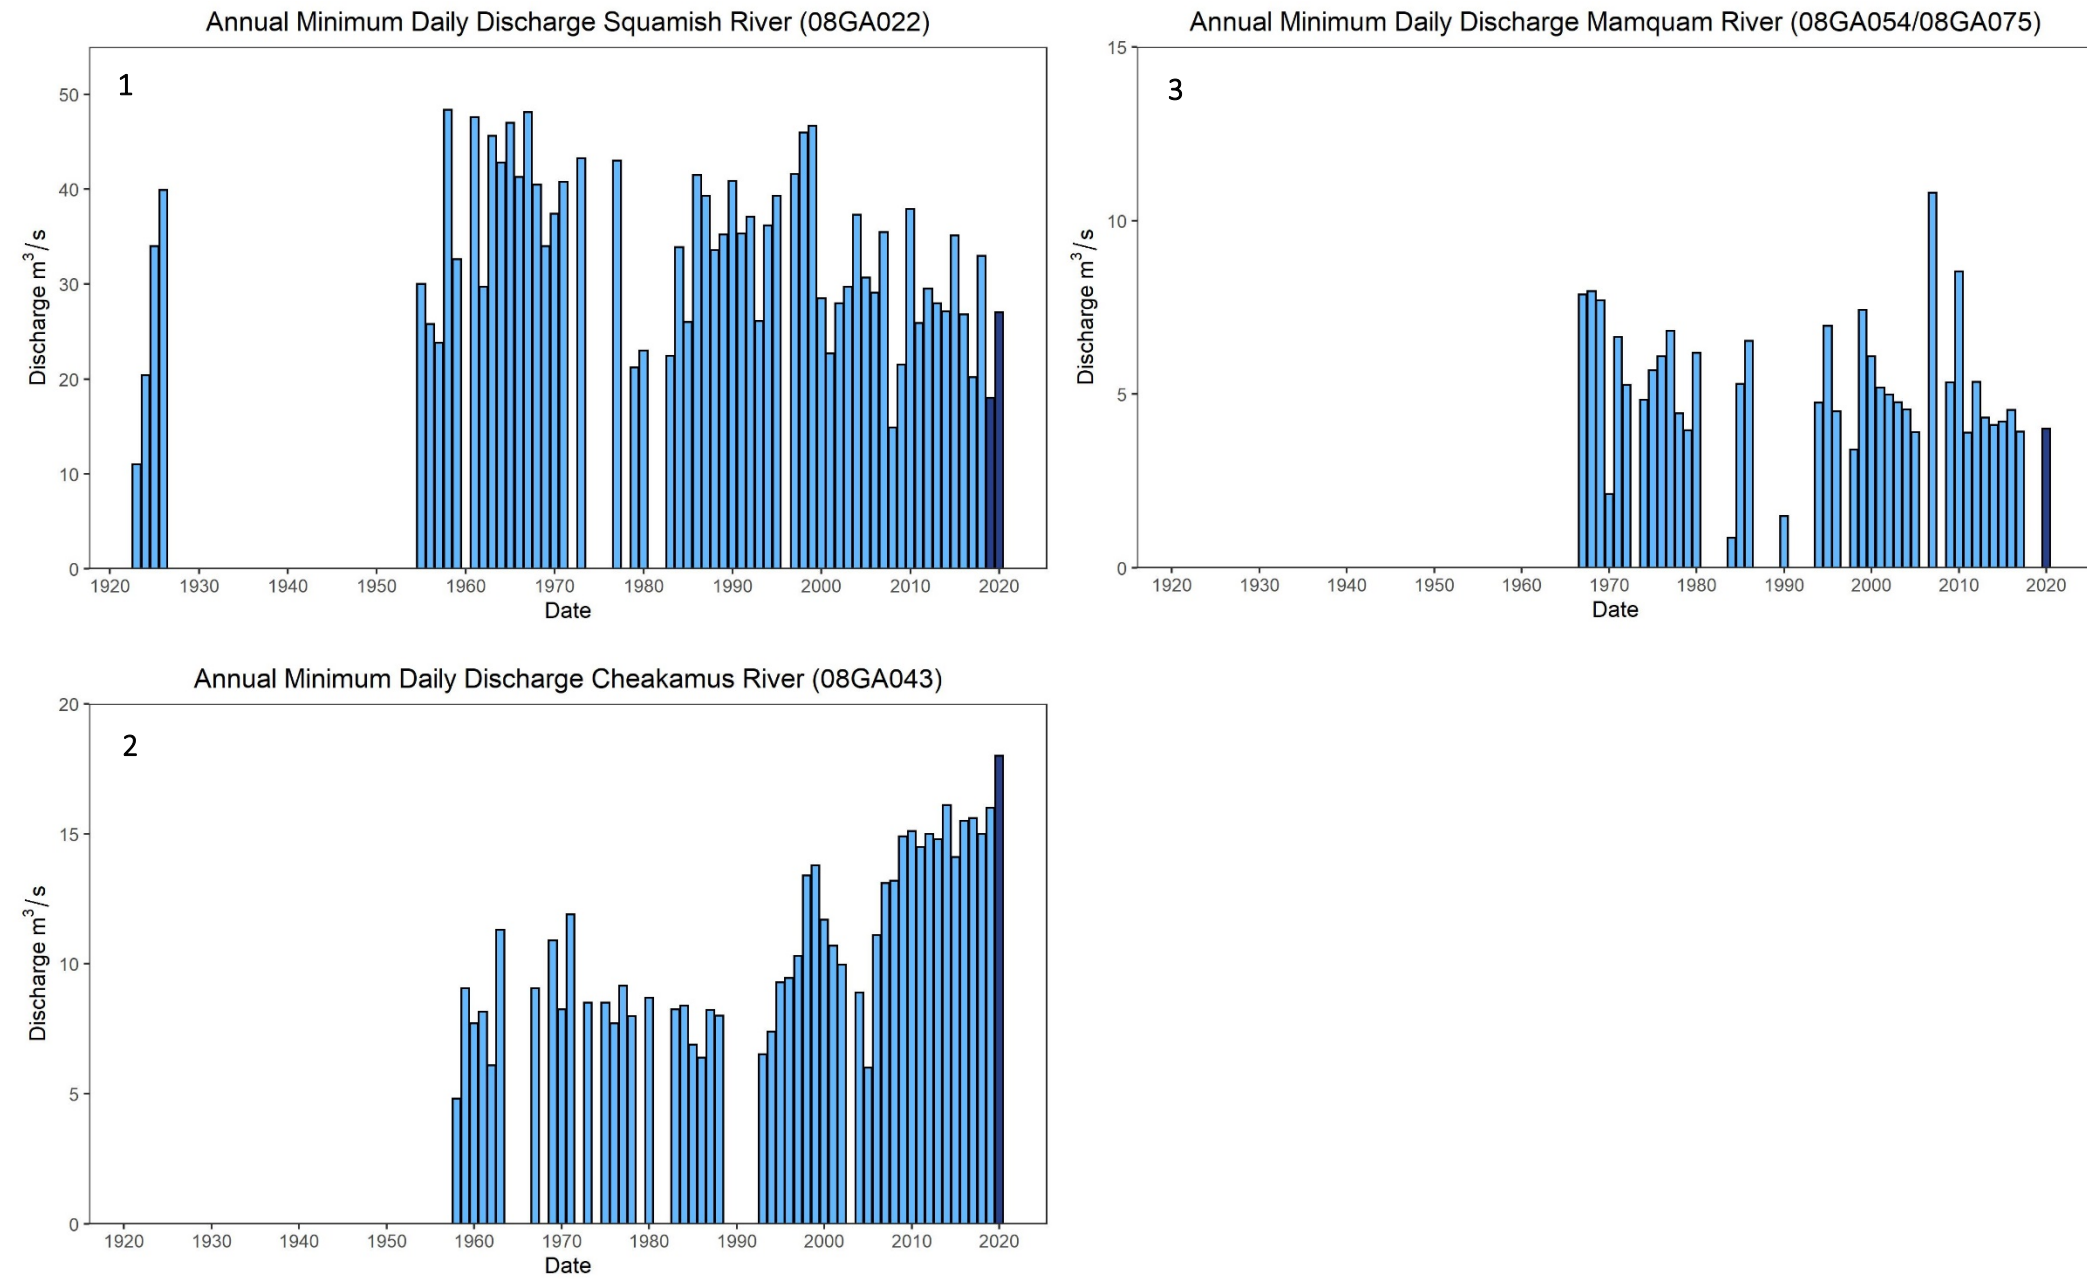
FIGURE 4.5 Historical variation in annual minimum daily flows for: 1) Squamish River near Brackendale (08GA022) (top left), 2) Cheakamus River near Brackendale (08GA043) (bottom left), 3) Mamquam River above Mashiter Creek (08GA054) between 1966-1986 and Mamquam River above Ring Creek (08GA075) from 1990-2020. Provisional data is shown in dark blue.

Given that poor mixing conditions have been identified when river flows and levels are relatively low, annual daily minimum flows for the Squamish, Cheakamus, and Mamquam rivers were reviewed (FIGURE 4.5). Low flows on the Cheakamus River are controlled by the Cheakamus Dam, and could at least partially reflect changes in the facility's operating regime. On the Squamish River, low flows appear to be decreasing over the period since the 1960s, with a few years of relatively high low flows in the late 1990s; however, no statistical analysis was completed to assess the trend in these flows. No observable trends in low flows were observed on the Mamquam River.

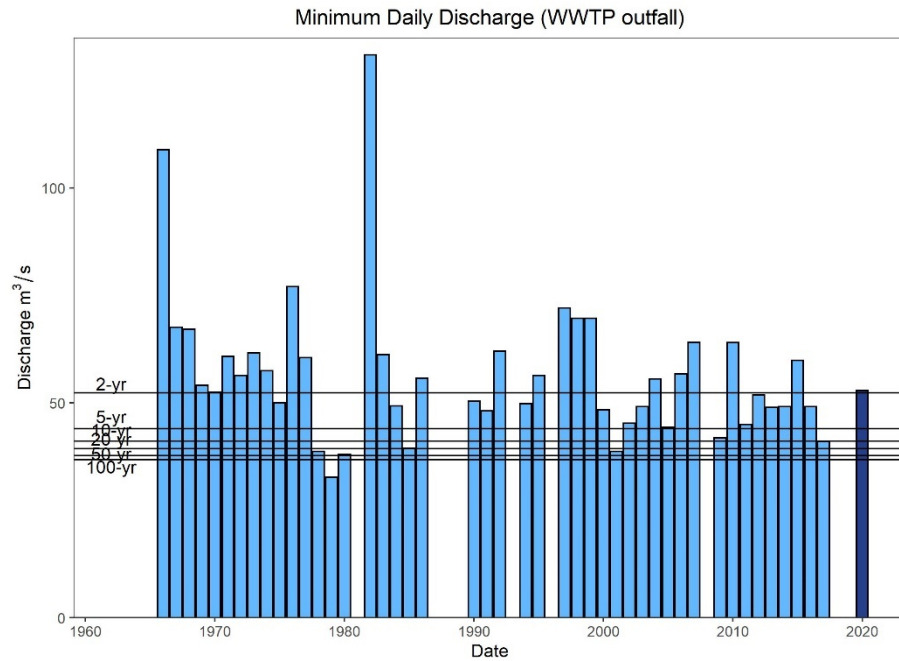
FIGURE 4.6 *Estimated annual minimum daily flows at the WWTP outfall. Provisional data is shown in dark blue. Horizontal lines represent the average return period for minimum daily flows.*

The estimated daily flows at the WWTP outfall show that low flows are much more consistent than high flows observed at the site from year to year. It is possible that low flows are decreasing (i.e., becoming more extreme) at the WWTP outfall; however, the period of record is much shorter than that recorded by the Squamish River near Brackendale (08GA022) station, which makes it difficult to observe a similar trend. The estimated high flows at the WWTP outfall show that large flood events with a greater than 10-year return period occurred near the WWTP outfall in 1975, 1980, 1984, 1990, and 2003.

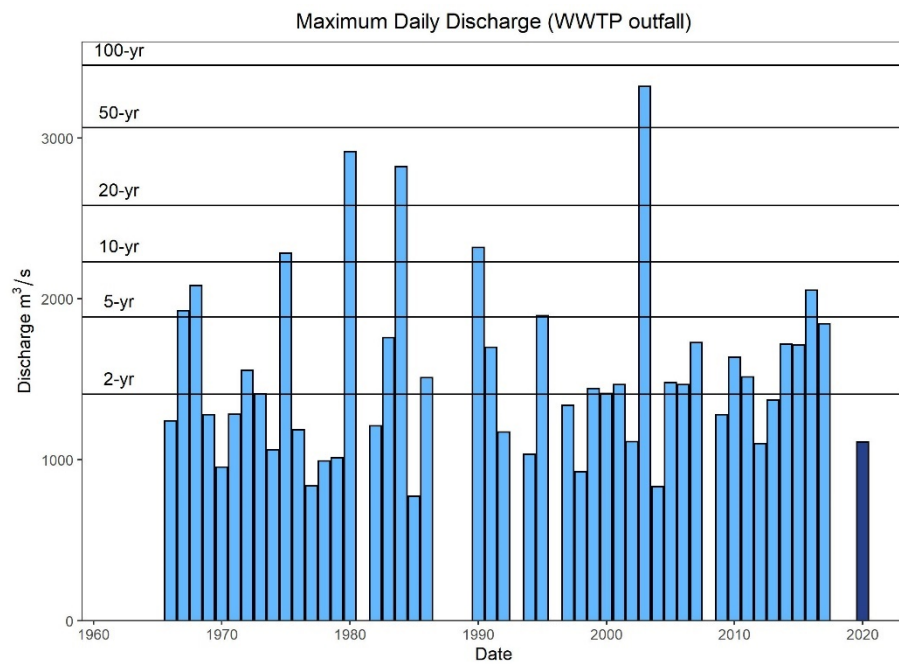
FIGURE 4.7 *Estimated annual maximum daily flows at the WWTP outfall. Provisional data is shown in dark blue. Horizontal lines represent the average return period for maximum daily flows.*

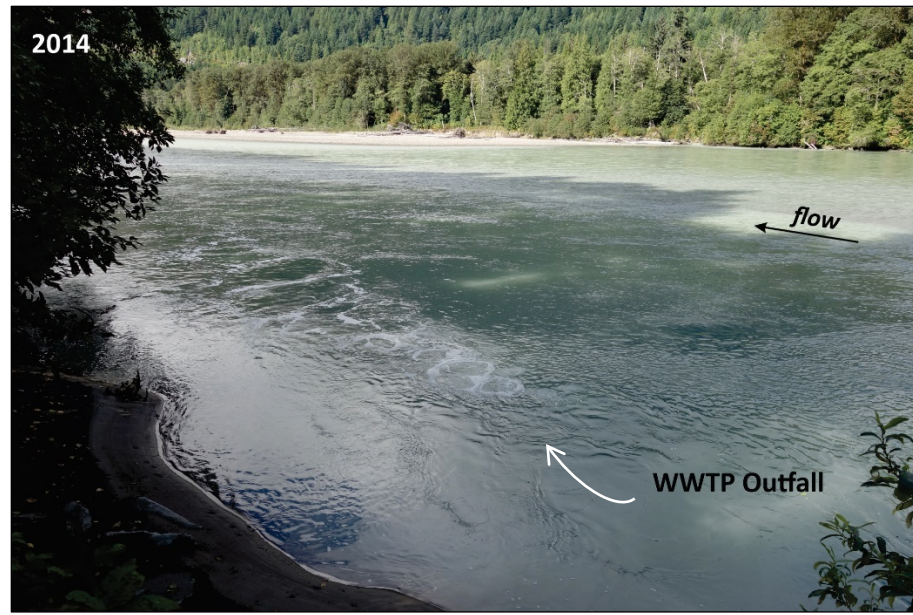
FIGURE 5.1 View downstream from the east (left) bank of the Squamish River near the WWTP outfall on September 3, 2014 (discharge approximately  $201 \text{ m}^3/\text{s}$ ). Notice the trail of bubbles moving downstream indicating where the WWTP outfall is situated. Photo taken by Lars Uunila.

On September 3, 2014, the discharge from the WWTP outfall was carried by the flow of the Squamish River (FIGURE 5.1). An assessment on April 7, 2015 by Great Pacific Engineering & Environment noted that the effluent plume rose to the surface and contacted the riverbank approximately 53 m from the outfall location. During a site visit on July 17, 2020, the brown turbid water in the main flow of the Squamish River was separated from slower flowing water from the Mamquam River that enters immediately upstream. The site was sheltered from the main river flow by the upstream bar resulting in relatively low flow velocities over the outfall even at relatively high flows in the Squamish River (approximately 500 m<sup>3</sup>/s) (FIGURE 5.2)<sup>3</sup>.

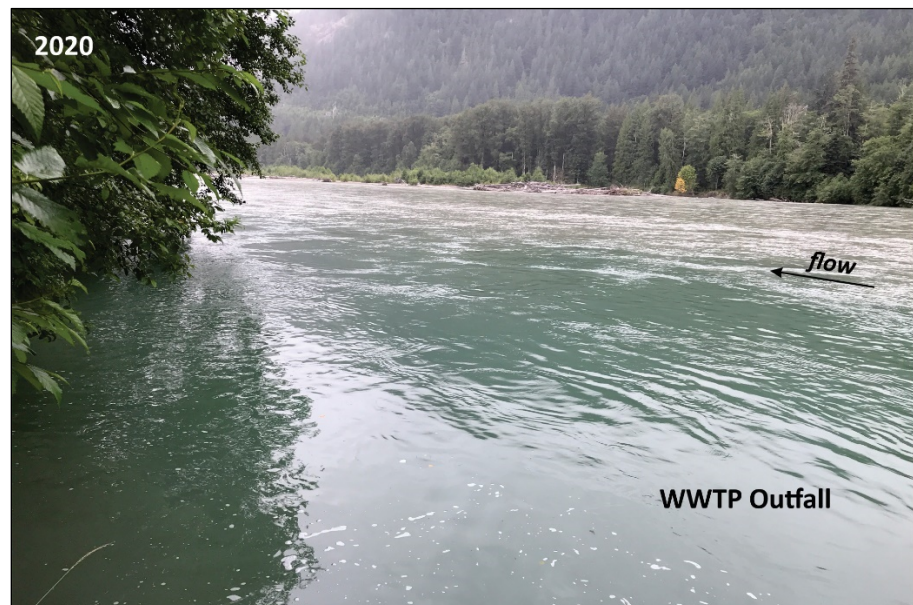
FIGURE 5.2 View downstream from the east (left) bank of the Squamish River near the WWTP outfall on July 17, 2020 (discharge approximately  $500 \text{ m}^3/\text{s}$ ). Note that the brown turbid water in the main flow of the Squamish River is separated from slower flowing water from Mamquam River that enters immediately upstream. Even at these relatively high flows, mixing conditions at the WWTP outfall are impaired by low water velocities near the shore. Photo taken by Lars Uunila.

<sup>3</sup> The low velocities over the outfall were observed during low tide. Tidal influence is expected to exacerbate the low velocities over the WWTP outfall.

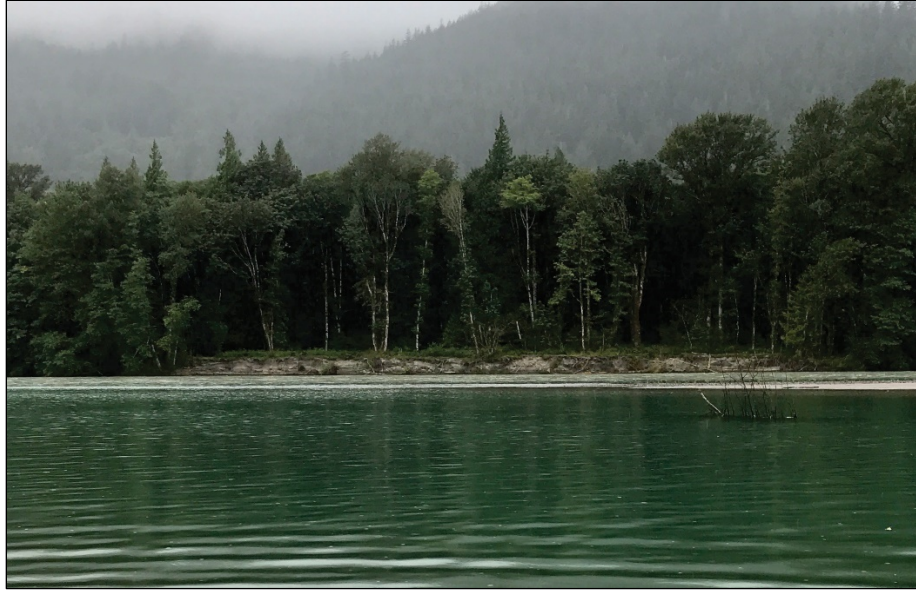
FIGURE 6.1 *View across from the east (left) bank of the Squamish River near the WWTP outfall on July 17, 2020 (discharge approximately 500 m<sup>3</sup>/s). Evidence of eroding banks on the west (right) bank near the WWTP outfall appears widespread. Photo taken by Lars Uunila.*

- Bank erosion was observed in 2019 as the enlarging sediment accumulations direct the river flow towards the opposite (west) bank near the Mamquam confluence (FIGURE 6.1).

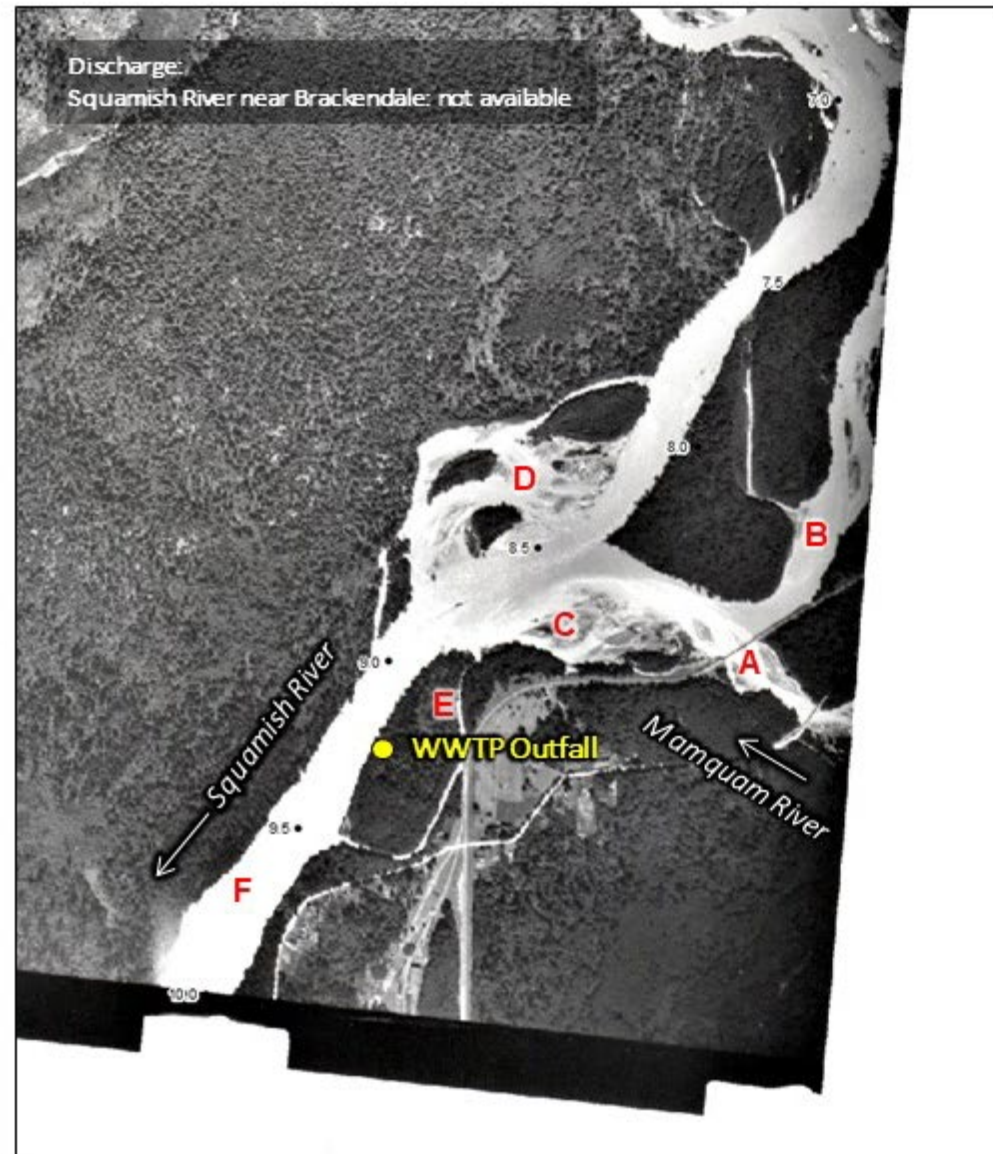
FIGURE 6.2 Historical changes in channel morphology near the WWTP Outfall: 1946 and 1964.

Date: 1946  
BC262-93

- Mouth of Mamquam River adjacent to railway bridge [A], and active side channel of Squamish River joins confluence of Mamquam River [B].
- Mamquam River fan is relatively small and unvegetated [C].
- Squamish River is multi-threaded and flows around vegetated islands [D]; there is an active side channel downstream of Mamquam confluence [E].
- Squamish River is relatively straight downstream of confluence [F].

Date: 1964-07-01  
BC5099-119

- Evidence of growth of fan at mouth of Mamquam River [G]; Mamquam River confluence moving northwestward into Squamish River [H].
- Gravel exposed within side channels [I, J].
- Vegetation establishing on mid-channel bars [K].
- Bank erosion on opposite bank of Mamquam confluence [L].

A summary of a detailed analysis of historical imagery near the WWTP outfall site is presented in FIGURE 6.2, FIGURE 6.3, FIGURE 6.4 and FIGURE 6.5. Due to the dike along the east (left) bank of the Squamish River, the river bank alignment near the WWTP outfall has not changed significantly since it was constructed; however, geomorphic changes upstream have driven sediment downstream and changed the local conditions at the outfall. Repeated cross-section surveys from 1976 and 2005 near the outfall location indicate approximately 10 m of erosion along the east (left) bank of the Squamish River and approximately 1 m of aggradation in places (KWL, 2011). The historical air photo analysis in the vicinity of the WWTP outfall indicates the following:

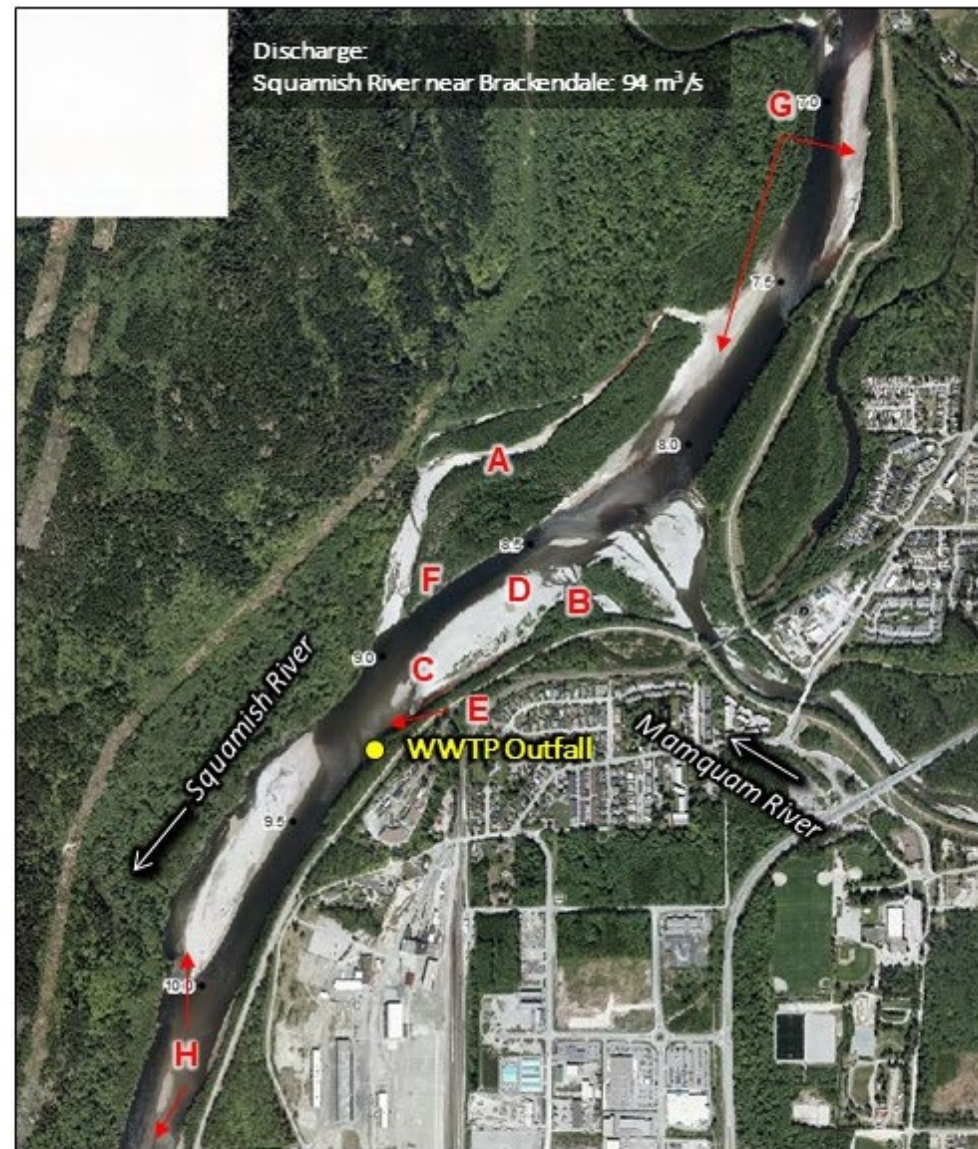
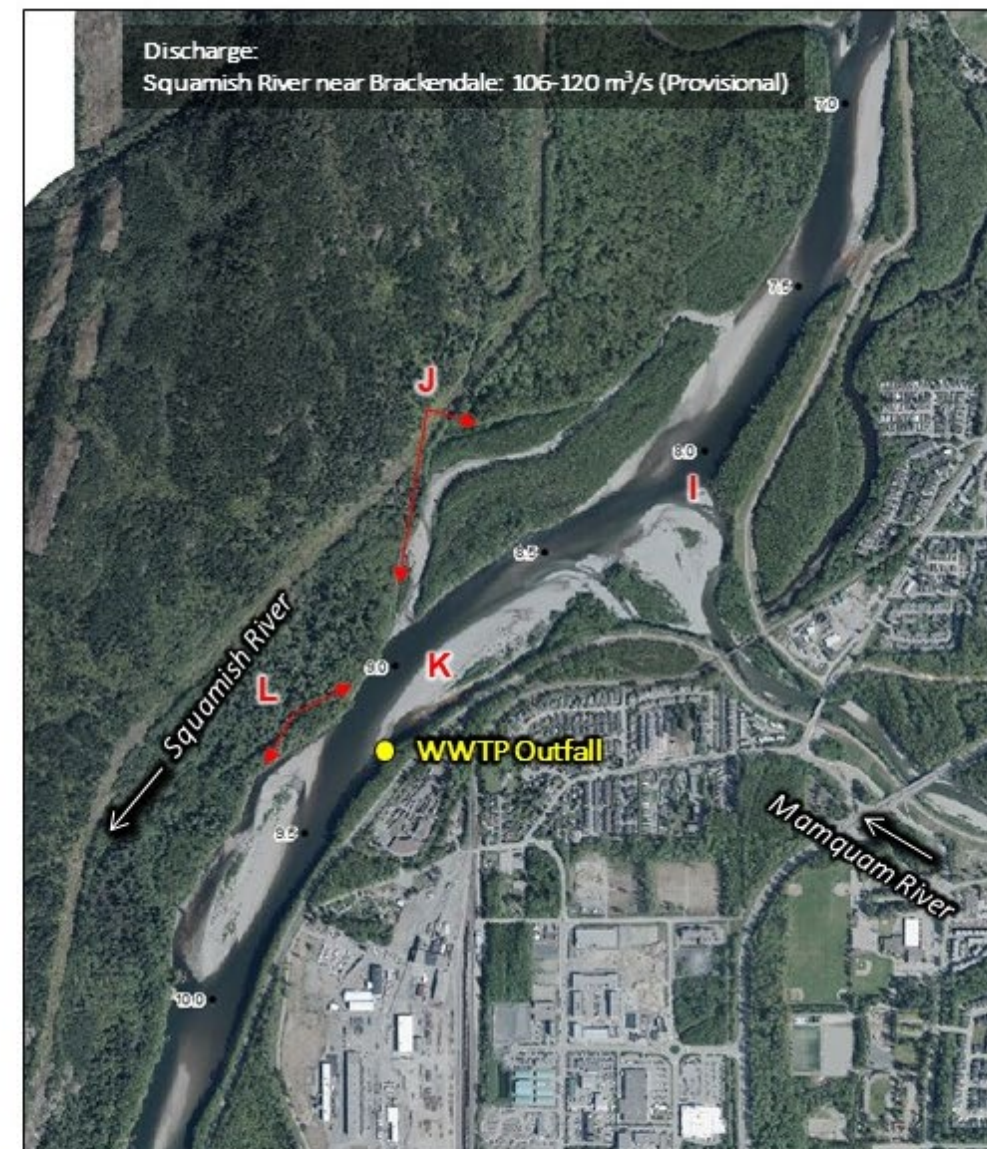
**Date: 2013-04-24**  
**District of Squamish Orthophoto**

- As bed material is deposited near the WWTP outfall, the bar has extended downstream and laterally across the channel.
- Establishment and growth of vegetation was observed since 2013 and large woody debris jams were observed in 2019 on the bar top; as the bar becomes more established it will continue to accrete laterally across the Squamish River.
