CHEEKYE RIVER TERRAIN HAZARD and LAND USE STUDY

Final Report – Volume 2

APPENDIX XII

HYDROLOGY

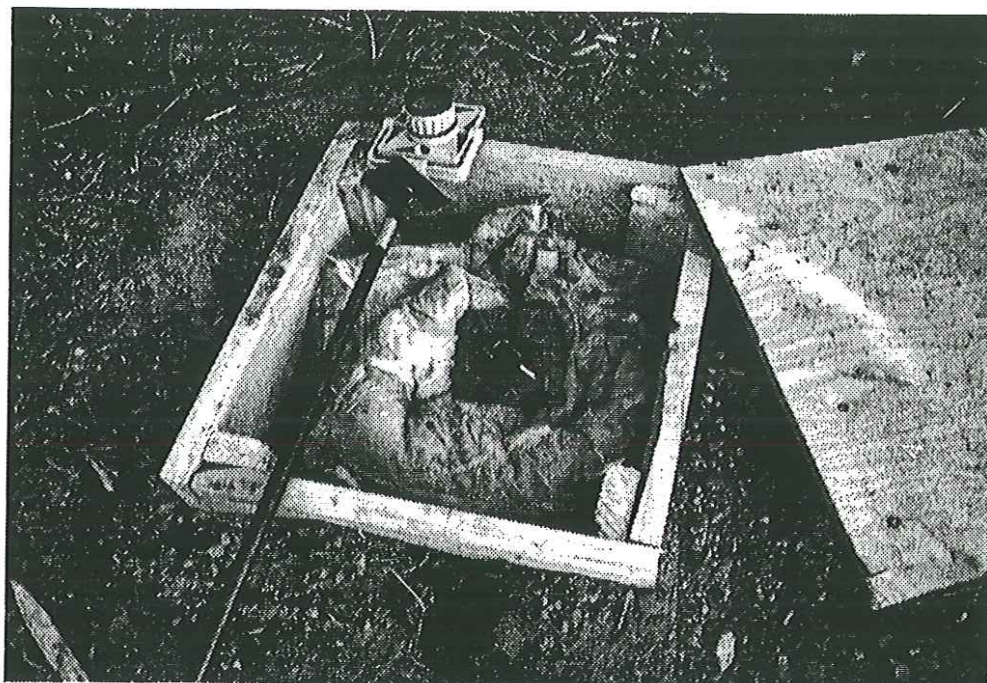
Typical Prism
Foundation Setup

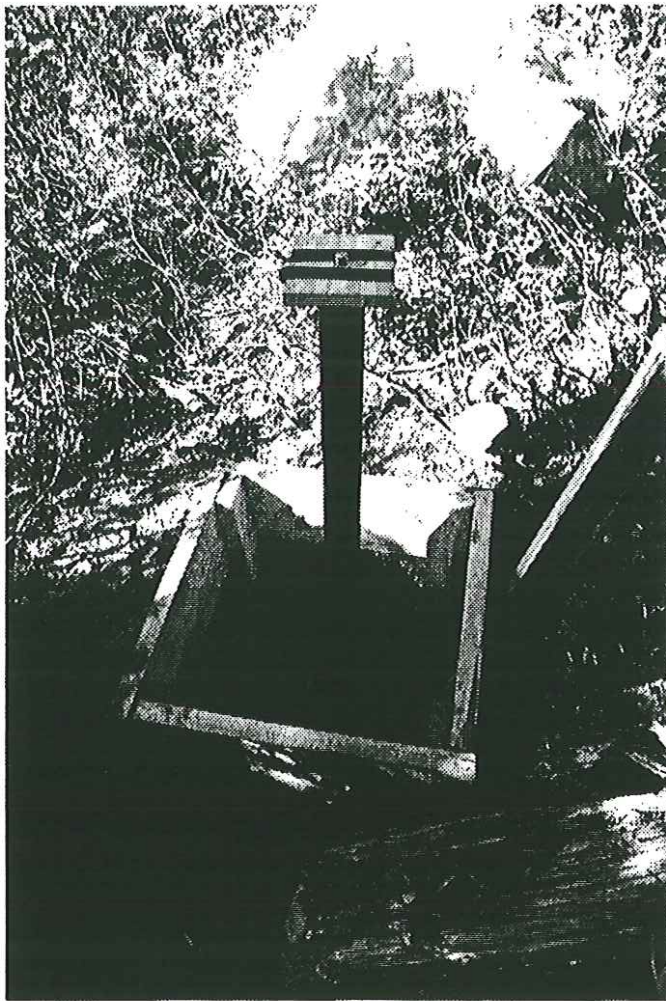
Monitoring Station Setup

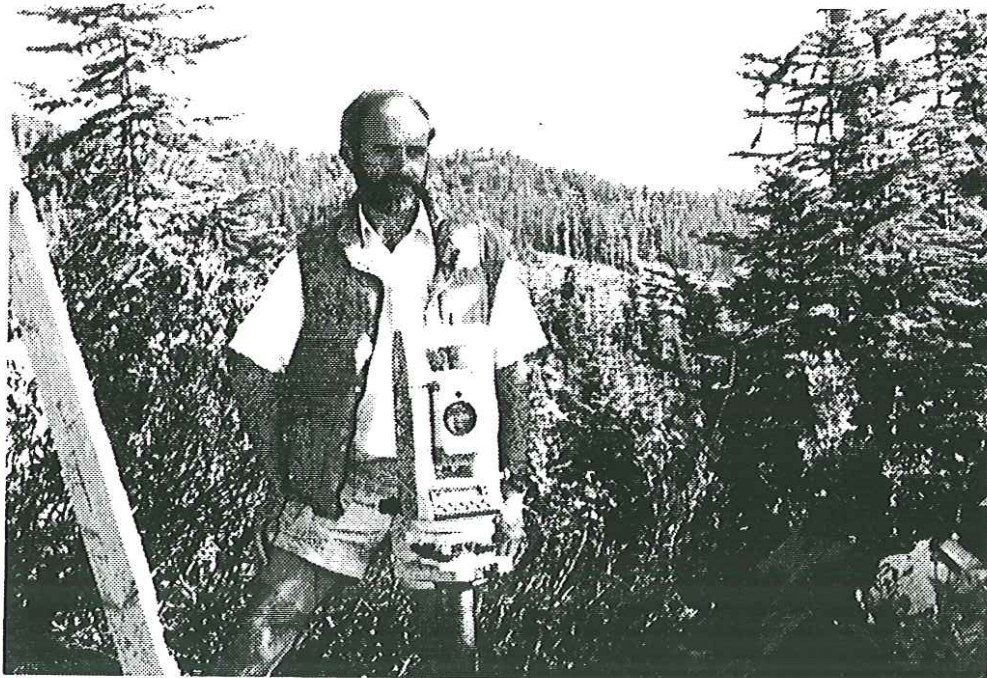
Instrument Setup
