W-2377 CHEEKYE RIVER

TERRAIN HAZARD and LAND USE STUDY

Final Report - Volume 1

CHEEKYE RIVER TERRAIN HAZARD AND LAND USE STUDY

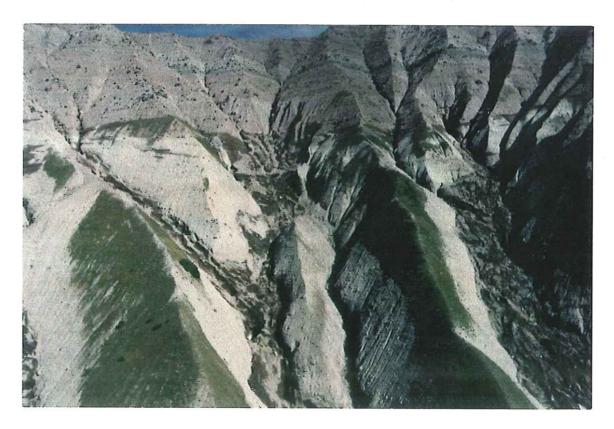
PLATE 2

Pyroclastic breccias in the headwall of Cheekye Valley.

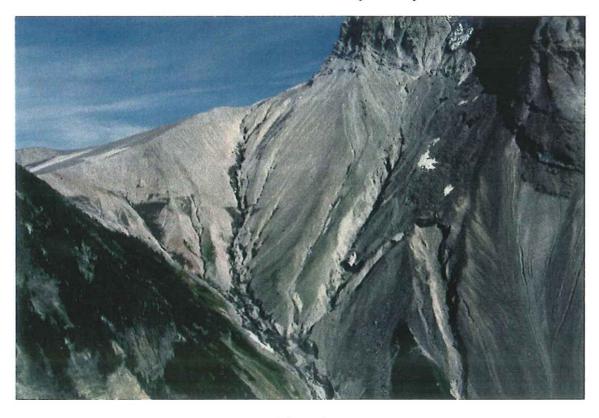
$\underline{\text{PLATE 4}}$ Pyroclastic breccias between Dalton Dome and Brohm Ridge.

The lower half of the stratigraphic column exposed in the headwall below Diamond Head is a grey-coloured variety, distinguished by a lack of boulder and cobble particles, although the matrix is less silty than that of the upper Cheekye Ridge breccias. A similar fine-grained deposit is found at the head of Brohm Ridge (Plate 4).

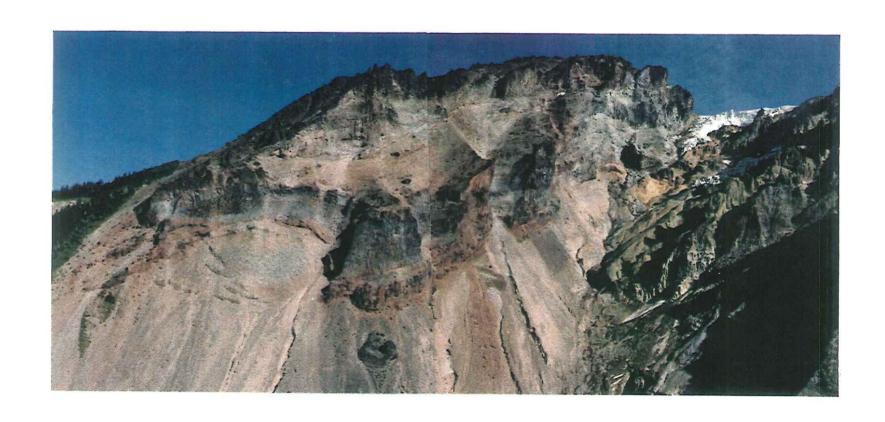
PLATE 5

Dalton Dome volcanic sequence.

A generalized stratigraphic column through the Dalton Dome volcanic sequence is shown in Figure 3.9 and can also be recognized on Plate 5. The sequence consists of alternating massive lava units and thinner interbeds of pyroclastic breccias and sandy gouge. The finest non-indurated material observed in the column is a 1 m thick layer of sandy gouge whose grain size distribution is shown in Figure 3.10. The material is a well graded, angular silty sand.

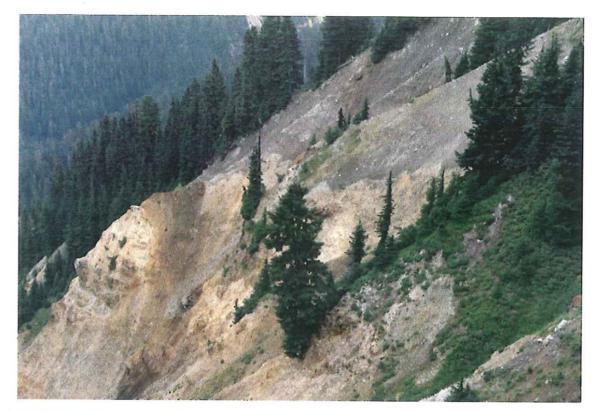
Contact between pyroclastic breccias and altered basement on Cheekye Ridge.

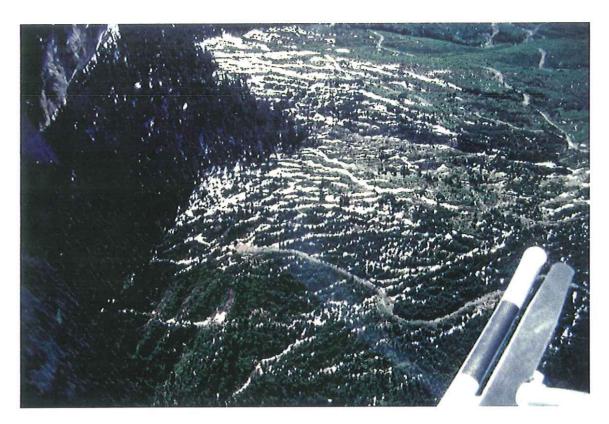
<u>PLATE 8</u>
Cheekye linears. Overall view looking east.

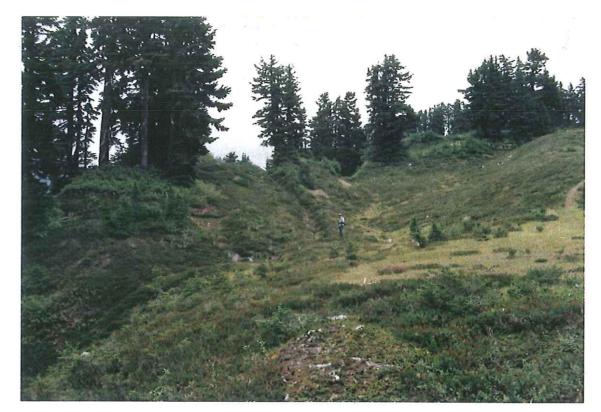
Minor sag features on Cheekye Ridge, Elevation 1,650 m. The valley is to the left.

Small groups of cracks indicative of normal sagging movements appear at El. 1650 on Cheekye Ridge and El. 1800 m on Brohm Ridge. These show relative vertical displacement with the downslope side moving down. Plate 10 and surveyed Section E-E show the former feature.

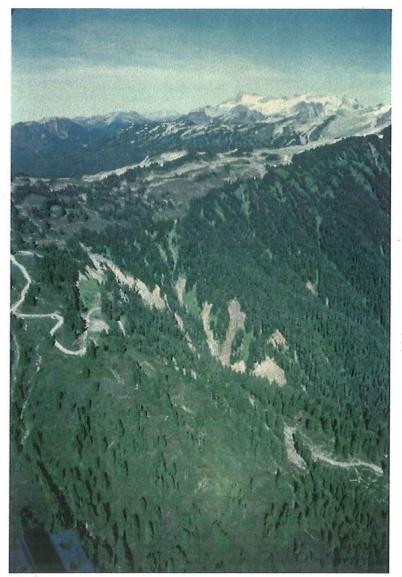
PLATE 11

Disturbed area on Brohm Ridge. Cheekye Valley is to the right.

Another swarm of linears was identified on Brohm Ridge, as shown in Figure 3.13 and on Plate 11. They are very similar to the Cheekye features in several aspects. The disturbed area is covered partly by a lava flow. In the lava, the linears assume the character of tension cracks and sharp-edged depressions, or vertical scarps with normal displacement.

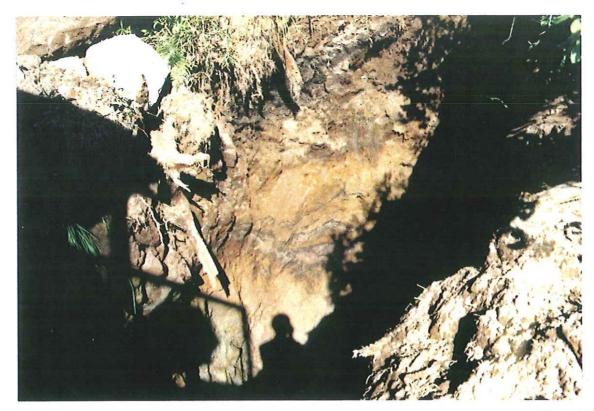
East side of Test Pit 91-C-2 on Cheekye Ridge, showing buried peat.

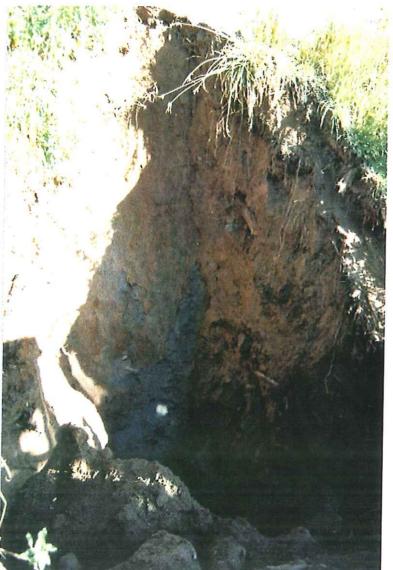
PLATE 13

West side of Test Pit 91-C-2 on Cheekye Ridge, showing steep shear surface.

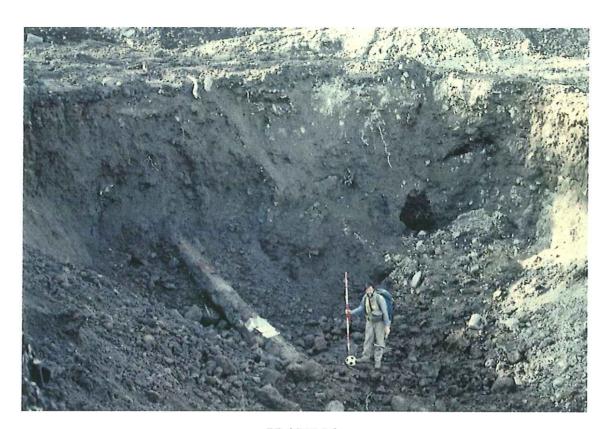
PLATE 16

Garbage Dump deposit and a buried log.

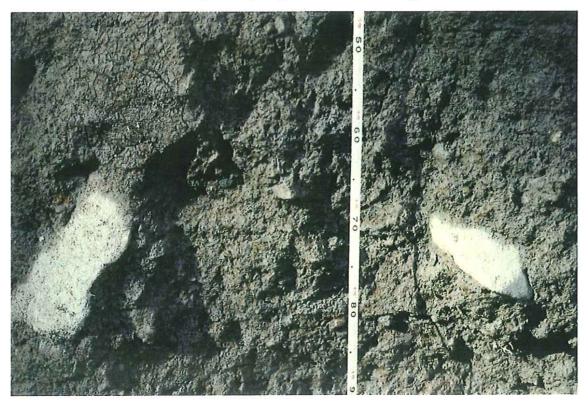
PLATE 17

Typical texture of the Garbage Dump deposit.

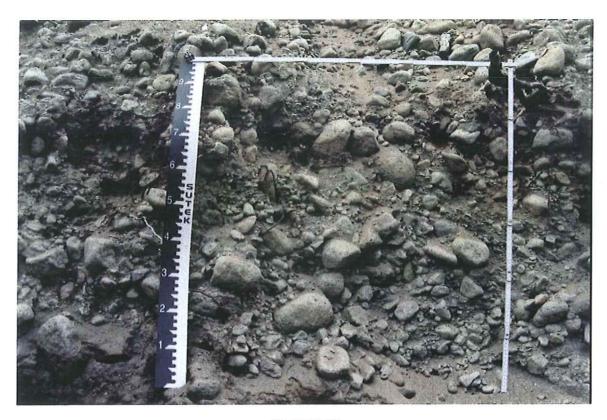
PLATE 18

Debris flood ("fluvial") deposit near the margin of Cheekye Fan.

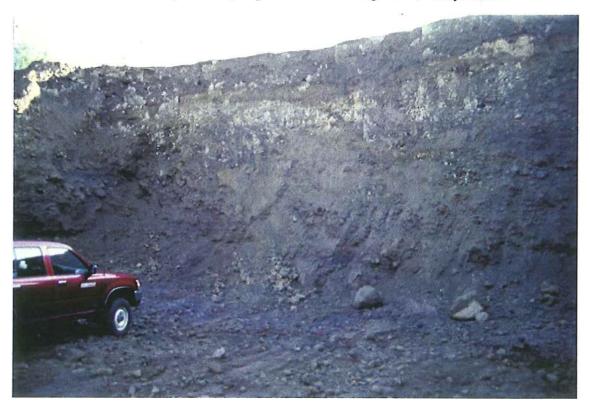
PLATE 19

Debris flow deposit (top layer) overlying a fluvial sequence near the Cheakamus River.

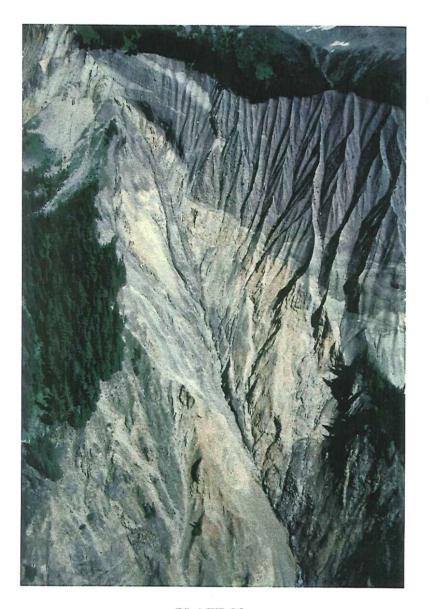
PLATE 23
Source area of the 1984 Mt. Cayley debris avalanche - debris flow.

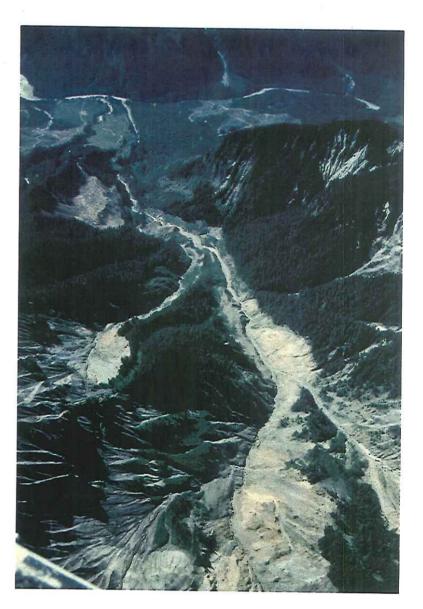
PLATE 24

Path of the 1984 Mt. Cayley debris avalanche. The right trimline in the first bend of the path is 115 m above the channel.

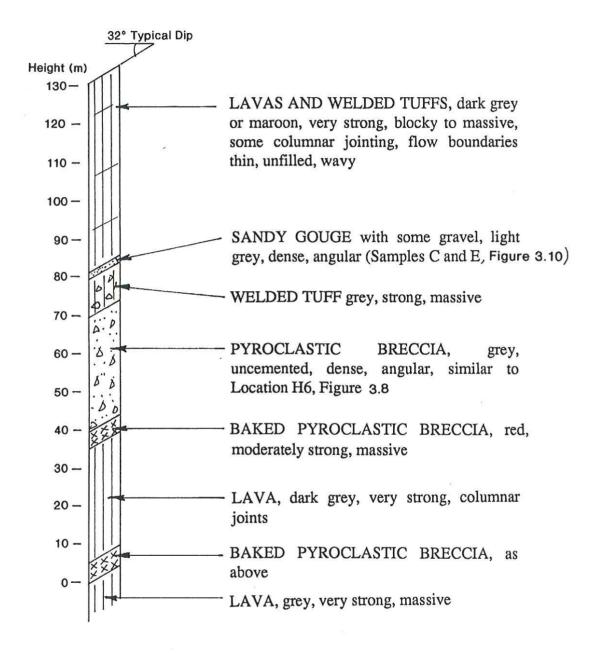
Figure 3.14

SCHEMATIC STRATIGRAPHY, EXPOSURE OF UPPER FAN DEPOSITS AT POWERLINE CROSSING OF CHEEKYE RIVER

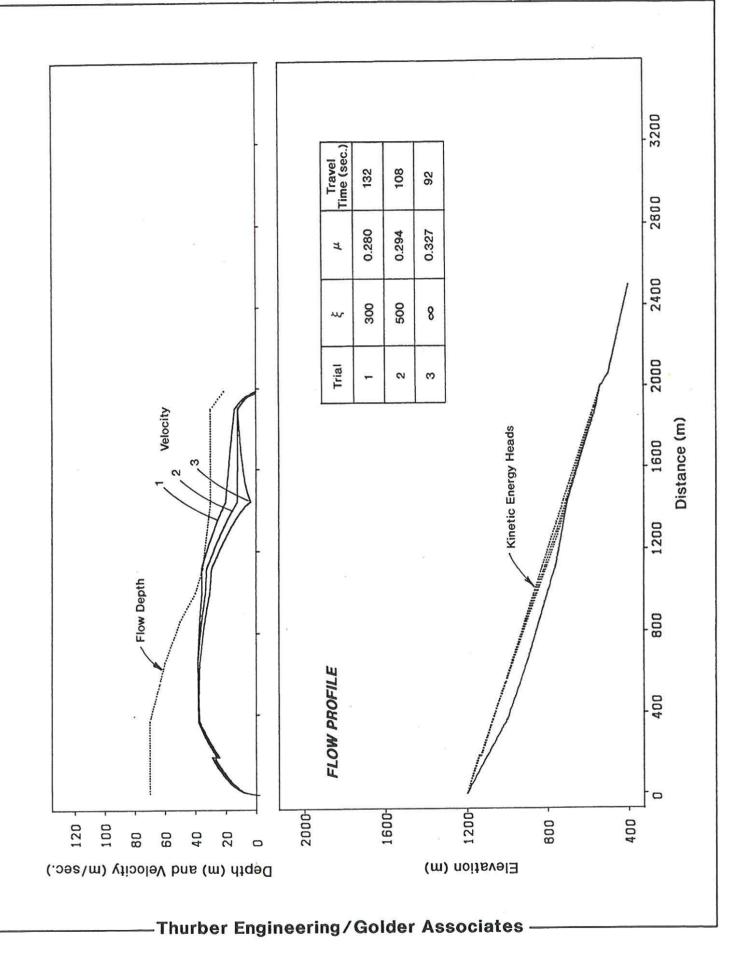
DYNAMIC ANALYSIS OF "LARGE" POTENTIAL ROCK AVALANCHE FROM DALTON DOME

- 7.16 Dynamic Analysis of "Large" Potential Rock Avalanche from Dalton Dome
- 7.17 Dynamic Analysis of "Small" Potential Rock Avalanche from Dalton
- 7.18 Dynamic Analysis of Large Scale Potential Failure of the Cheekye Ridge

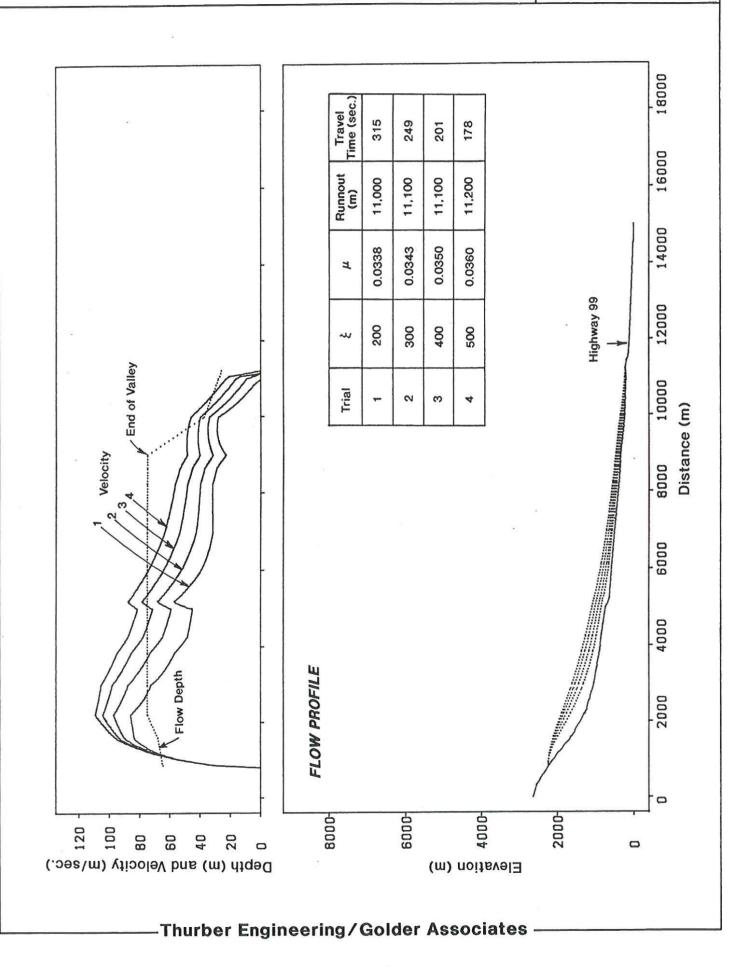
Figure **7.18**

DYNAMIC ANALYSIS OF LARGE SCALE POTENTIAL FAILURE OF THE CHEEKYE RIDGE
