MEMORANDUM

DATE: November 24, 2014
TO: Deborah McQueen, Hummingbird Lane Joint Venture
Triage and Planning Unit, Fisheries and Oceans Canada
CC: Caroline Ashekian, Environmental Coordinator, District Of Squamish
Sarah McJannet, Acting Director of Planning, District of Squamish
FROM: Mike Nelson, R.P. Bio., Cascade Environmental
Karlene Loudon, B.Sc., B.T.M., Cascade Environmental
RE: Riparian Area Regulation Assessment for 1038 Finch Drive, Squamish, BC
FILE #: 604-01-01

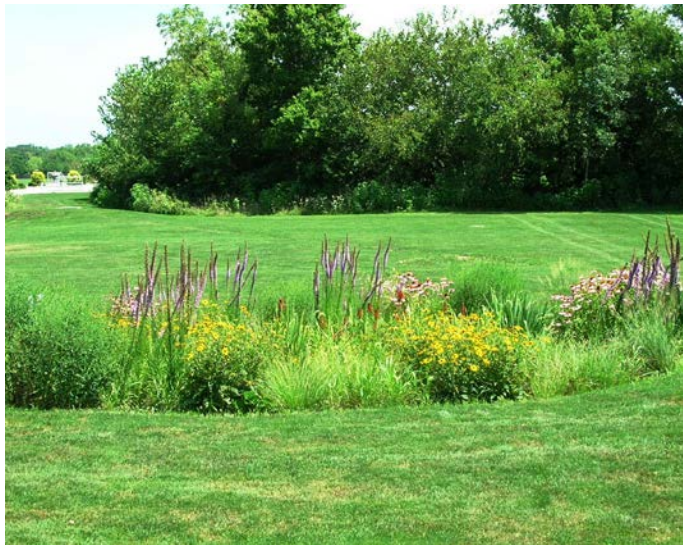
Photo 10: Photo of an example rain-garden. Photo taken from www.indy.gov on November 13, 2014.

The intention of the rain-garden is to mimic and improve the infiltration function of the former west ditch. The feature will be 2 m wide and be planted with native species. The channel itself will be over-excavated and a perforated drain-pipe will run the length of the rain-garden, allowing excess water to flow into south ditch at the southwestern property boundary. A geotextile will be placed on top of the pipe, followed by a layer of drainage tile and 30-50 cm of silty loam. The rain-garden would then be planted with facultative wetland sedge, reed species and shrub. The total area of the rain-garden riparian feature is 240 m².
